# **The Restoration of a Historical Sediment Study and the use of LiDAR in the Determination of Elevations in the Whitewater River Valley.**

By Lawrence Svien, Graduate Student, Penn State MGIS program

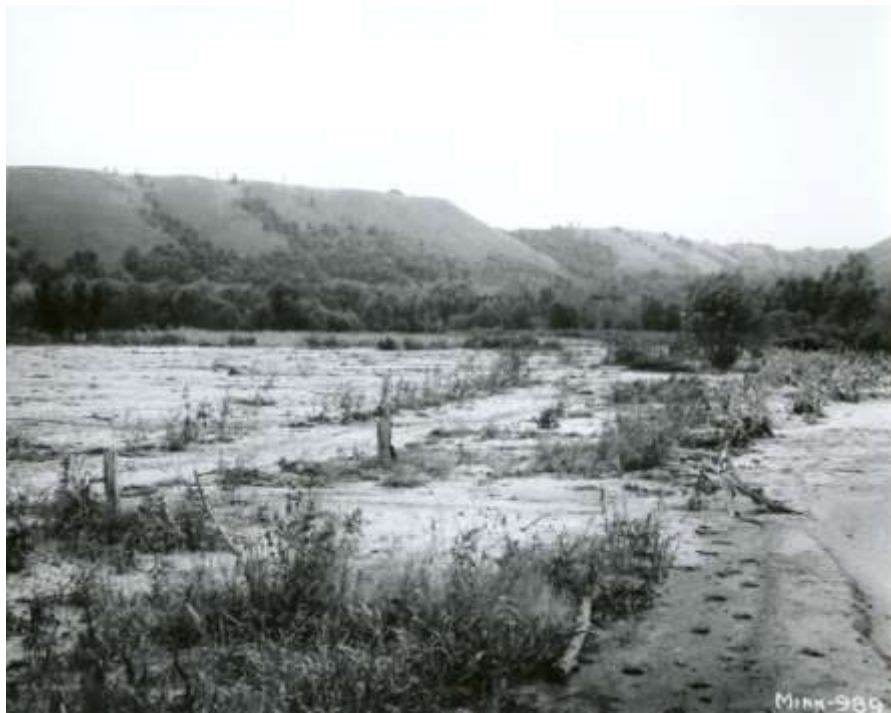
Figure 5 Typical damage to the cropland in the Whitewater flood plain after a flood event. Notice the lack of trees and permanent cover on the hillsides in the background. Also notice the height of the fence posts in the foreground. Fences usually are 4 feet or more above ground level. Photo Courtesy of the USDA Soil Conservation Service

In the 1920's and 1930's because of increasingly intensive farming practices, the lack of conservation measures, and permanent cover on critical slopes the town of Beaver and the Whitewater River flood plain began to experience increasing levels of flooding and inundation. Historical records relate how in 1938 the town and valley area were flooded 28 times. (The Beaver Story, We Remember, 1962) The upland erosion associated with the flooding also deposited tremendous amounts of sediment in the valley floodplain damaging cropland, infrastructure, and buildings (Fig. 5).

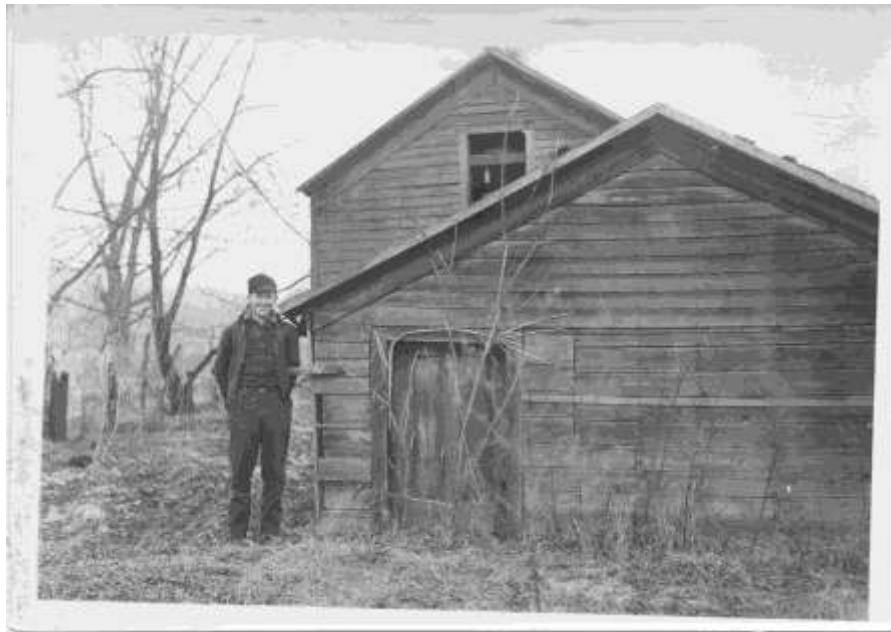
Figure 6 Damage to a dwelling in the Whitewater valley due to sedimentation. Photo Courtesy of the Winona County Historical Society.

Due to the almost continuous flooding damage and sedimentation people began to leave the valley and the State of Minnesota began to purchase the land for establishment of a Wildlife Management Area (WMA). The purchasing of the land was completed in the 1960's and much valley floor is now WMA, State Forest, or State Park land. When some of the older buildings were salvaged or torn down it was discovered that what was assumed to be the first floor was actually the second floor. The owners had just built onto the existing building upward after the first story had become filled with sediment (Fig. 6).

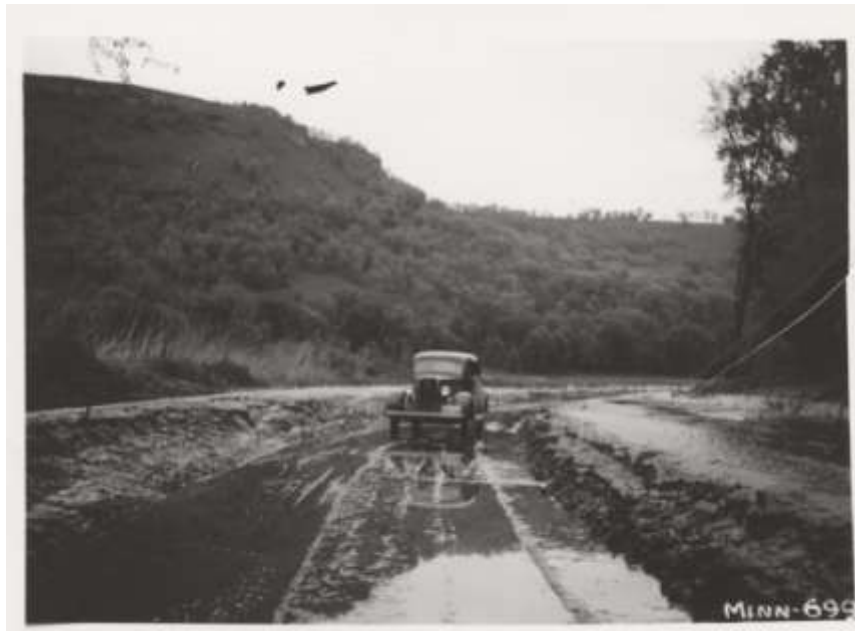
Figure 7 Road Damage due to flooding and sedimentation in the Whitewater Valley. Photo courtesy of USDA Soil Conservation Service.

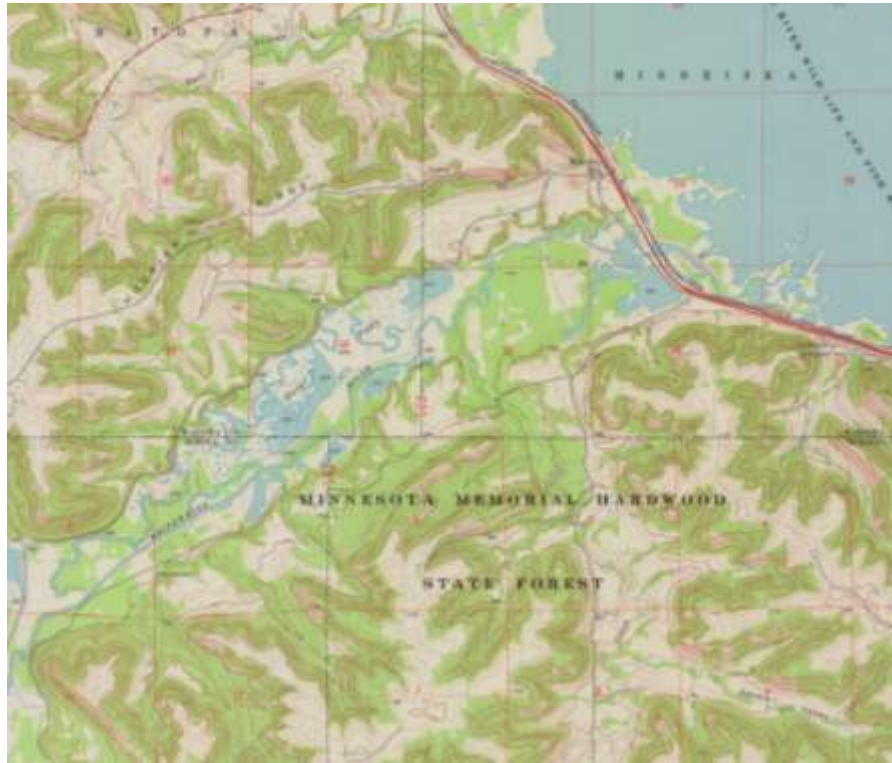
Figure 10 Topographic map of the lower main branch Whitewater River, USGS Weaver Quadrangle 7.5 minute series, 1972. Notice the increasing amount of water and wetlands symbols in the valley floodplain as compared to the 1937 topographic map (figure 3)

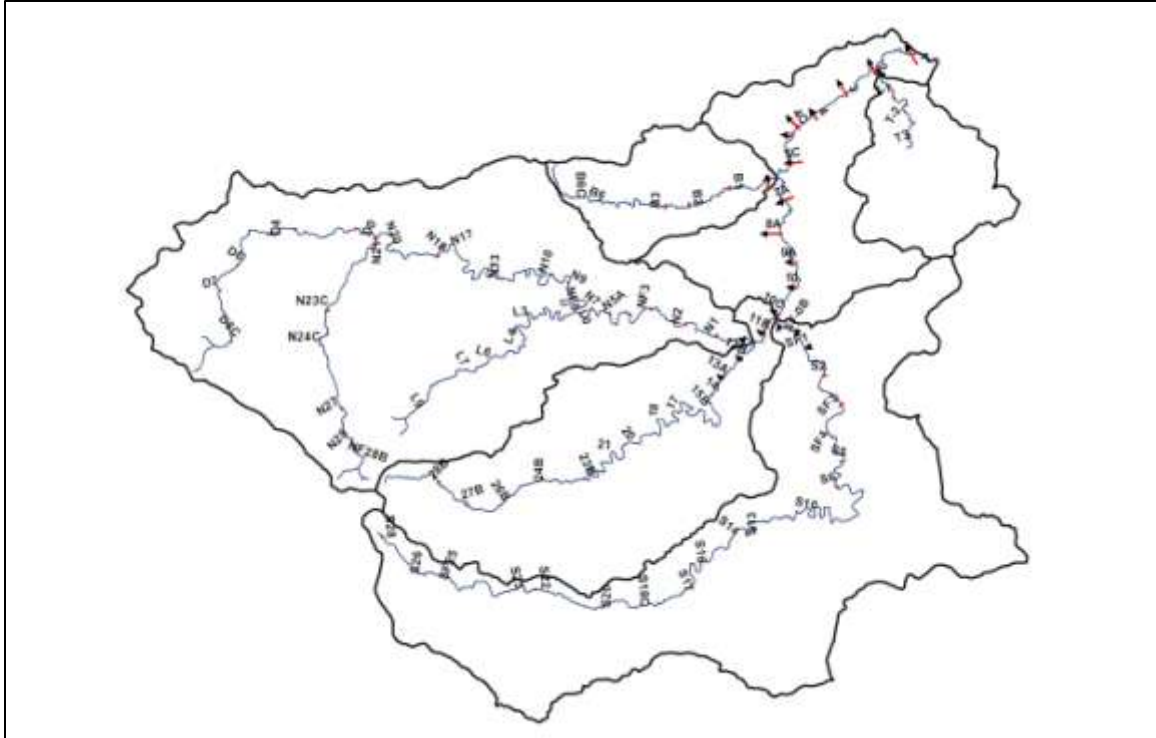
Figure 11. Location of Happ Sediment Study ranges. Also pictured are sub-watershed boundaries

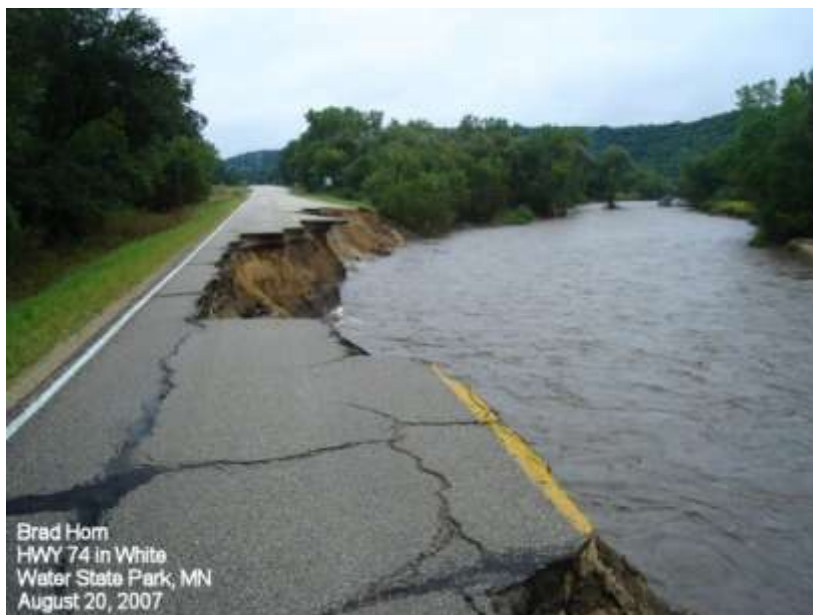
Figure 12 Road Damaged in 2007 Flood Event in the Whitewater River Photo courtesy Wikipedia.

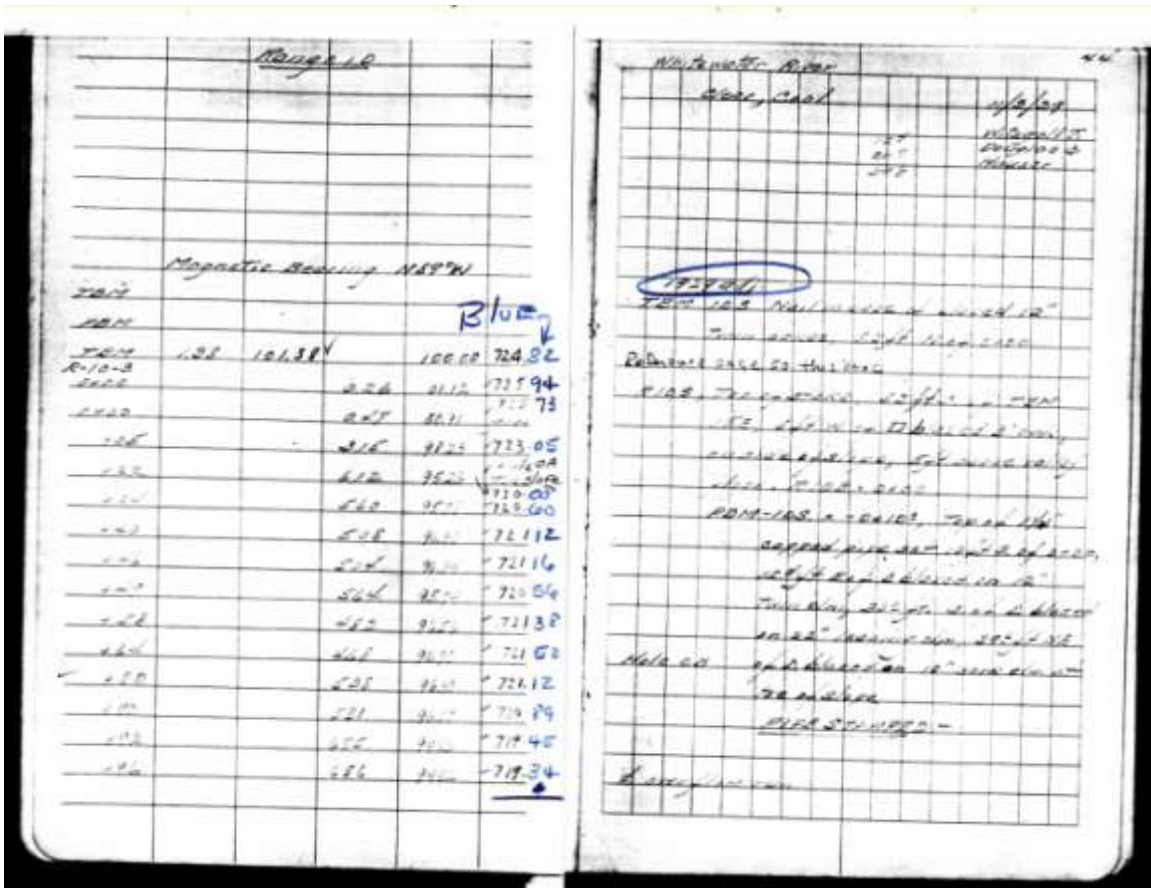
Figure 13 An example of the original survey notes from the Happ survey in 1939

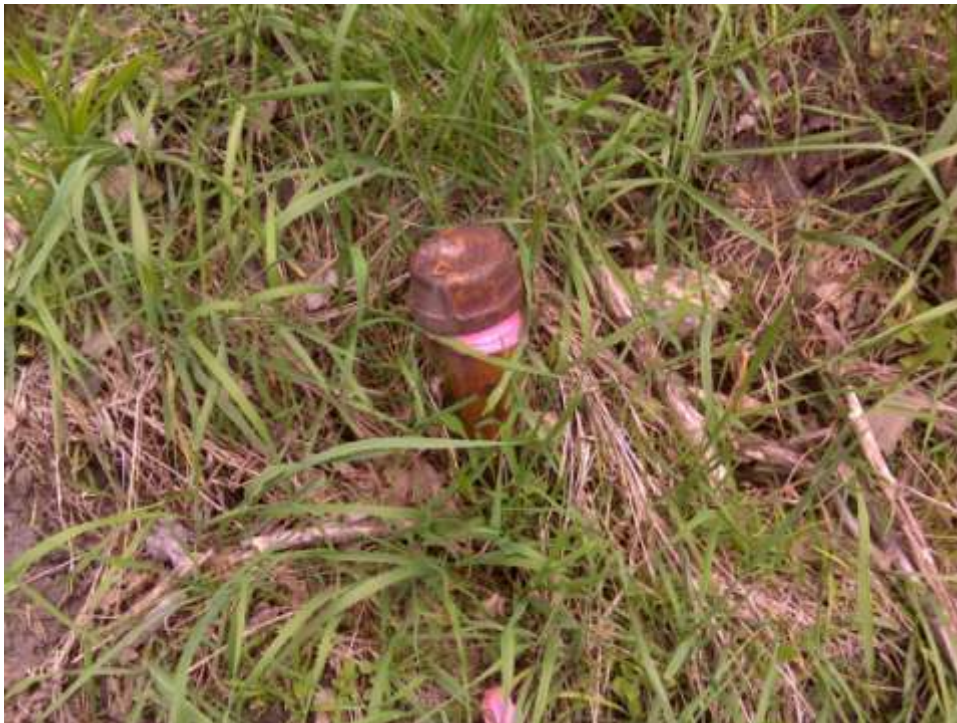
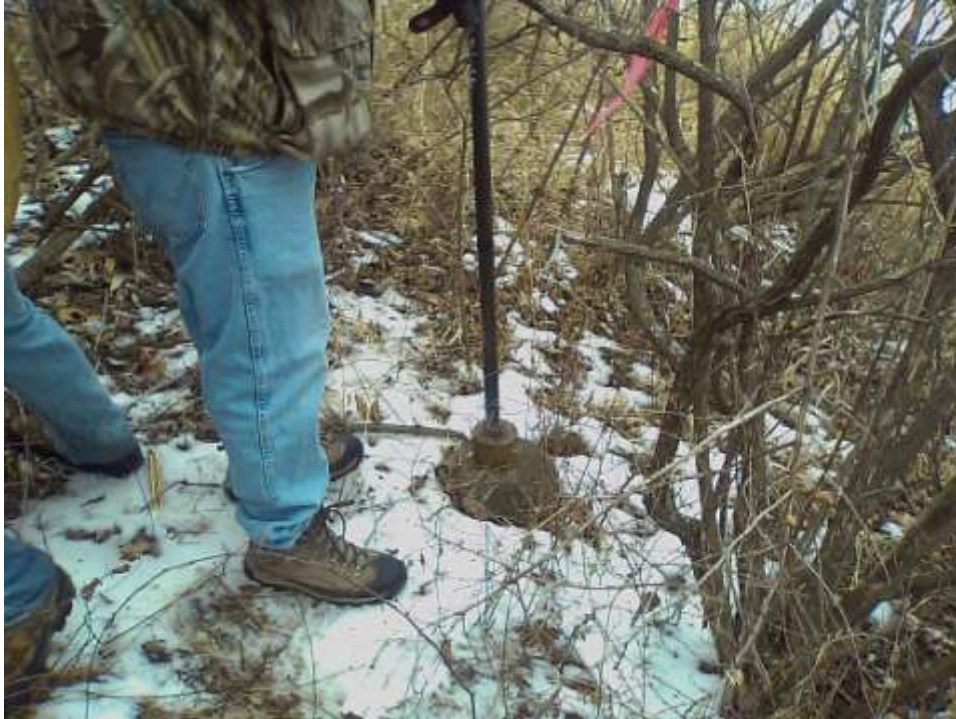
Figure 14 Examples of the monuments that marked the endpoints of the x-section lines

once the monuments were located they were marked with flagging and paint. After the monuments were located either concurrently or during later visits the location was recorded using GPS. Originally the initial effort was using a NDGPS differentially corrected Garmin GPS in the USDA configuration 1 (Configuration I, ND). Later the NRCS upgraded to the Trimble GEOXT 2008 (GeoExplorer 2008 Series Documentation, ND) which provided additional precision and the ability to edit shapefiles directly in the field. After the end points had been located where possible the location and elevation was further refined by use of a survey grade Trimble R8 GNSS receiver.

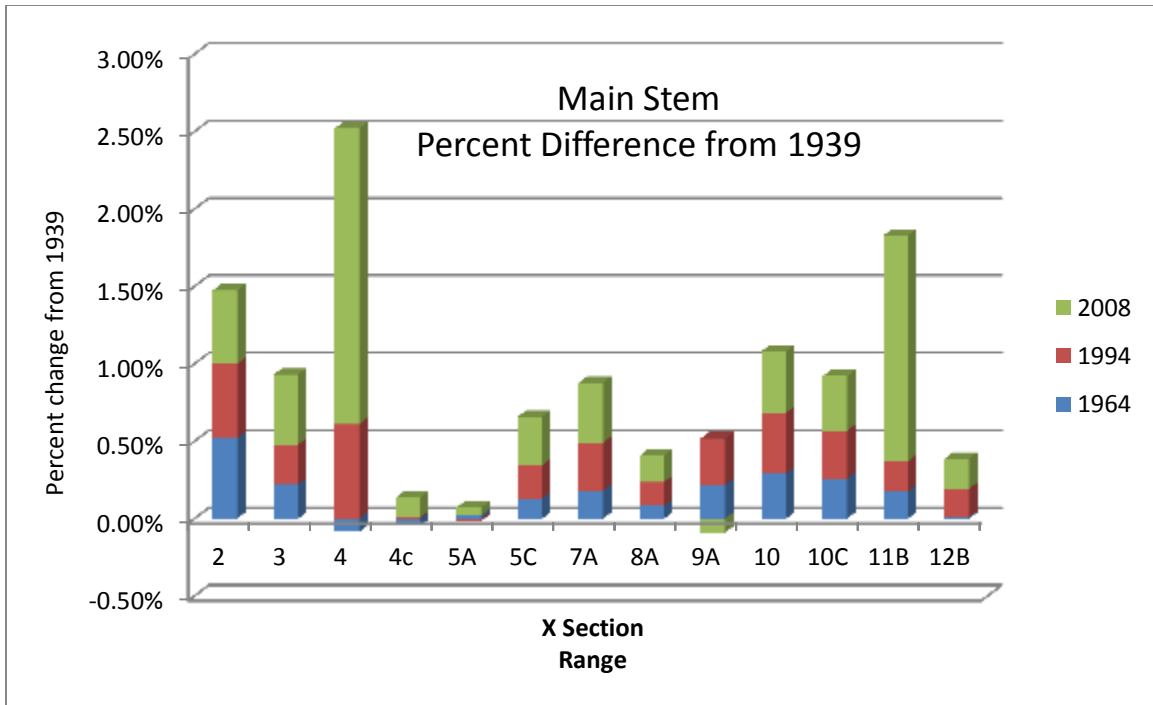
Chart 1 Percent change Main Stem for each epoch using 1939 as the baseline

All surveys previous to the 2008 LiDAR collection were converted to sea level elevations and UTM coordinates. The cubic volumes were calculated for each epoch (1939, 1964, 1994, and 2008) on each range line. Comparison between epochs was made using the differences between the charted range elevations. The differences are expressed as a percent of the total volume of the range as measured in 1939. Since there has not been established a true pre-European settlement baseline elevation, 1939 was used as the baseline. It is known by the history of the area that significant amounts of sediment had already been deposited prior to 1939, it is beyond the scope of this study to establish that baseline

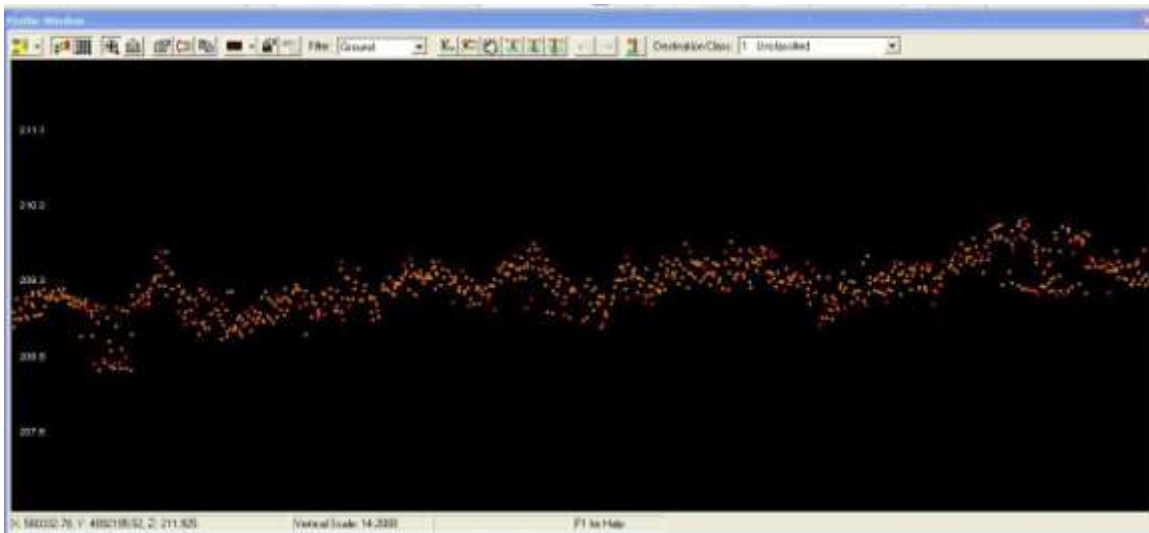
Figure 17 Profile of las points displayed in LP360

When viewing the graphed data extracted from the LIDAR dataset the lines are very irregular. I believe it to be the influence of the heavy reed canarygrass cover in the valley on the LiDAR return. Because the area is not managed for agriculture and there is no active burning in the valley, the whole valley floor has been taken over and reed canarygrass and scattered willow stands dominate.

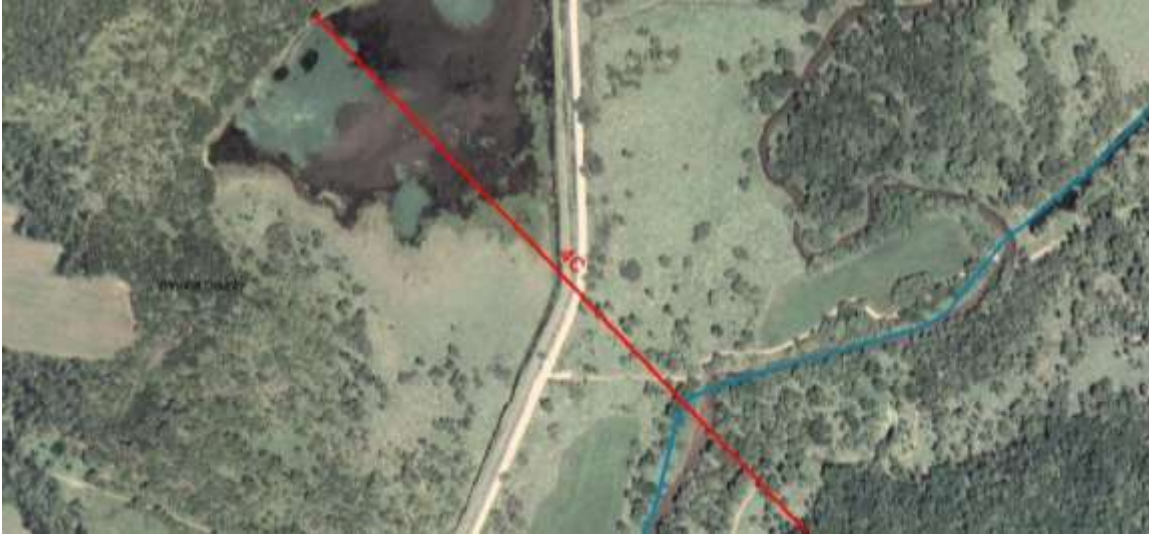
Figure 18 The area displayed in Figure 15 is along the range line between the road SE to the river

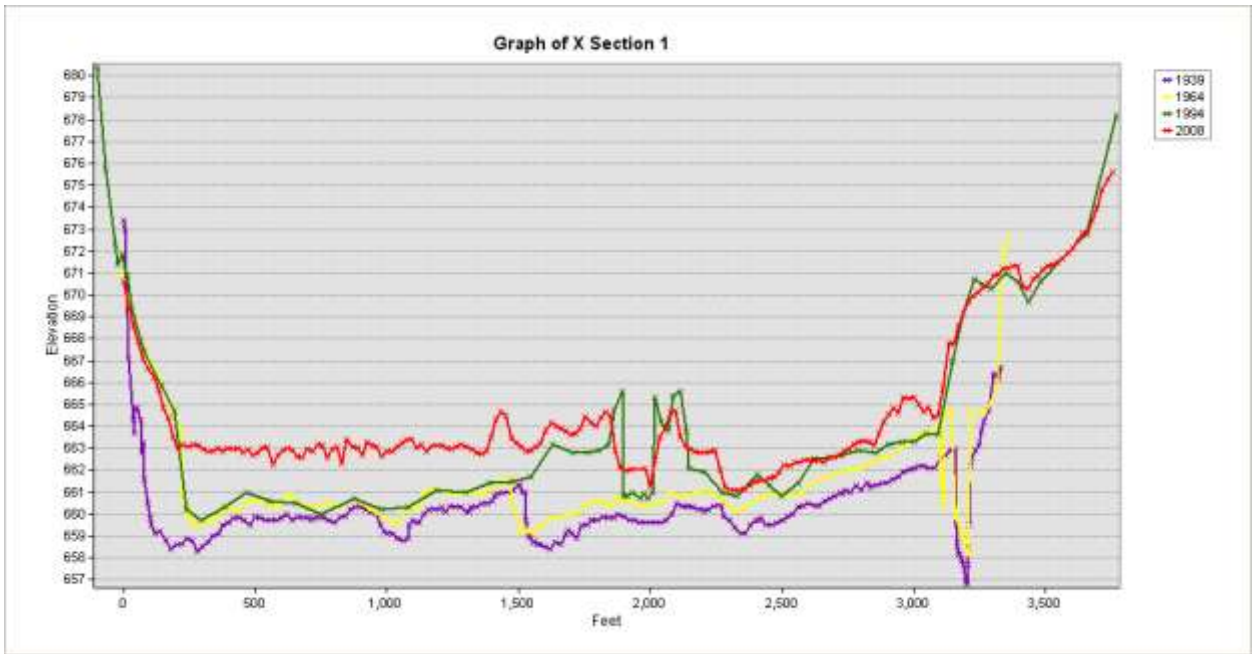
Plot of elevations of the various surveys.

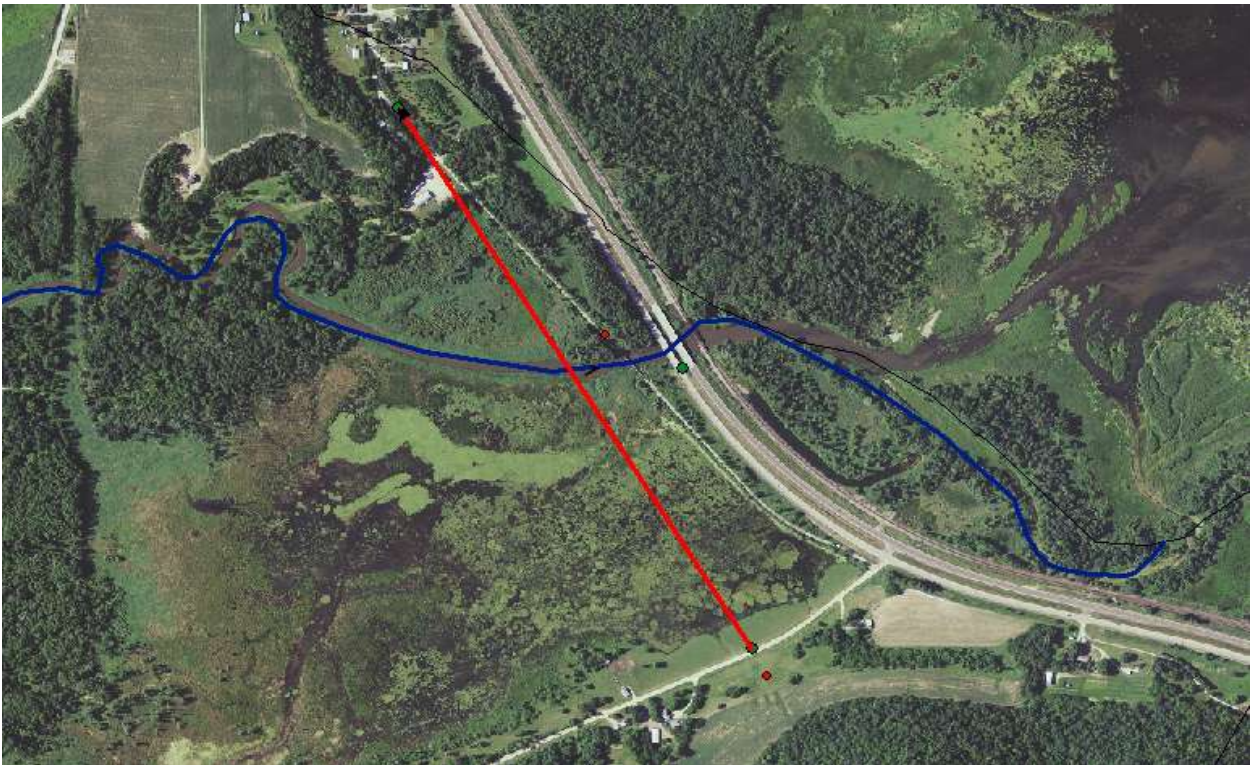
X Section Range 1 Whitewater Main branch. This is the outlet of the Whitewater at its confluence with the Mississippi River. Station 0+00 is located right down stream and goes from south east to northwest. Significant manipulation of the area due to the installation of the railroad and twice relocating US Hwy 61 has caused the manipulation of the river channel and restriction of flow due to the two bridges installed. While the south endpoint established in 1939 has been relocated in 2011 the north endpoint monument has been lost and reset repeatedly during each survey making the northern data somewhat suspect.

The flood of 2007 has severely impacted the area around Range 12B. This area had significant flood damage and as a result also significant reconstruction activities. In addition because of all the changes to the endpoint monuments Range 1 was considered to be an outlier and not included in this analysis.

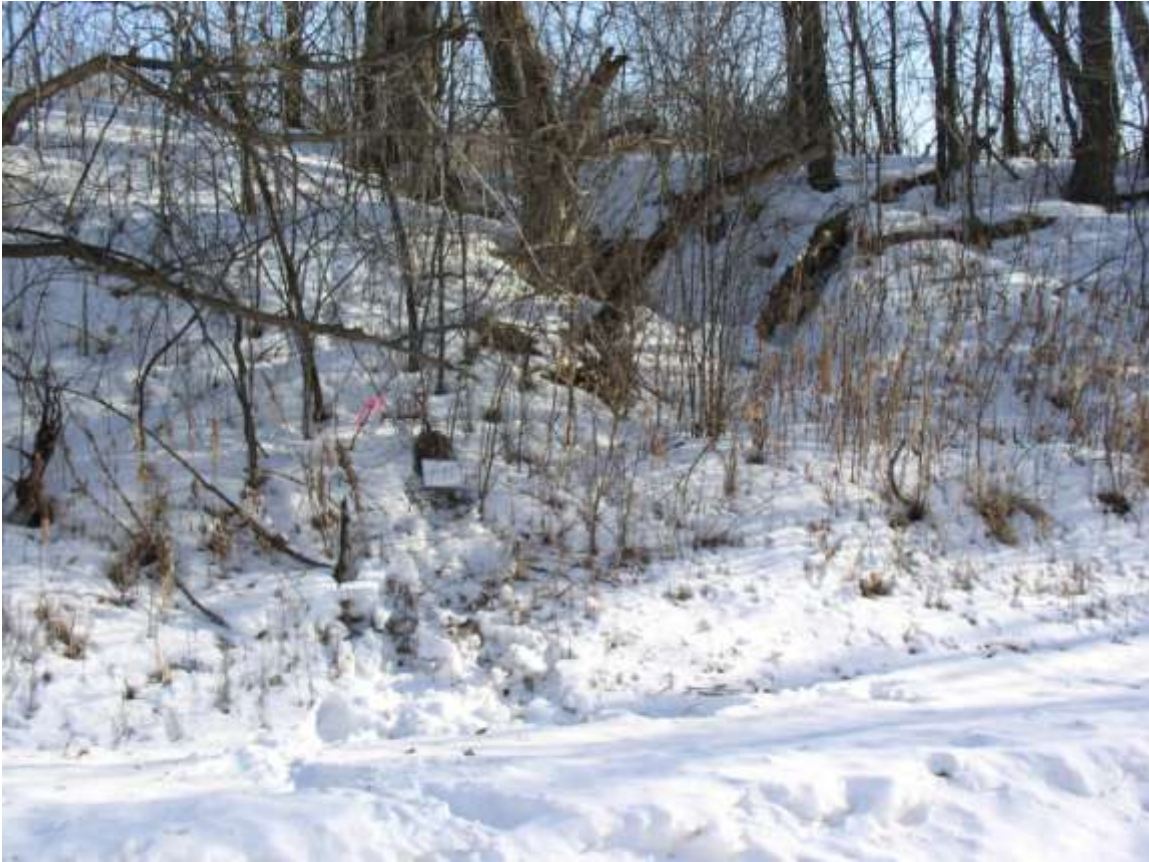
Monument 1-N This monument has been repeatedly moved during the life of the survey. It was originally established during the 1939 establishment period but lost and re-established both in the 1964 and 1994 surveys. Photo by Doug Christianson

The endpoint was then moved to a higher elevation further north but was again lost before the 1994 survey. Again the end point was moved to another higher elevation and again it was further north. The south end point monument was thought to have been lost between the 1964 and 1994 surveys but was found this past summer by Doug Christenson and the author. A fence was used to reference the location of the monument. The monument was recorded in distance and direction of the fence line in the survey notes. The fence was moved right before the 1994 survey and the survey party was unaware of the change and therefore were looking in the wrong location. It happened to be found because one day during a search the landowner drove by and inquired what was going on. In the following conversation it was discovered the fence had been moved further off the road and probably more in accordance with the county legal right-of-way. Once the additional distance was accounted for a quick scan with a metal detector located the monument, bent over and buried about 10 inches below ground on the road shoulder. Being that the monument was bent, probably by equipment resurfacing the road, we can only estimate the probable location and elevation of the original end point.

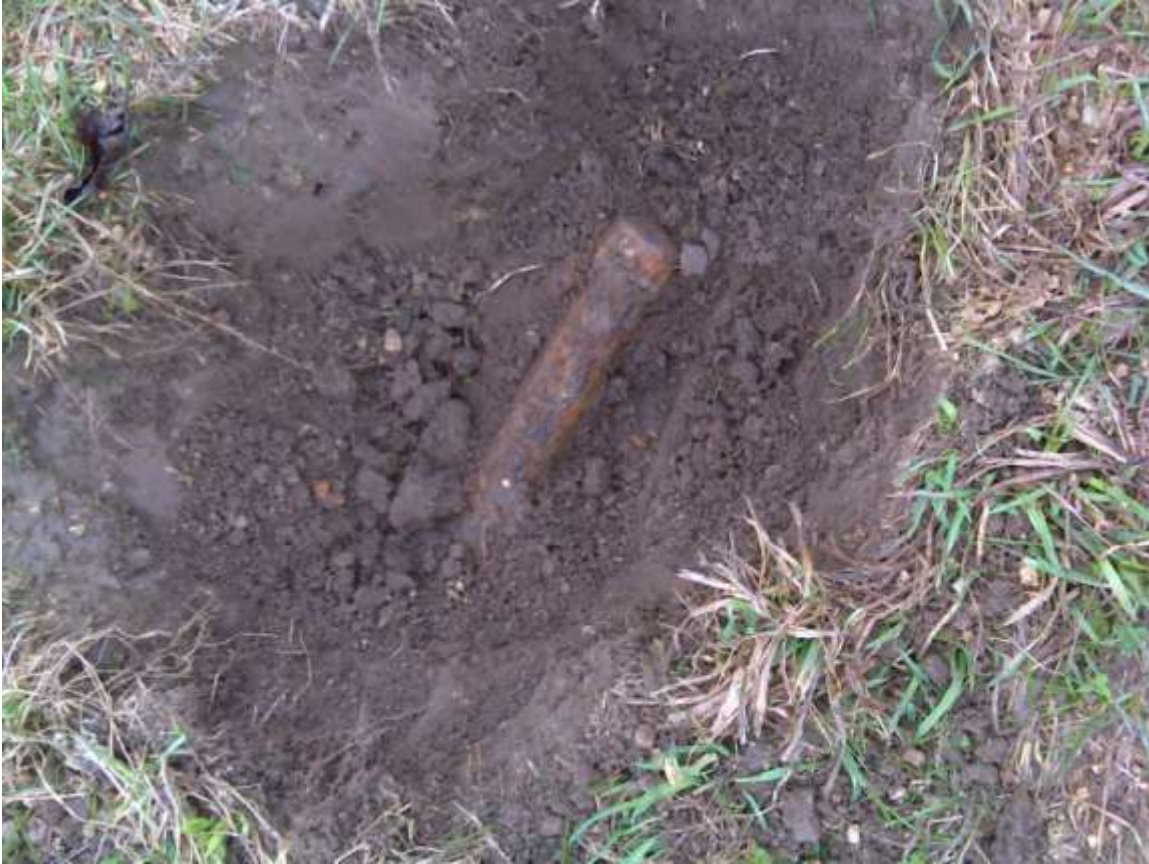
Monument 1-S. This monument was located on 4/22/11 after repeated attempts over a number of years to locate. It was during one of the attempts while looking for it with a metal detector that the owner of the property came by. Through a conversation it was discovered that the fence referenced in the 1994 survey was moved 1 month after the survey. The road was widened and the fence was moved. It is now only 2 feet off the shoulder of the current road and most likely was bent during construction activities. Photo by author.

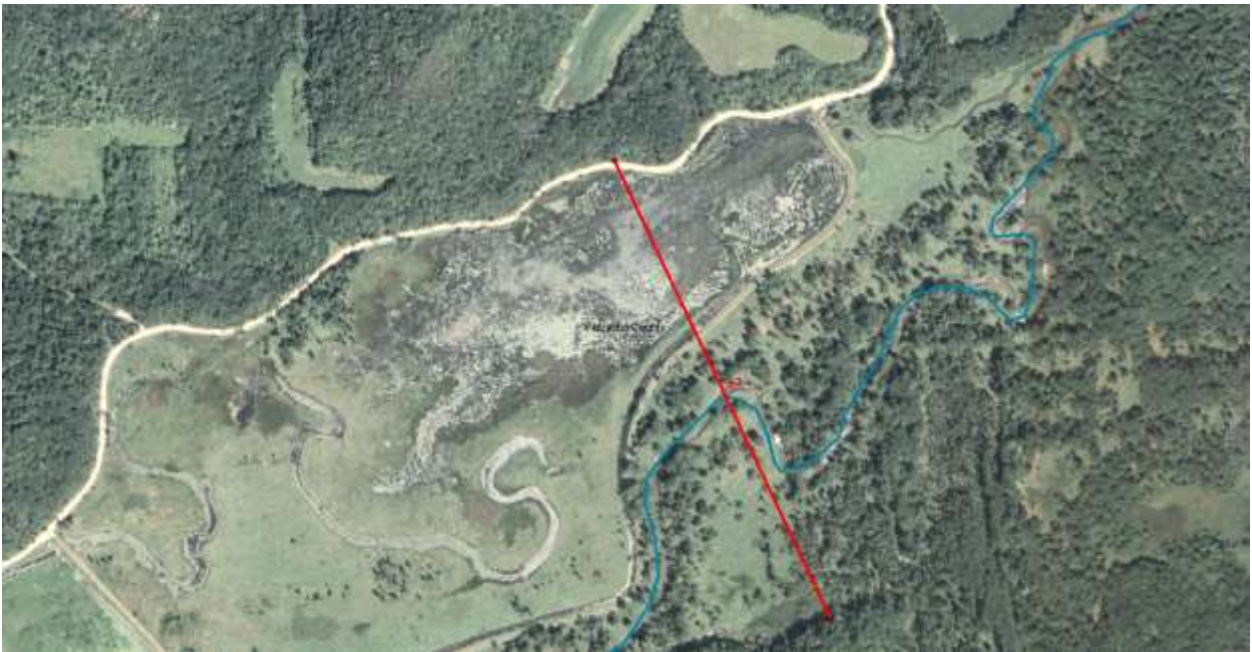
X Section Range 2 Whitewater Main branch. Station 0+00 is located right down stream and goes from southeast to northwest.

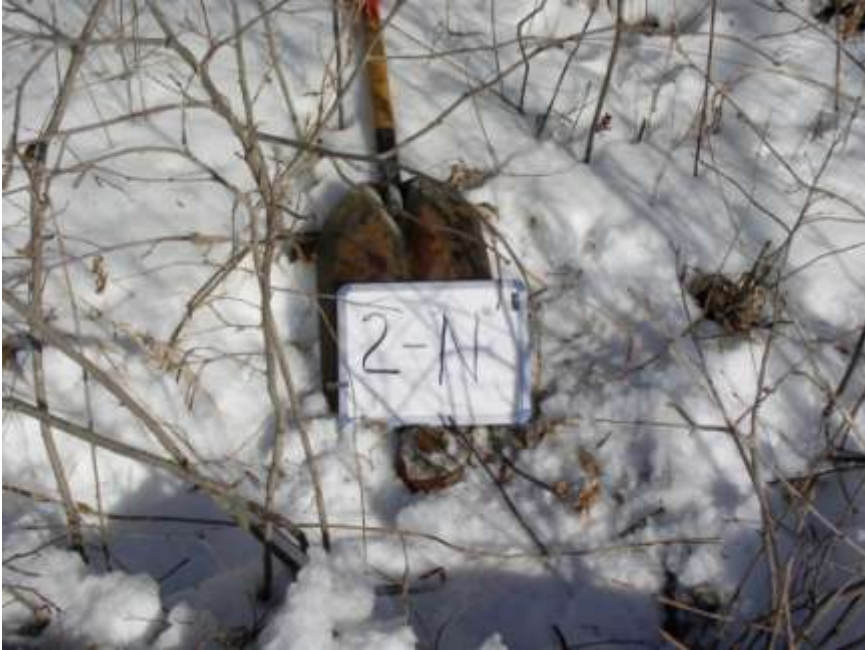
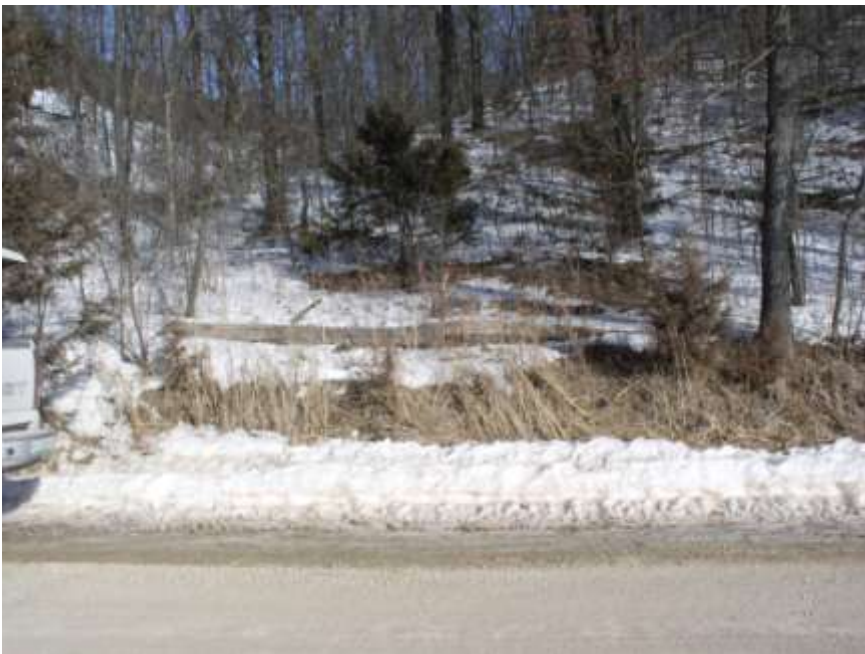
Monument 2-N. Located 2/06/09. End point of Range 2. The pipe within a pipe and filled with concrete was typical of the early monument established by Dr. Happ. Later monuments were a 2" diameter pipe with a stamped threaded cap. Photo by Doug Christianson.

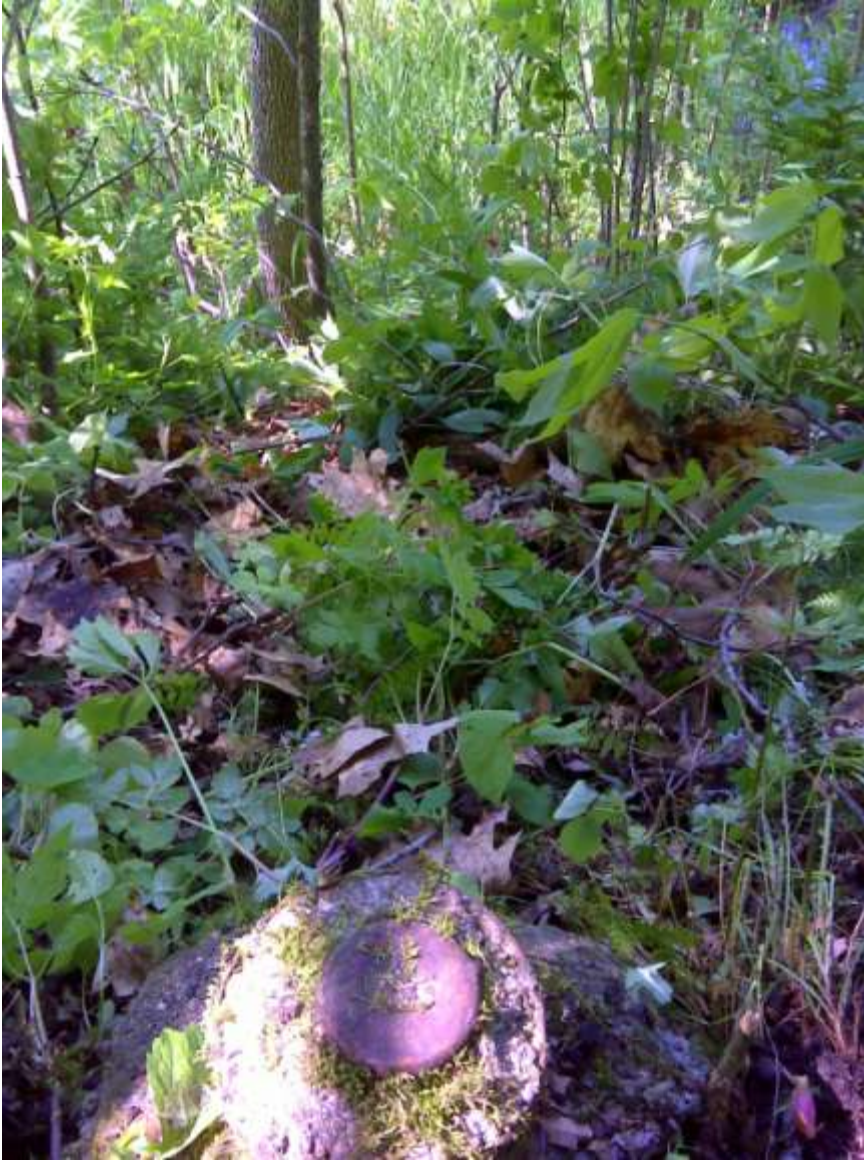
Monument 2-S. Located 5/26/11 Beginning point 0+00 of Range 2 Looking in approximate direction (NNW) of X-section. Even by the end of May the heavy vegetation would make any type of survey during the summer months almost impossible. Photo by author

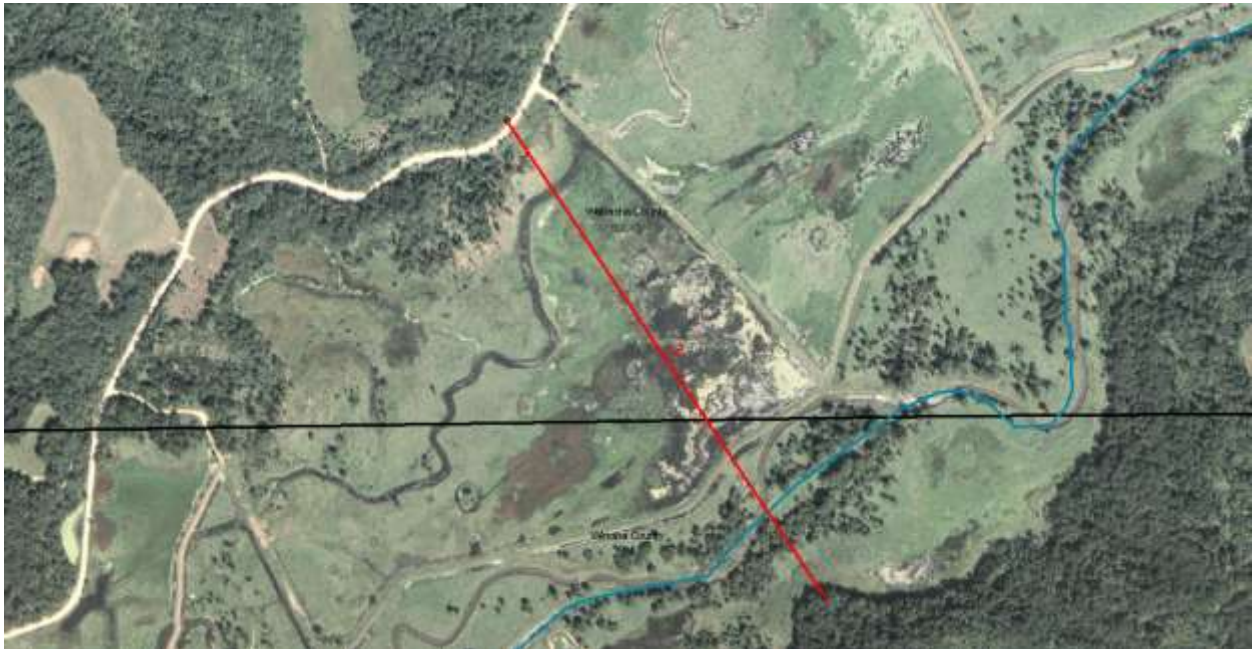
X Section Range 3 Whitewater Main branch. 0+00 is located right down stream and goes from southeast to northwest.

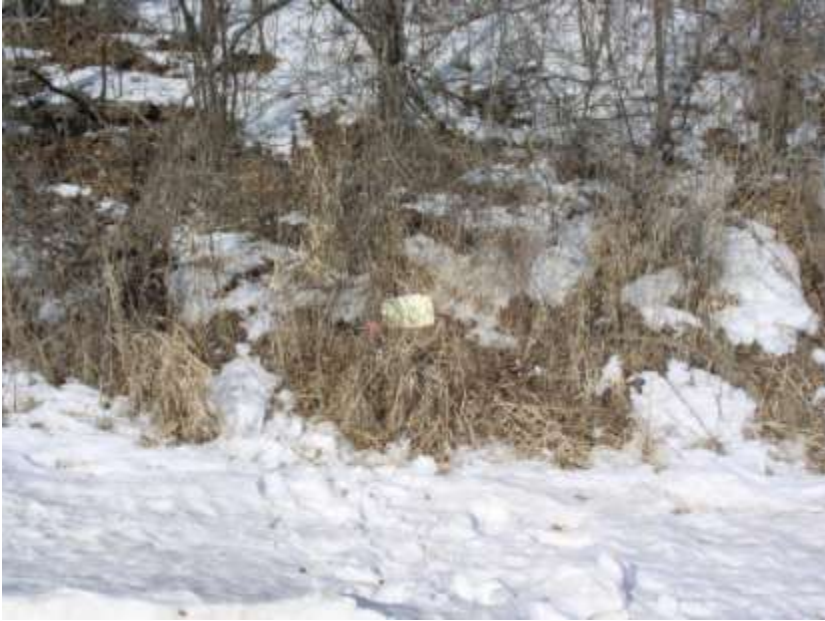
Monument 3-N Located 2/06/09 End point of Range 3 Photo by Doug Christianson

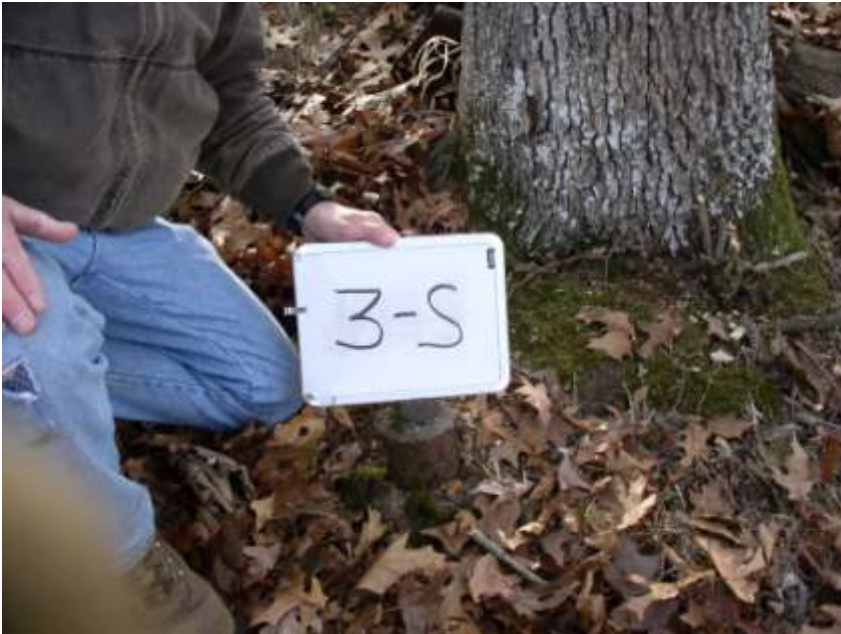
Monument 3-S Located 2/18/09 Beginning point 0+00 of Range 3 Photo by Doug Christianson

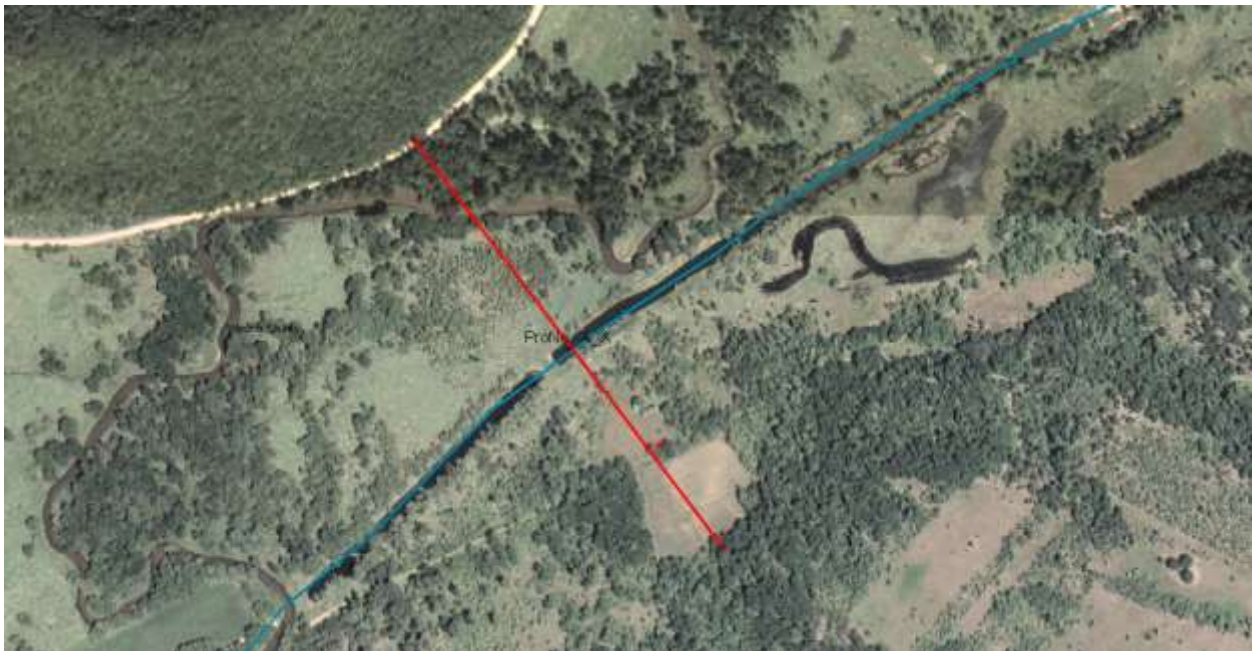
X Section Range 4 Whitewater Main branch. 0+00 is located right down stream and goes from southeast to northwest.

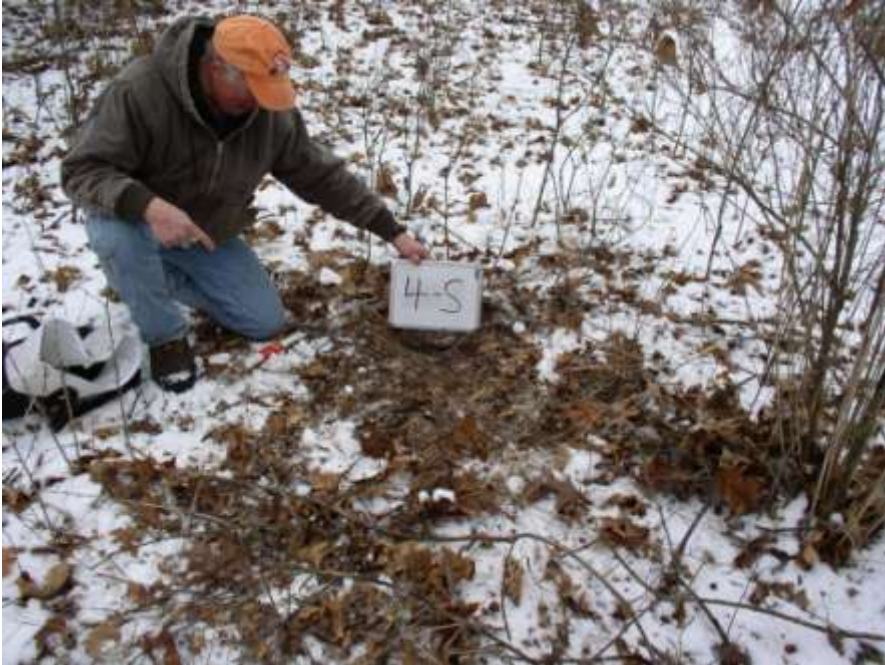
Monument 4-S. Located 3/09/09. WAE employee Steve Erickson in photo. Beginning point 0+00 for Range 4. Photo by Doug Christianson.

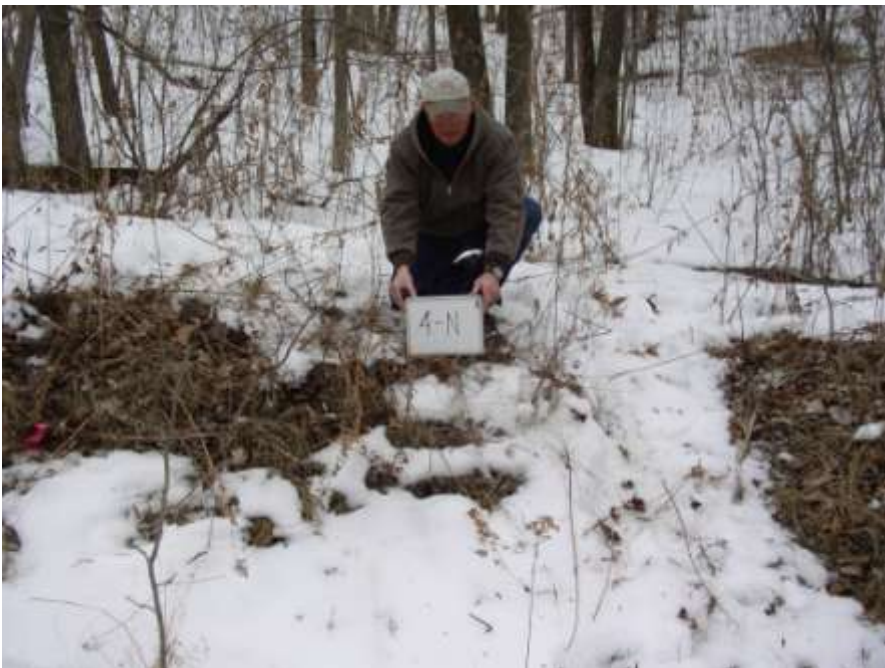
Monument 4-N Located 2/6/09. WAE employee Steve Erickson in photo. End point of Range 4. Photo by Doug Christianson.

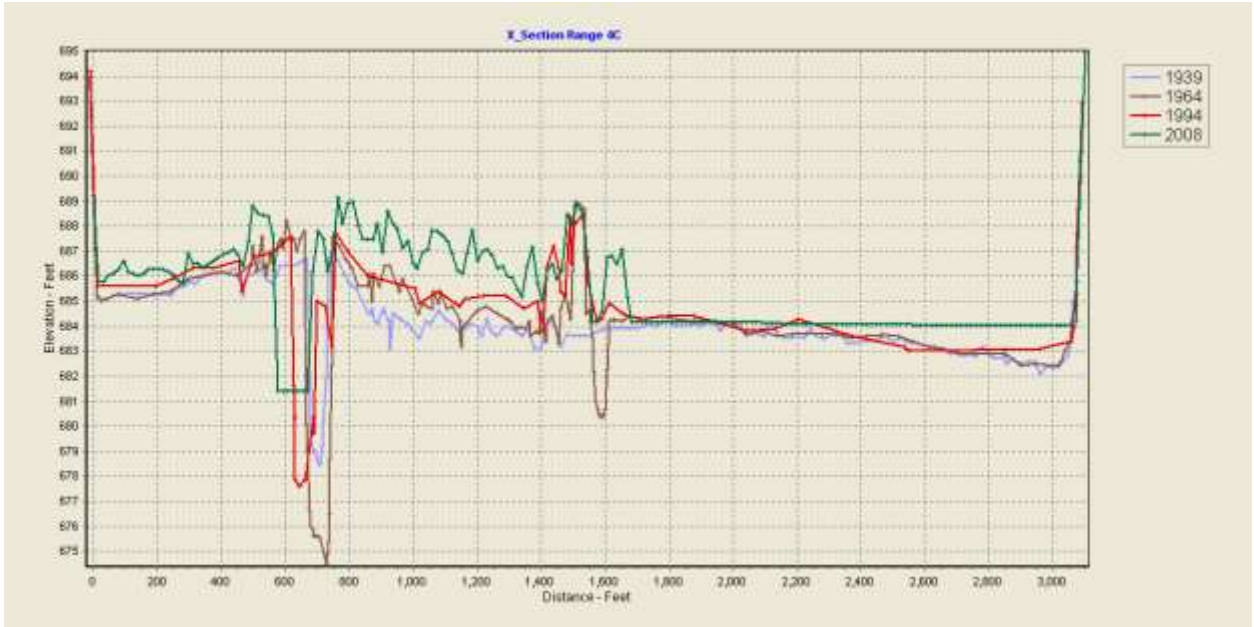
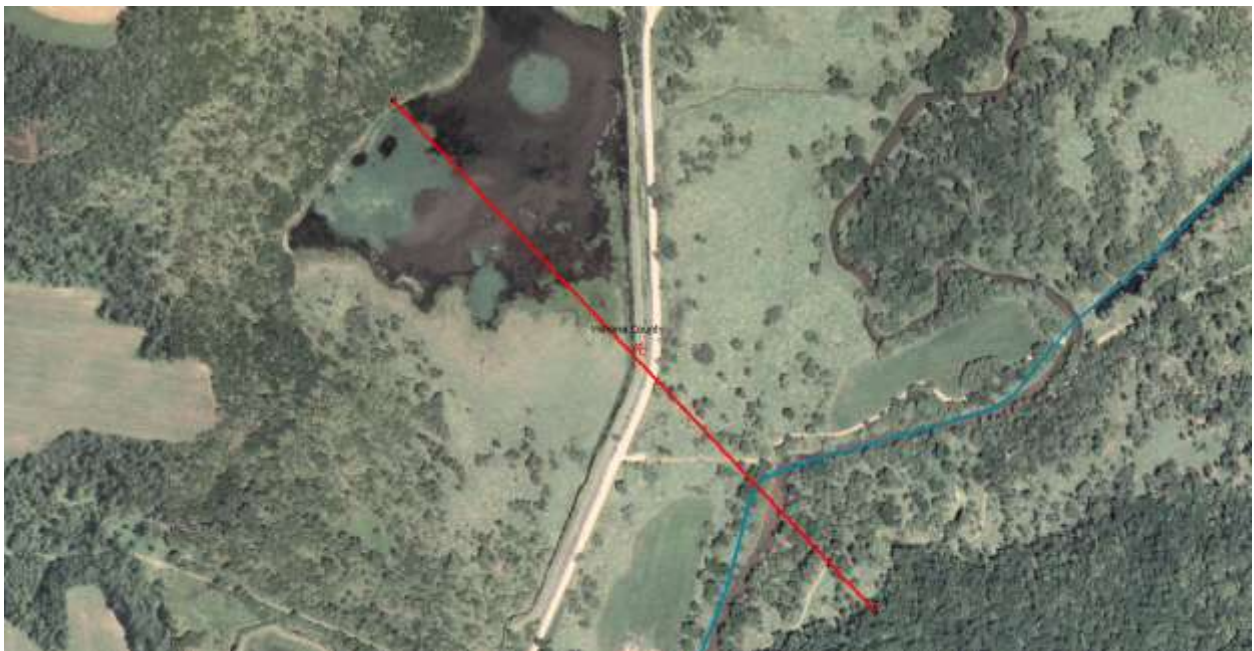
X Section Range 4C Whitewater Main branch. 0+00 is located right down stream and goes from south east to northwest.
