# **The Restoration of a Historical Sediment Study and the use of LiDAR in the Determination of Elevations in the Whitewater River Valley.**

By Lawrence Svien, Graduate Student, Penn State MGIS program

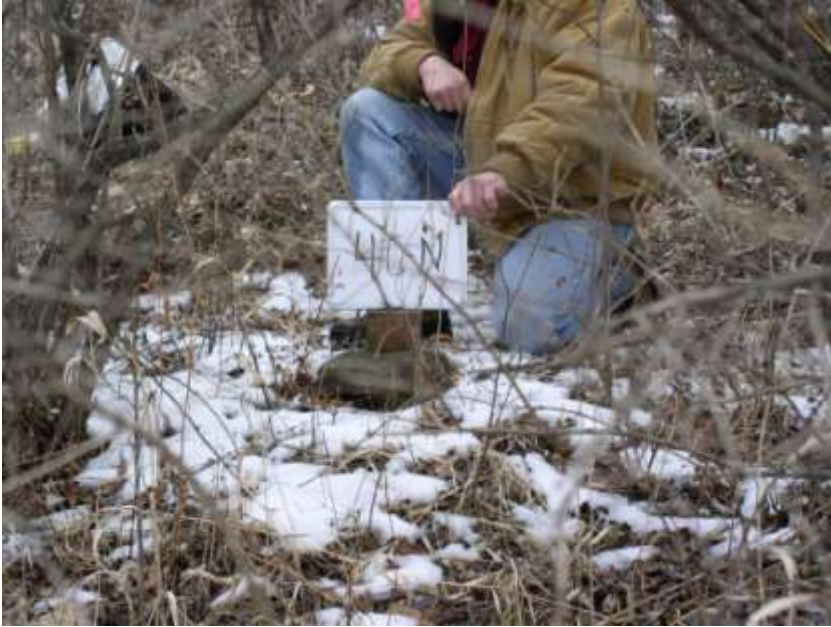
Monument 4C-N. Located 3/5/09. End point of Range 4C. Photo by Doug Christianson.

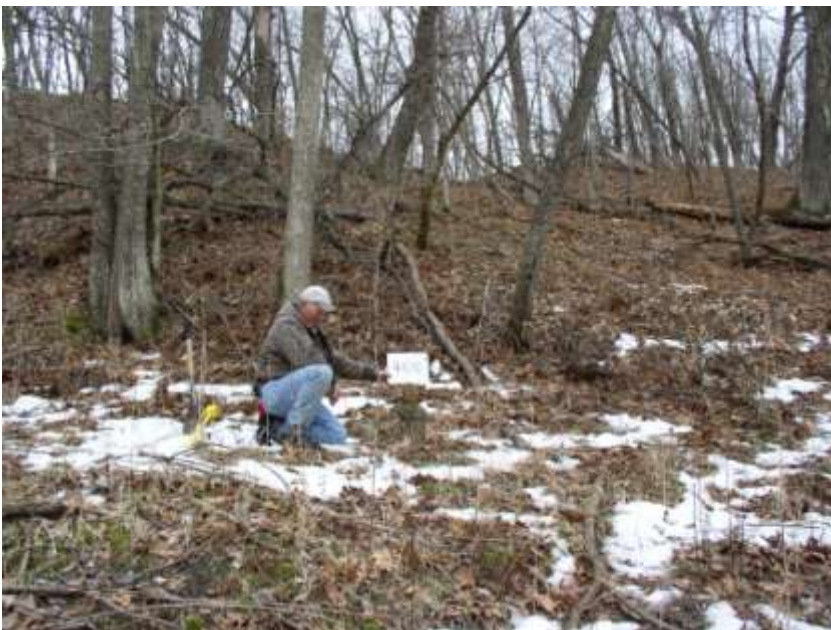
Monument 4C-S. Located 2/12/09. Beginning point 0+00 for Range 4C. WAE Steve Erickson in photo. Photo by Doug Christianson.

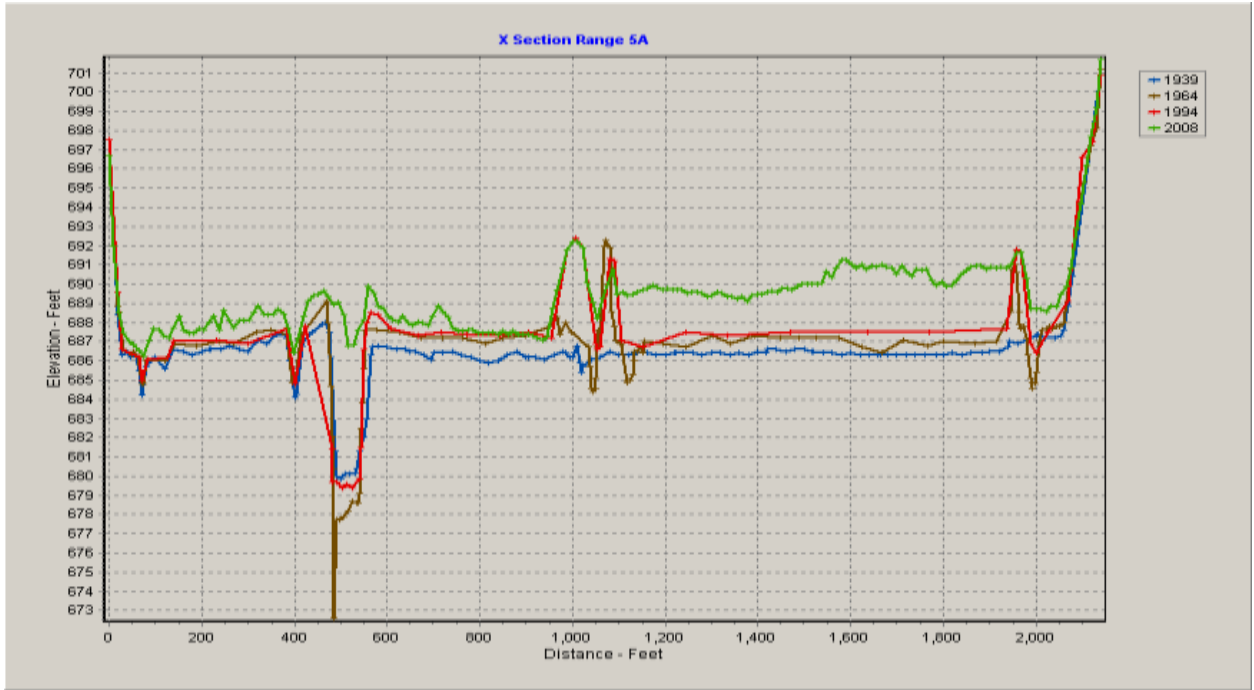
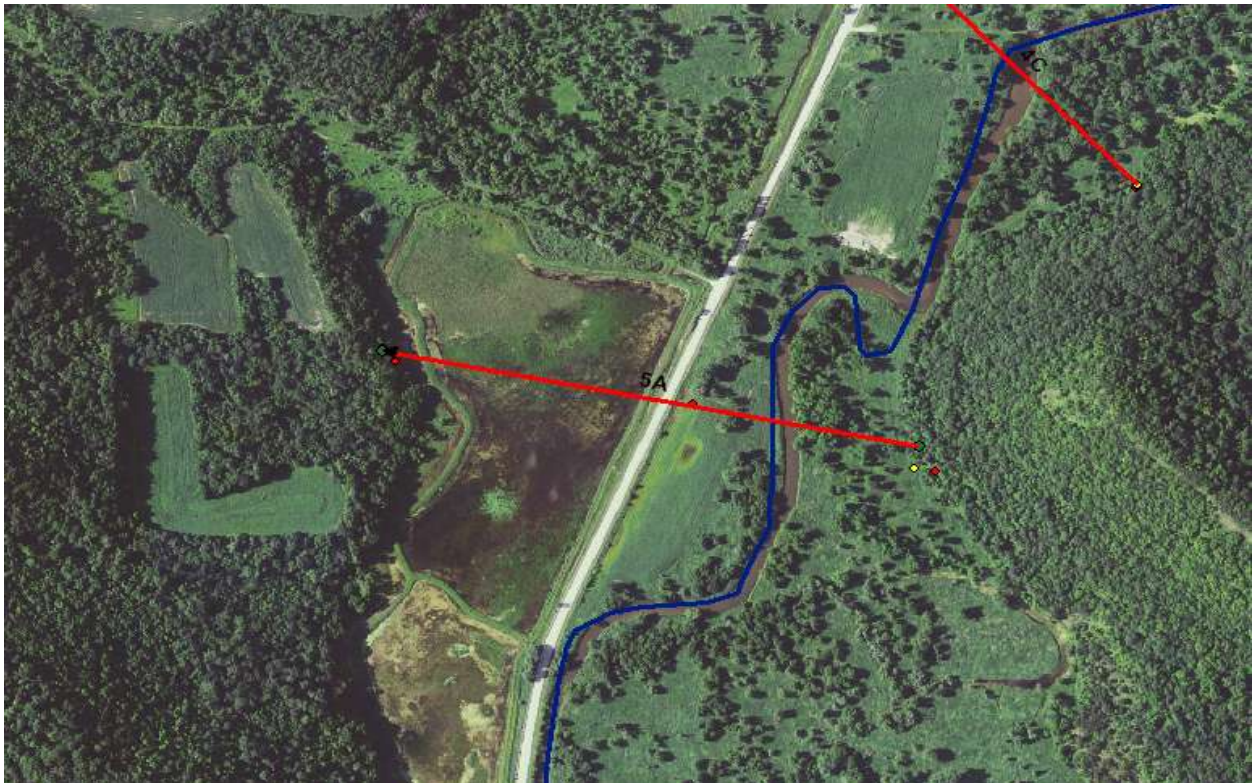
X Section Range 5A Whitewater Main branch. 0+00 is located right down stream and goes from east to west.

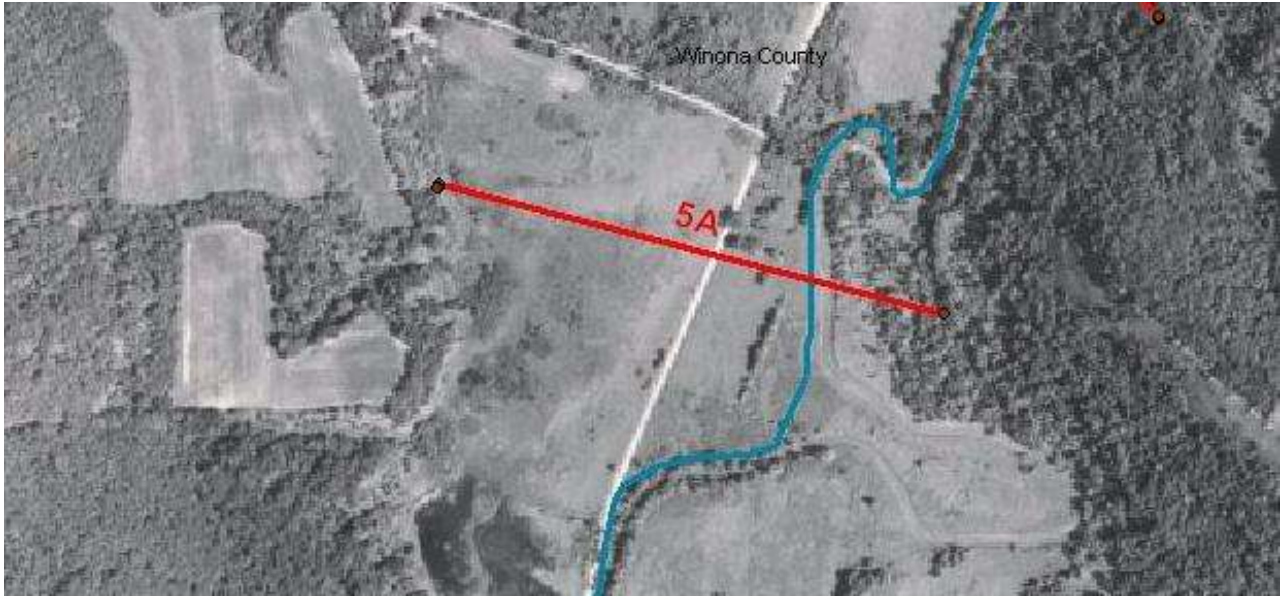
Range 5A with 1954 Photo Observe the meander in the SE corner is cut off in Figure . Rectification of the photo had a RMS error of 30.1 meters.

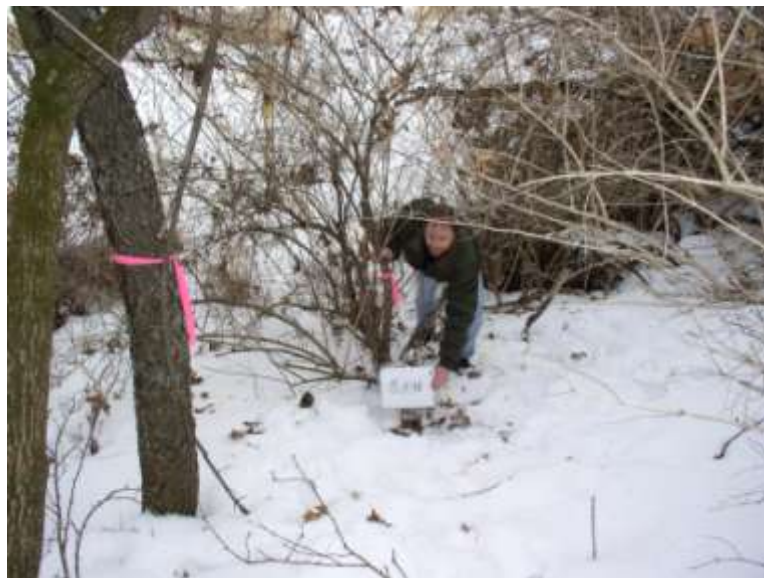
Monument 5A-N. Located 2/06/09. NRCS employee Mark Kanable in photo. End point for Range 5A.

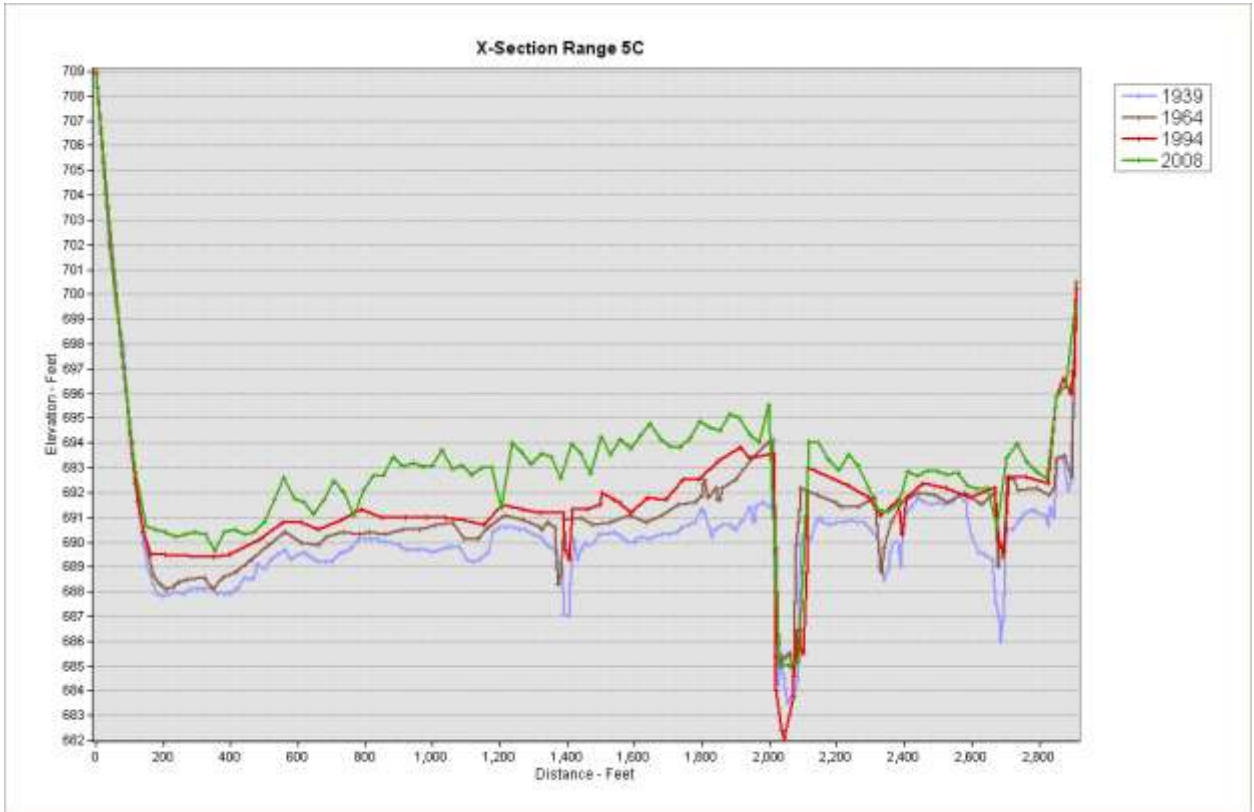
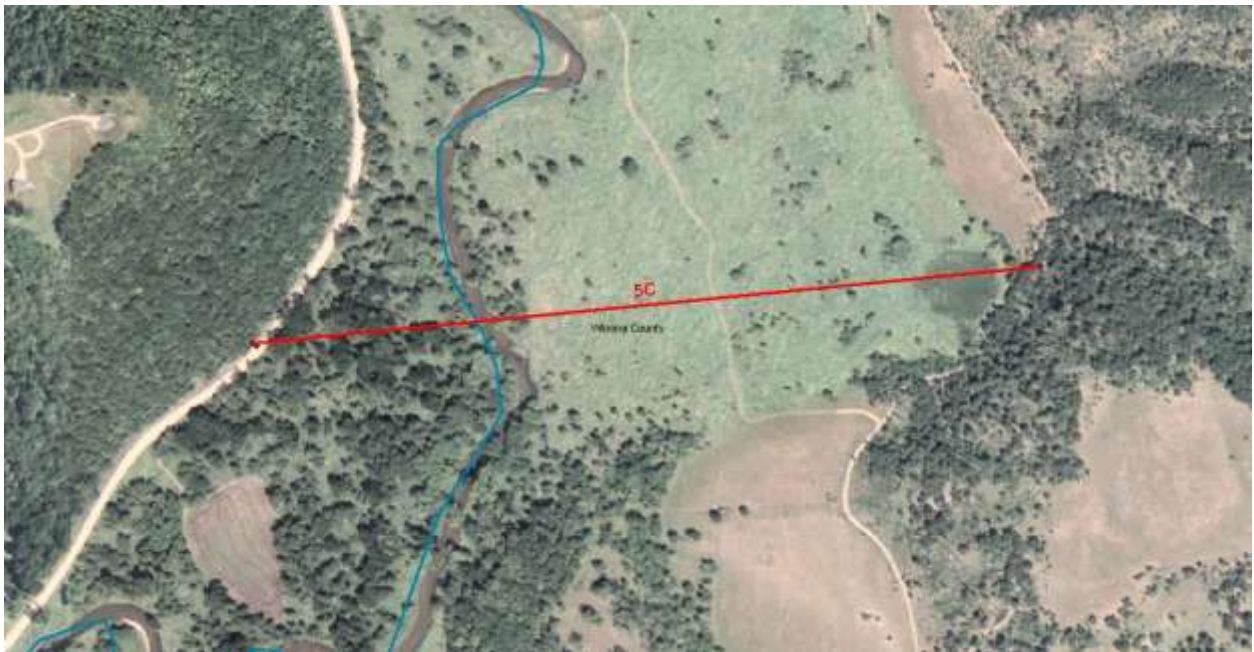
X Section Range 5C Whitewater Main branch. 0 is located right down stream and goes from east to west.

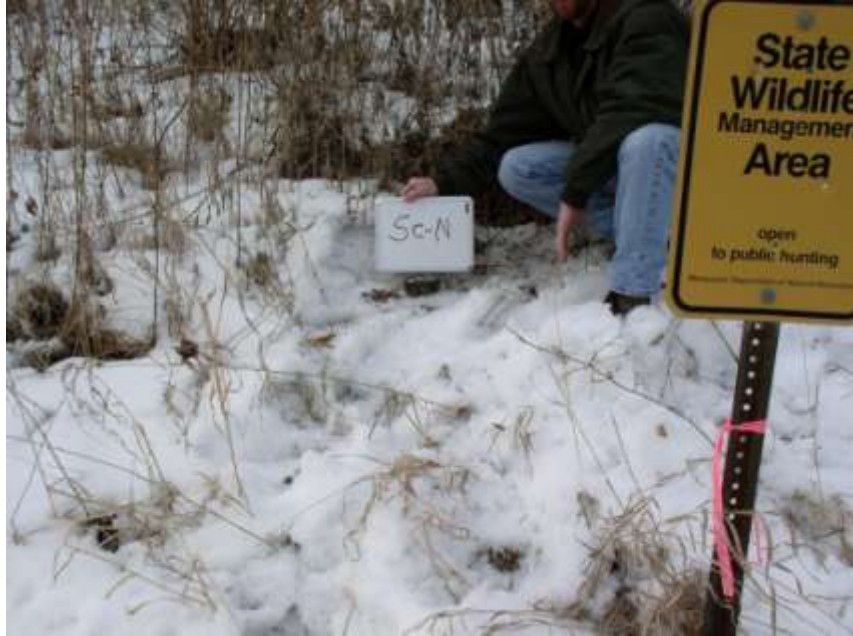
Monument 5C-N. Located 2/06/09. NRCS employee Mark Kanable in photo. End point for Range 5C. Photo by Doug Christianson

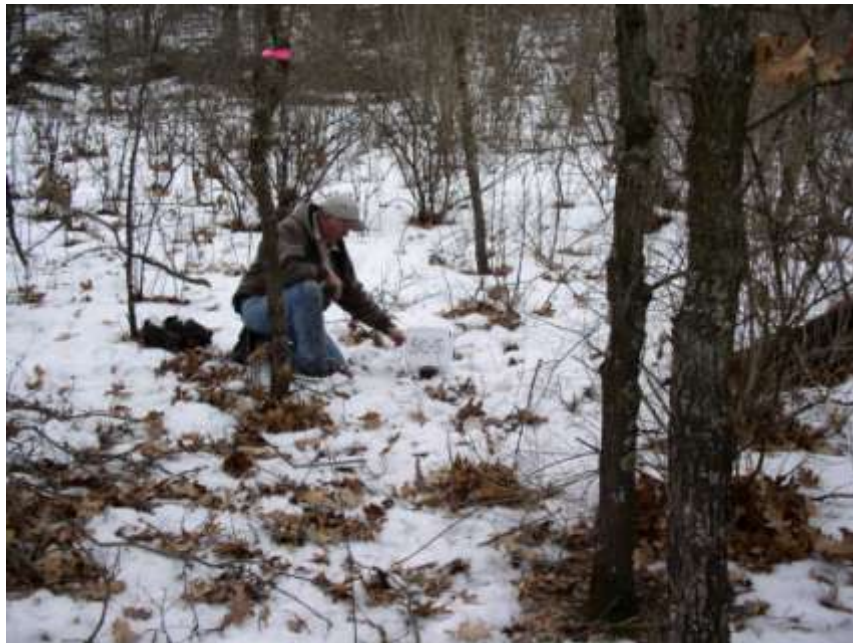
Monument 5C-S. Located 2/12/09. WAE Steve Erickson in photo. Beginning point 0+00 for Range 5C. Photo by Doug Christianson.

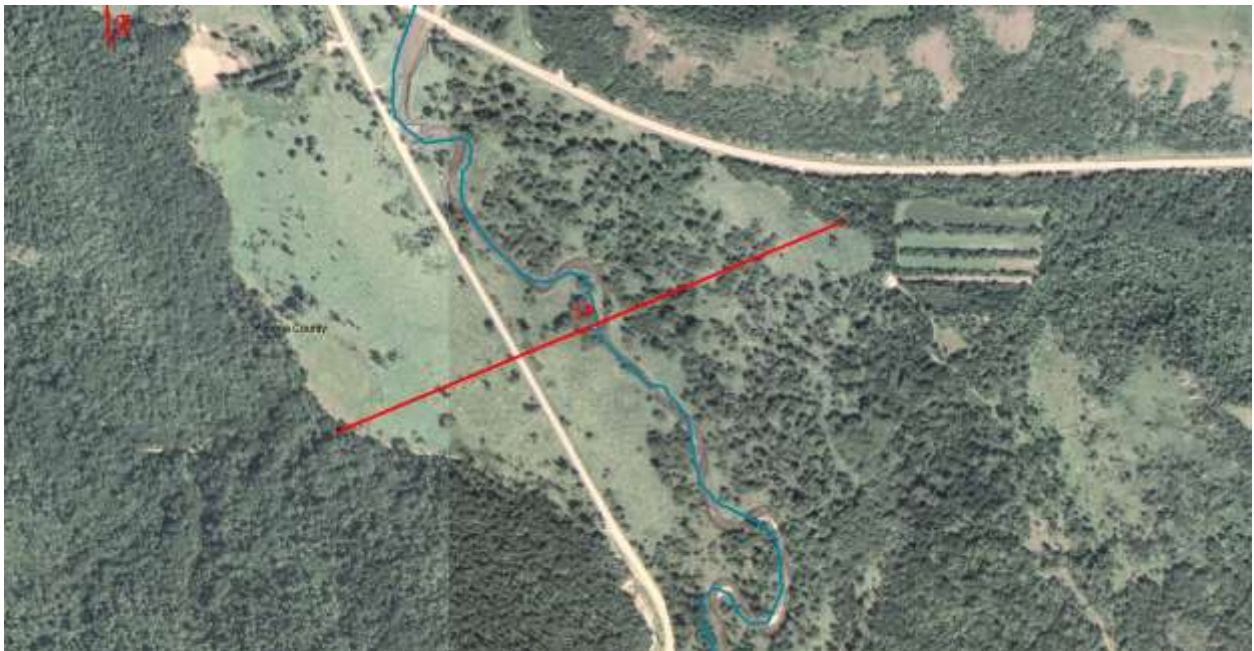
X Section Range 7A Whitewater Main branch. 0+00 is located right down stream and goes from northeast to southwest.

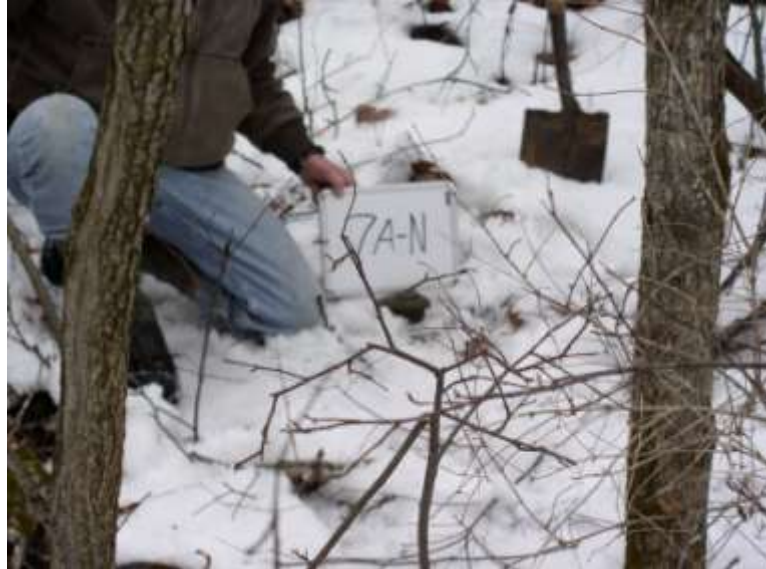
Monument 7A-N. Located 2/10/09. WAE Steve Erickson in photo. End point for Range 7A. Photo by Doug Christianson.

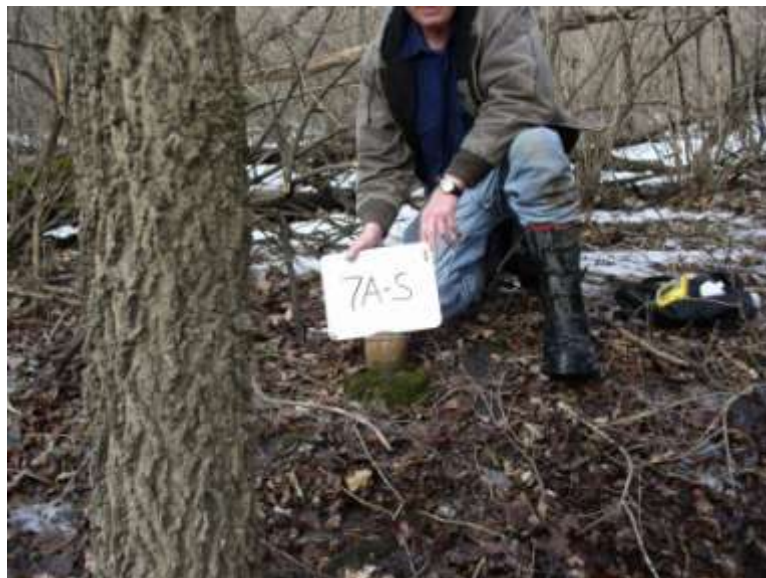
Monument 7A-S. Located 2/10/09. WAE Steve Erickson in photo. Beginning point 0+00 for Range 7A. Photo by Doug Christianson.

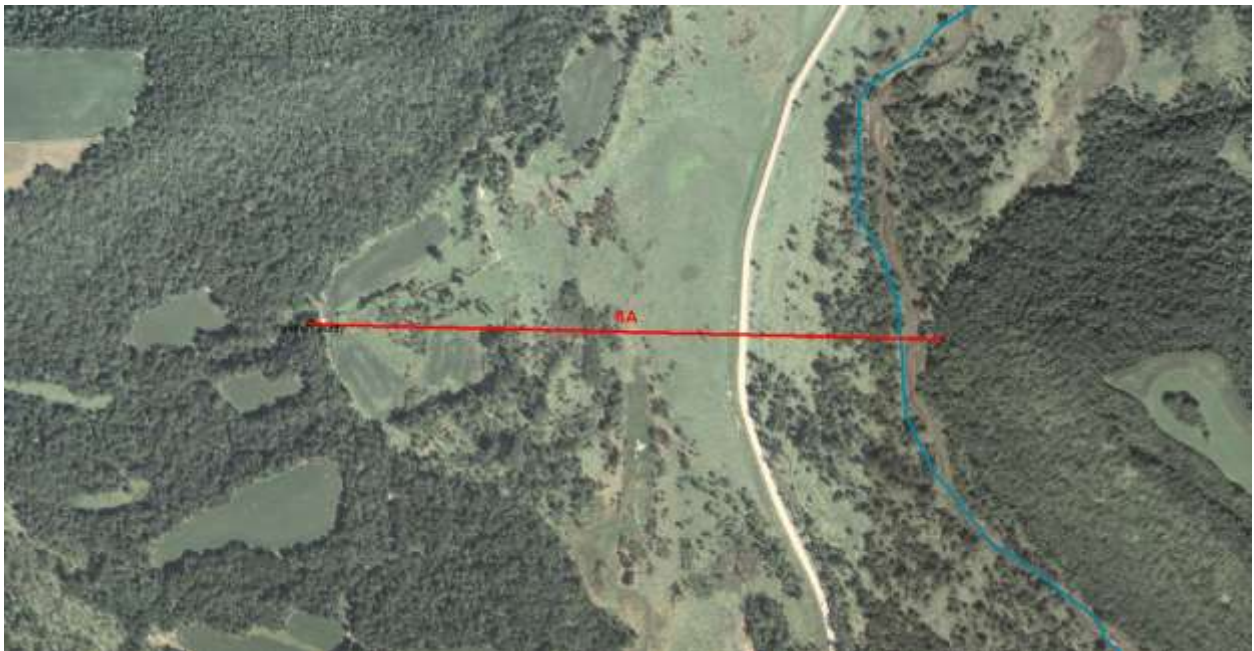
X Section Range 8A Whitewater Main branch. 0+00 is located right down stream and goes from east to west.

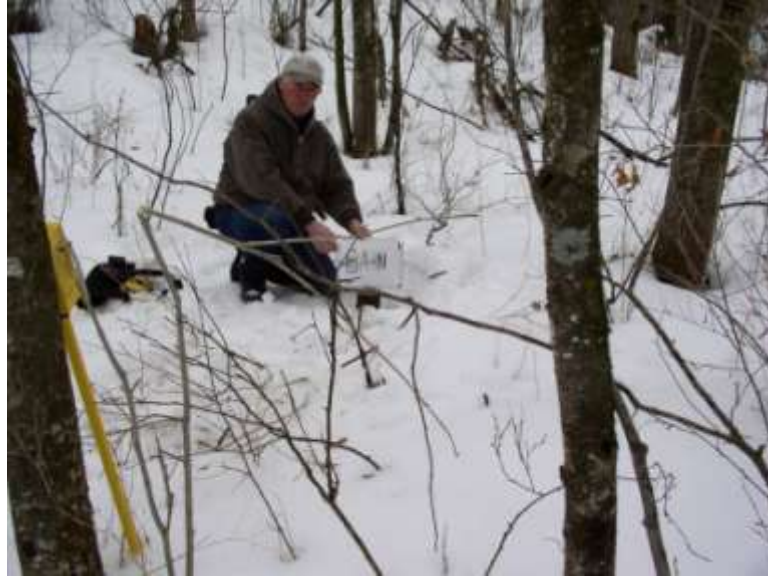
Monument 8A-N. Located 2/09/09. WAE Steve Erickson in photo. End point for Range 8A. Photo by Doug Christianson

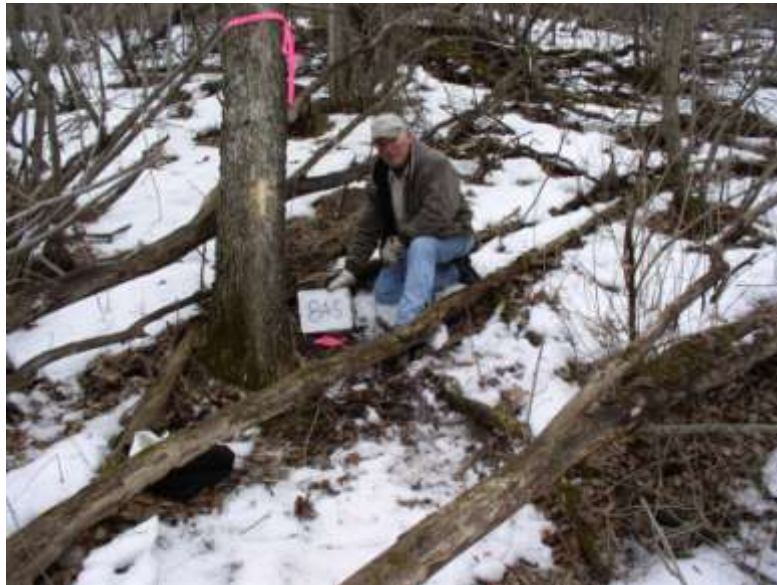
Monument 8A-S. Located 2/12/09. WAE Steve Erickson in photo. Beginning point 0+00 for Range 8A. Photo by Doug Christianson

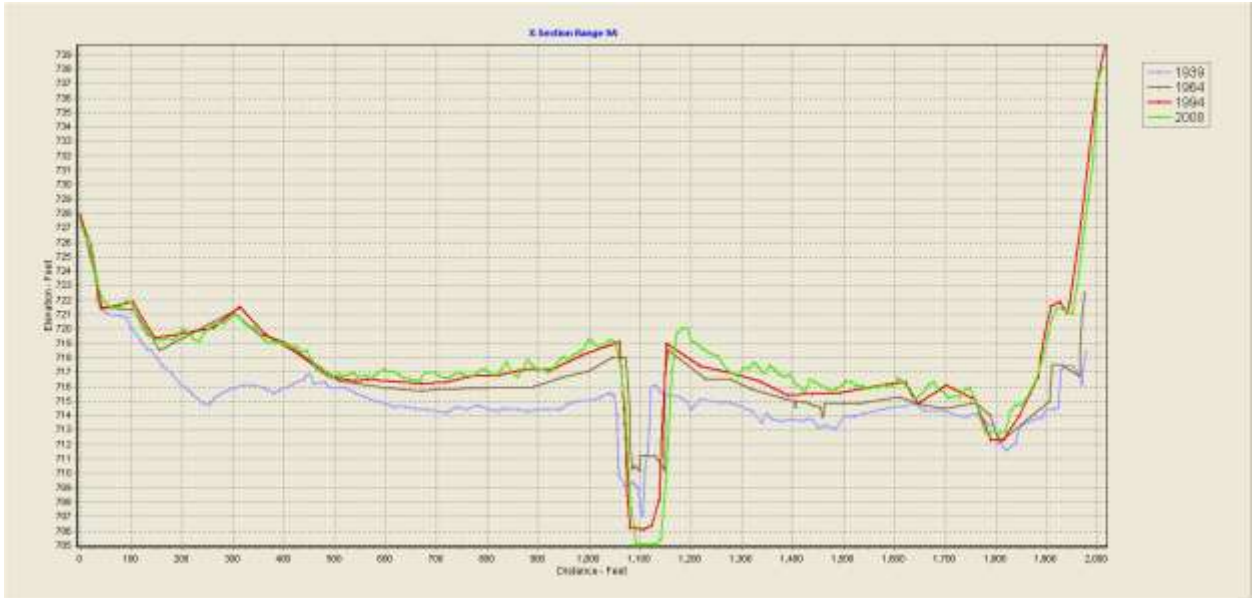
X Section Range 9A Whitewater Main branch. 0+00 is located right down stream and goes from east to west. Endpoint 9A-S at the 0+00 end remains in place and was located the last time on 2/12/2009.

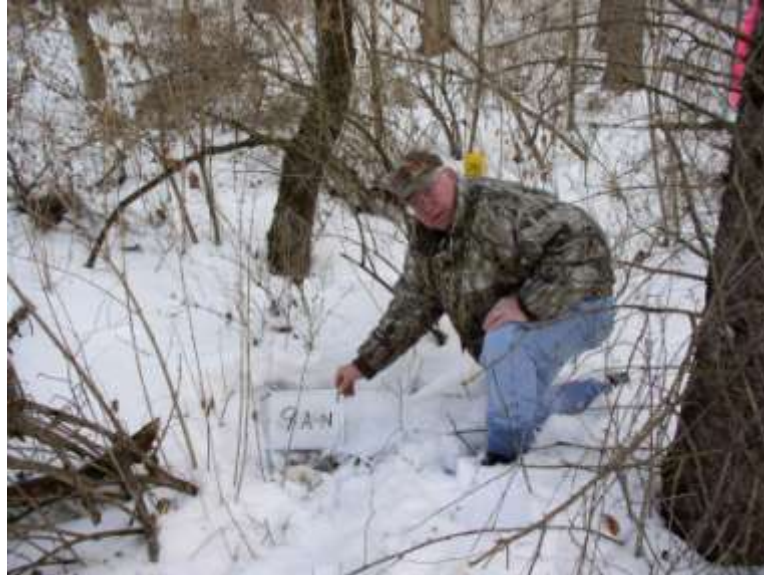
Monument 9A-N on the west end of the range was lost between the 1964 and 1994 surveys. The original endpoint was located approximately in the road and was probably lost due to construction. During the 1994 survey the endpoint was extended to be away from the road and construction influence. A 4 foot re-bar was placed on the hillside. The line was extended approximately 37 feet further depending on what range distance is used. NRCS employee Doug Christianson in photo. Photo by Doug Christianson.

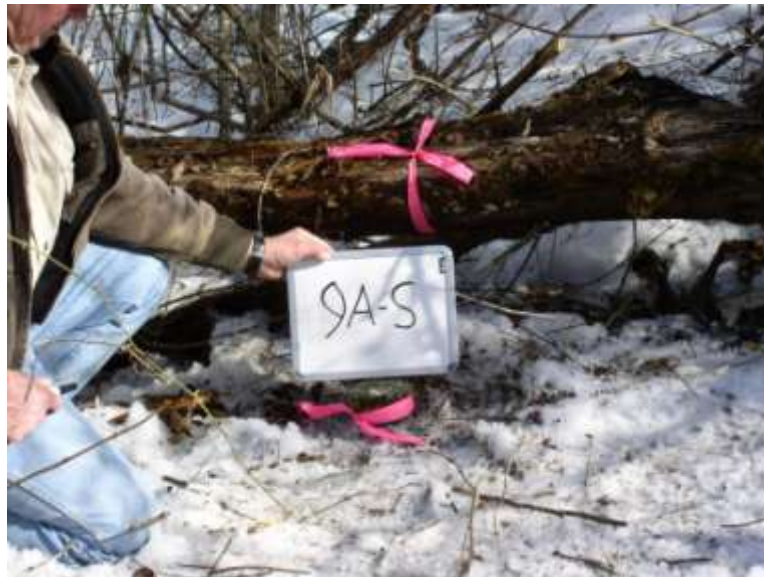
Monument 9A-S. Located 2/12/09. WAE Steve Erickson in photo. Beginning point 0+00 for Range 9A. Photo by Doug Christianson.

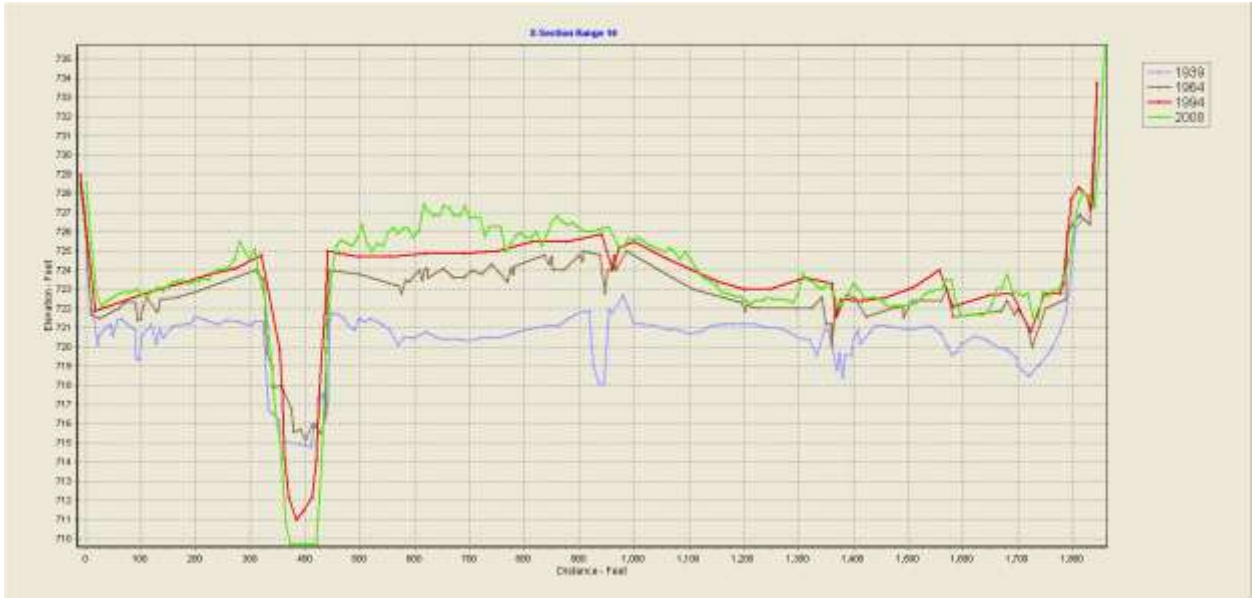
X Section Range 10 Whitewater Main branch. 0+00 is located right down stream and goes from east to west.

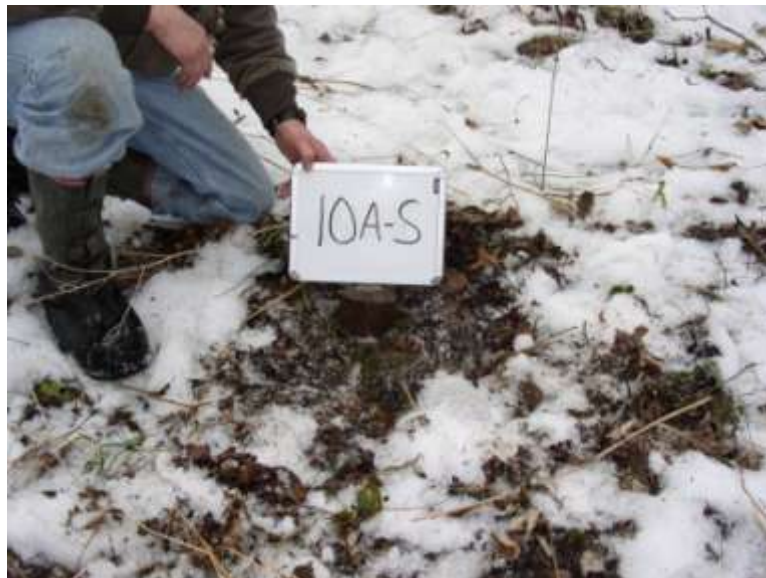
Monument 10-S. Located 2/11/09 Beginning point 0+00 for Range 10. Photo by Doug Christianson.

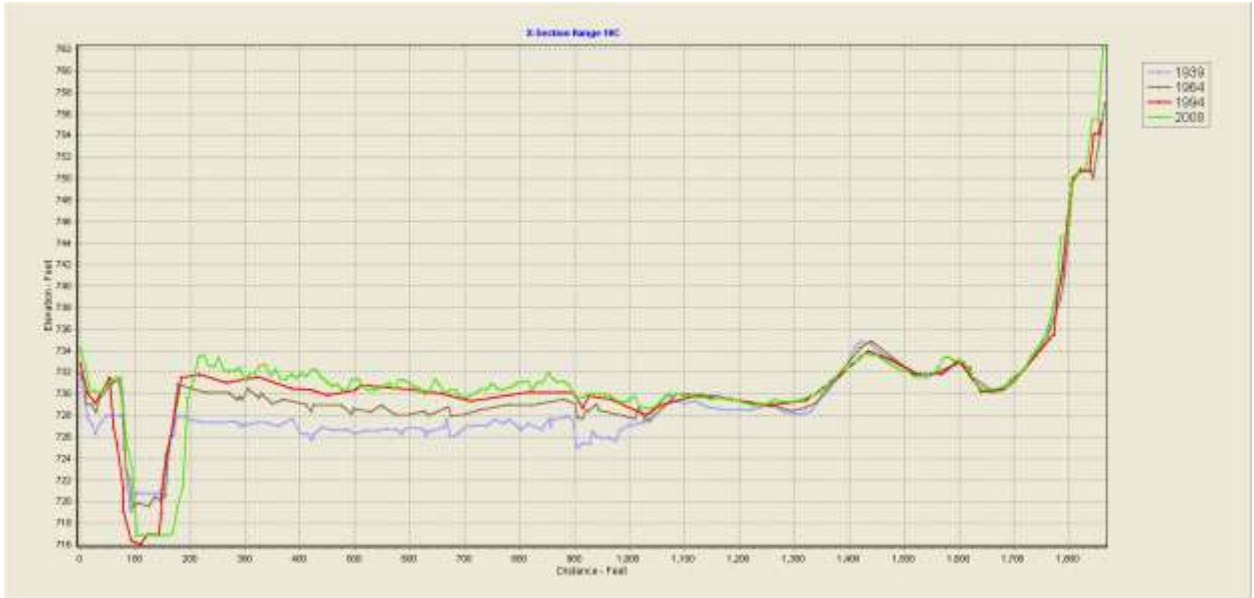
X Section Range 10C Whitewater Main branch. 0+00 is located right down stream on the SE end of the line and goes to the NW

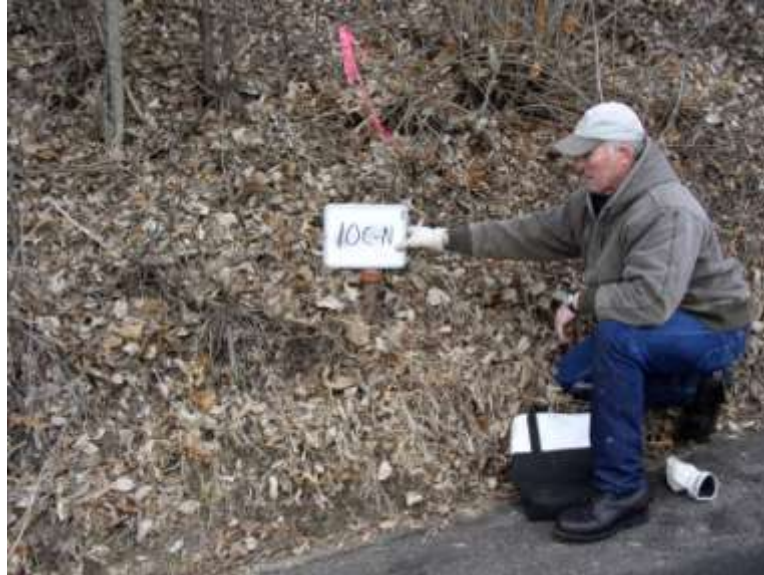
Monument 10C-N. Located 2/09/09. WAE Steve Erickson in photo. Only approximately 2 feet off of private driveway. Landowner knew the pipe existed but was not aware what its purpose was. Photo by Doug Christianson.

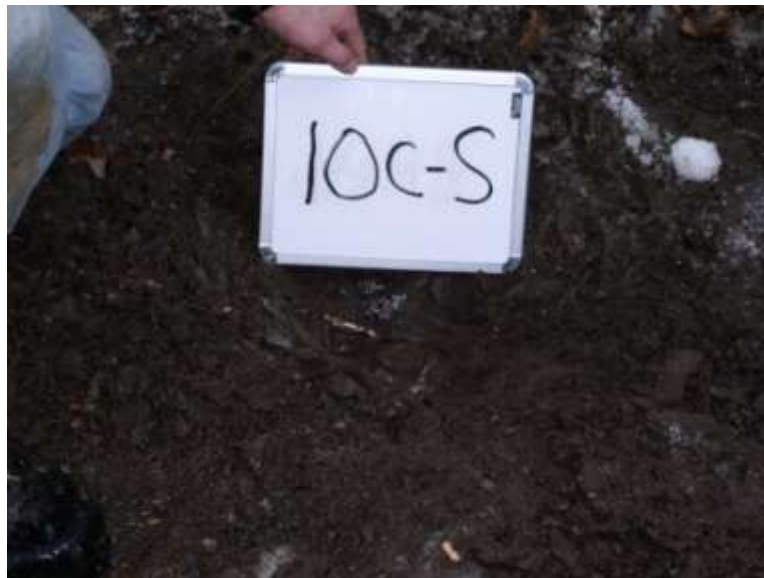
Monument 10C-S. Located 2/11/09. Monument was buried approximately 4 inches below the surface. Beginning point 0+00 for Range 10C. Photo by Doug Christianson.

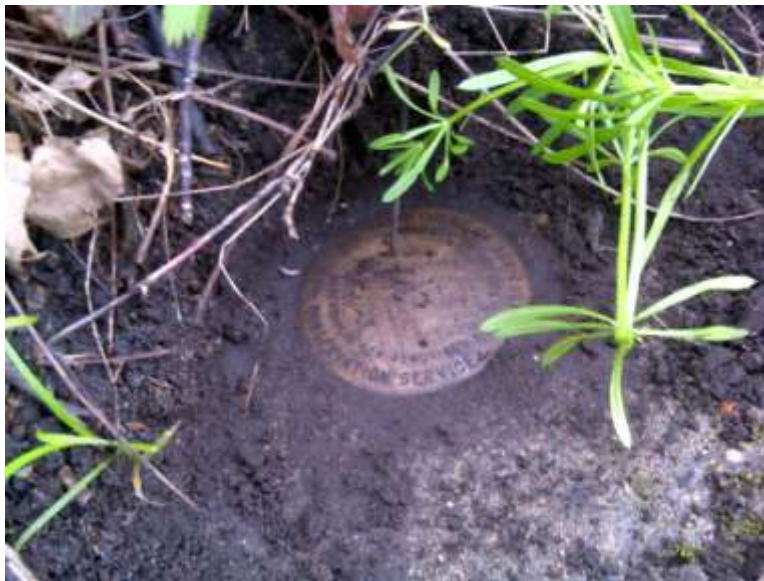
Monument 11B-S. Located 5/12/11. 11B-S is the only endpoint monument which is marked with a brass cap set in concrete. 11B-S could not be located during the 64 and 94 surveys and was considered lost until located by this study in the summer of 2011. Because the cap is brass the normal use of a metal detector did not work. The red point on the photo above was the assumed located location for many years. It was finally locate by running a line from 11B-N through a stake that was still in place on the earthen dike from the 94 survey. Measuring the surveyed distance from the notes and using the azimuth we got to within 5 feet of this location. A 4 foot steel rebar was driven into the ground next to the brass cap to aid in future locating. The beginning point 0+00 of Range 11B. Photo by author

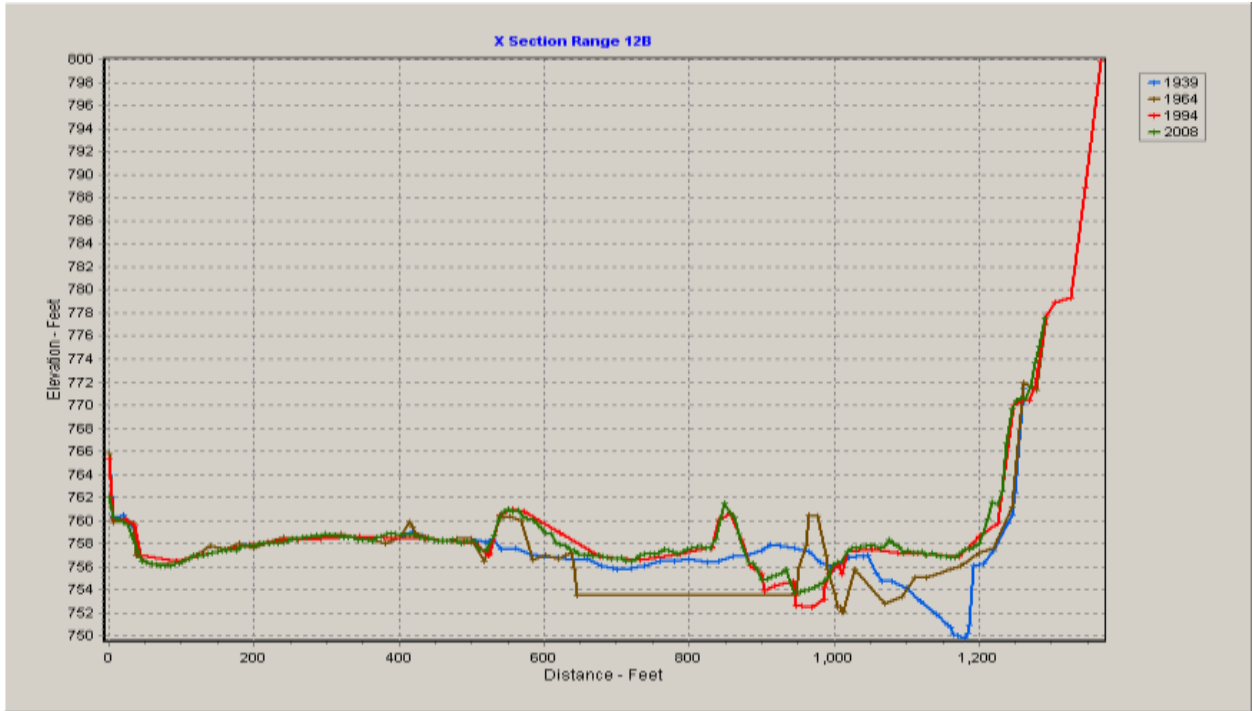
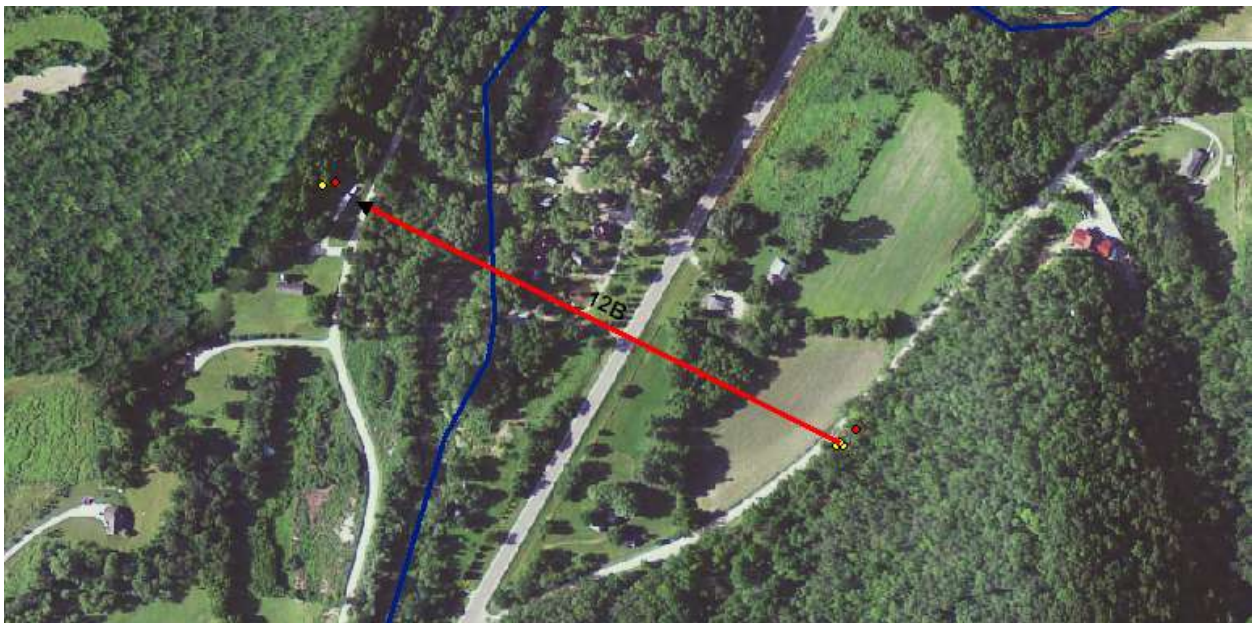
X Section 12B Middle Branch of the Whitewater. 0+00 is located right down stream and is located on the SE end of the line moving to the NW. Monument 12B-L was lost due to construction activities in the area and had been replaced with a 4 foot rebar in a higher elevation during the 94 survey. Also the area west of the highway was highly disturbed and damaged during the flood event of 1978.

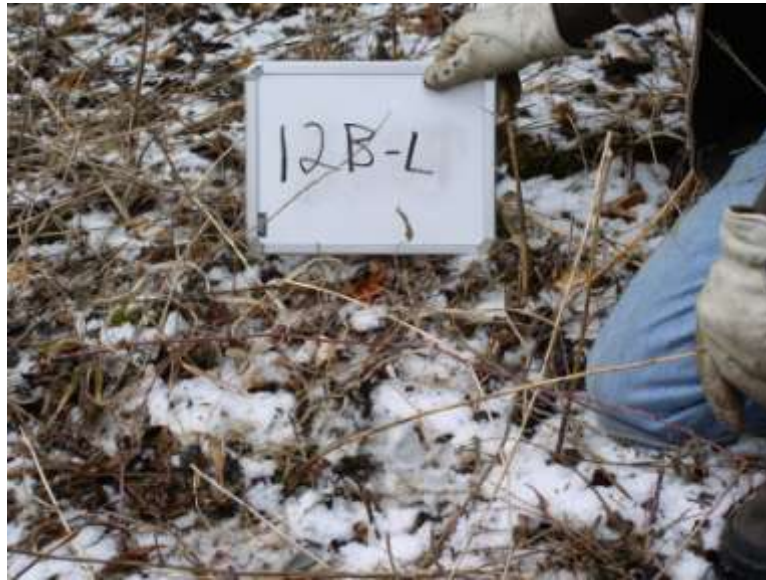
Monument 12B-L Located 3/09/09. This monument was lost due to construction activities around the building site and was re-established during the 94 survey. Monument is now a 4 foot rebar driven into the ground. Photo by Doug Christianson.

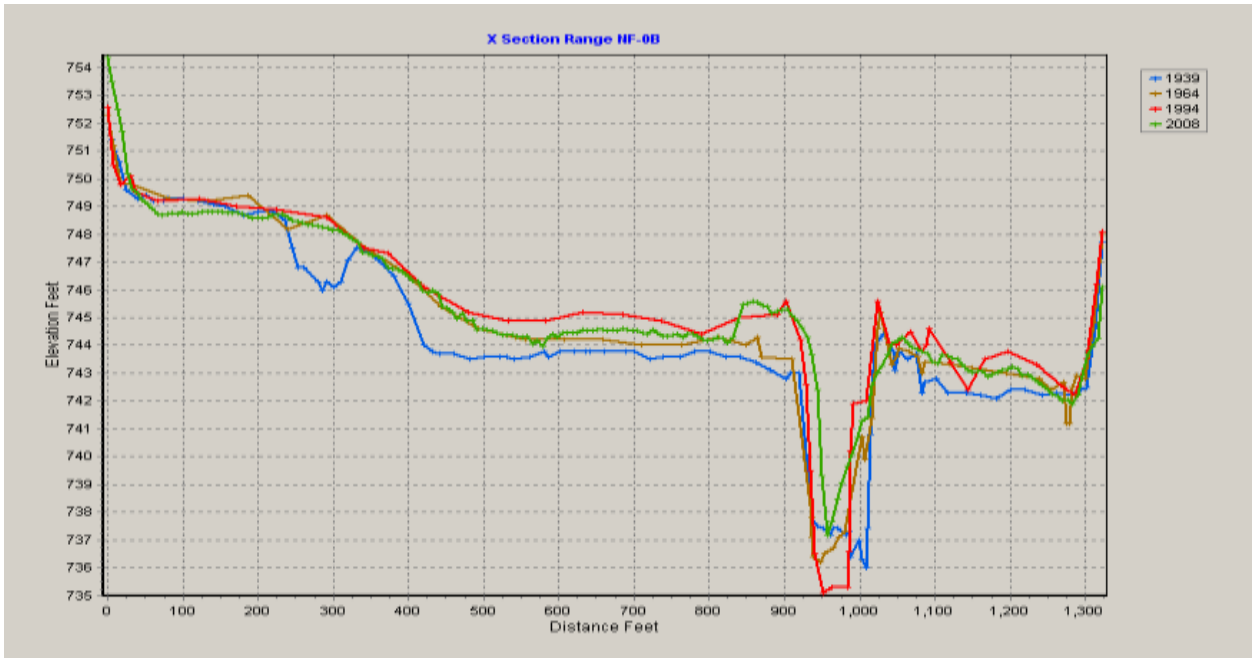
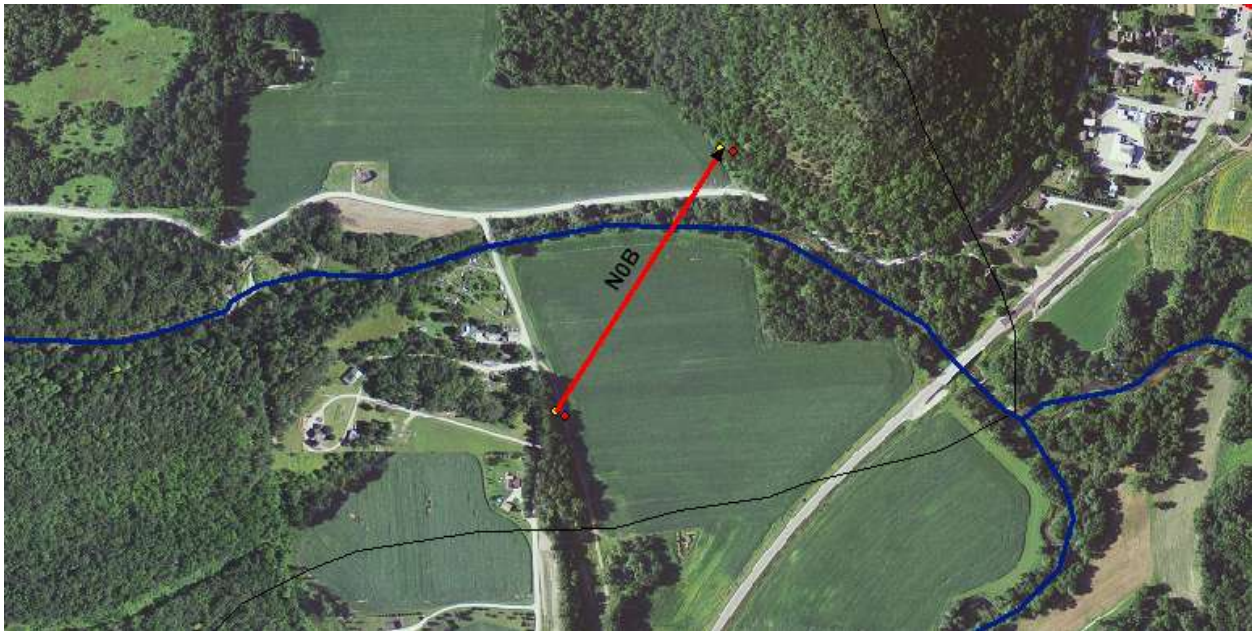
X Section NF-0B near the confluence of the North Fork and the Middle Fork of the Whitewater River. 0+00 is located right down stream and is located on the southwest end of the line moving to the northeast. .

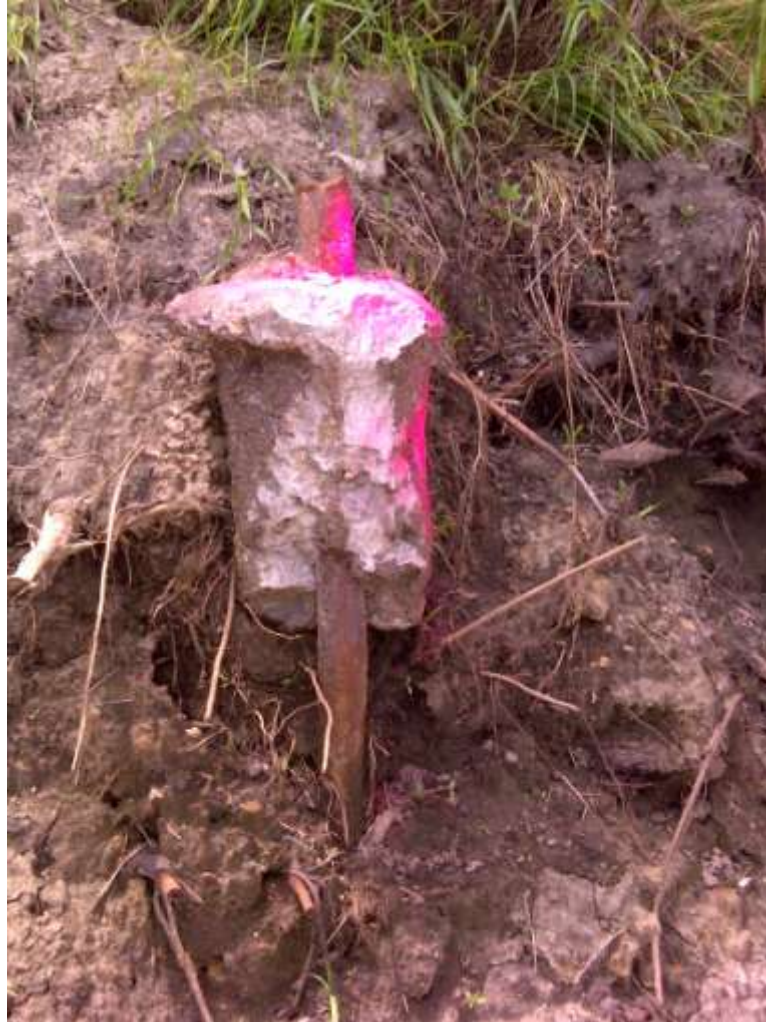
Monument NF-0B. Neither monument could be located involving a number of visits. Located 6/27/11. NF-OB-W was discovered after a visit at the site of a recent excavation. Approximately 3 feet of the monument was exposed and partially damaged. Absolute elevation and latitude-longitude is suspect due to the damage. Photo by author.

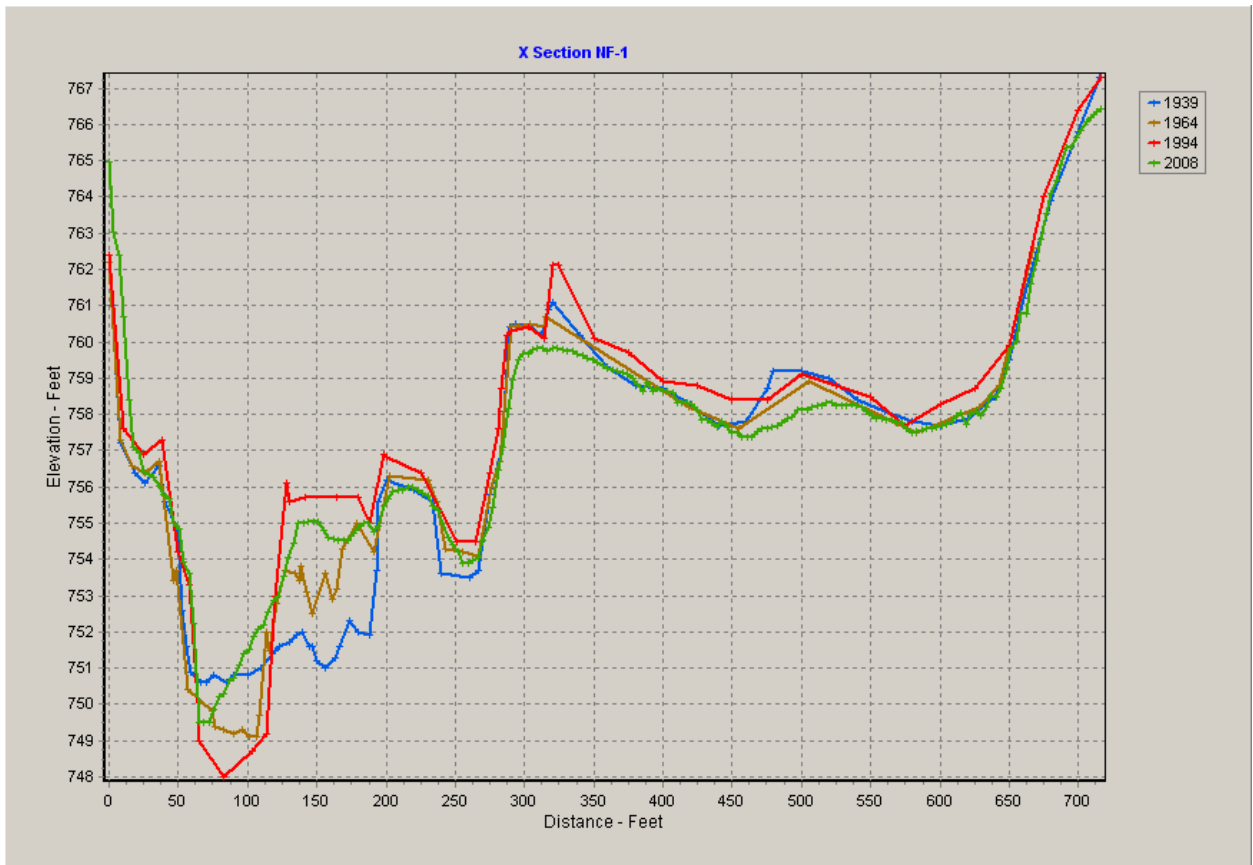
X Section Range N1 on the North Fork of the Whitewater. 0+00 is located right downstream and is the SW end of the line. NF-1-S south of the river was located but NF-1-N was lost in the 1964 survey and relocated to a point in the south road ditch. The line was extended by bearing and distance based on original survey.

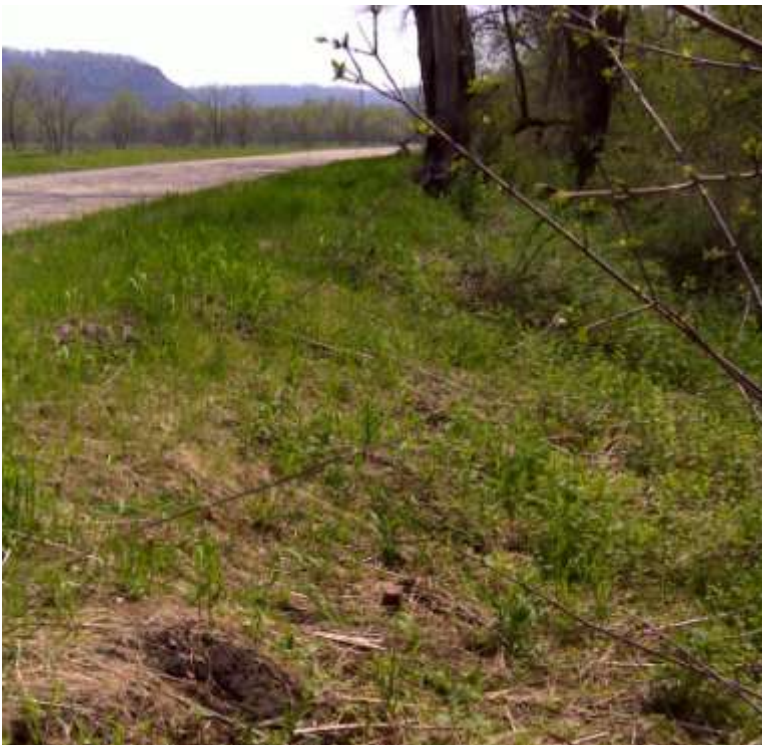
Monument NF-1-N. Located 5/10/11. Established in 1939 and lost between the 1939 and 1964 surveys it was re-established in 1964 by Dr. Happ. Instead of being the end point of the range the monument now is a reference point for establishing the line. The end of the line extends 435 feet north (to the left in the photo). Photo by author.
