# **The Restoration of a Historical Sediment Study and the use of LiDAR in the Determination of Elevations in the Whitewater River Valley.**

By Lawrence Svien, Graduate Student, Penn State MGIS program

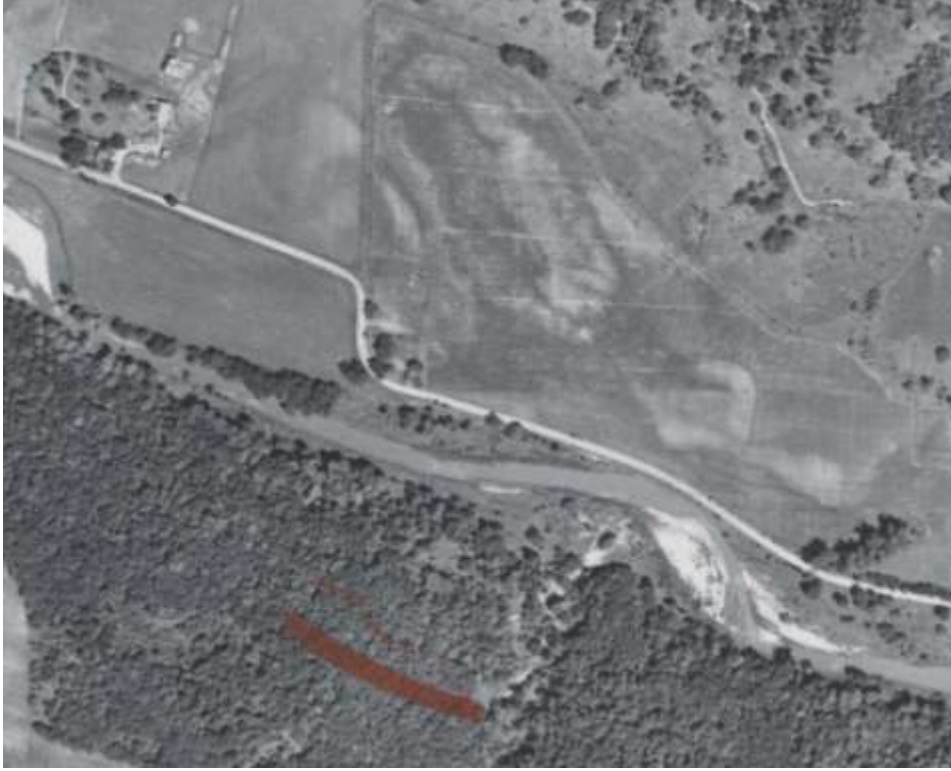
1954 Photo of same area in X Section N1 for comparison purposes. Much of the area north of the road is being farmed at the time of this photo. Photo courtesy of the USDA Natural Resources Conservation Service.

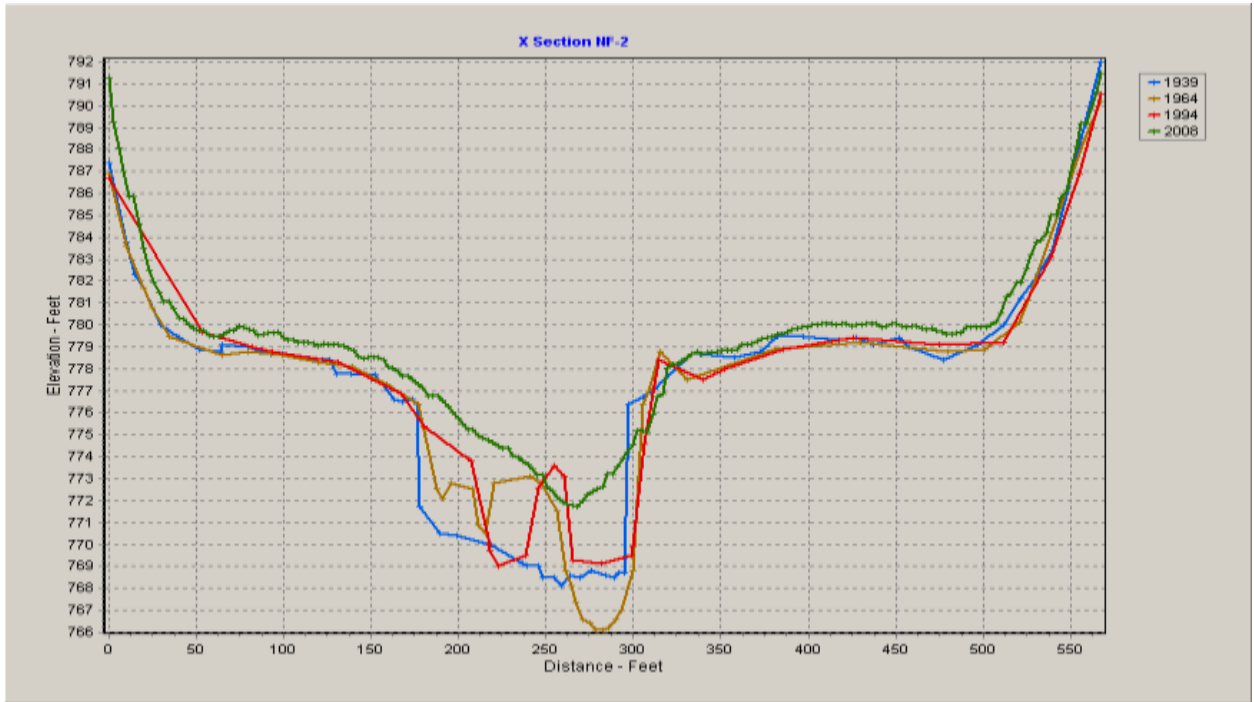
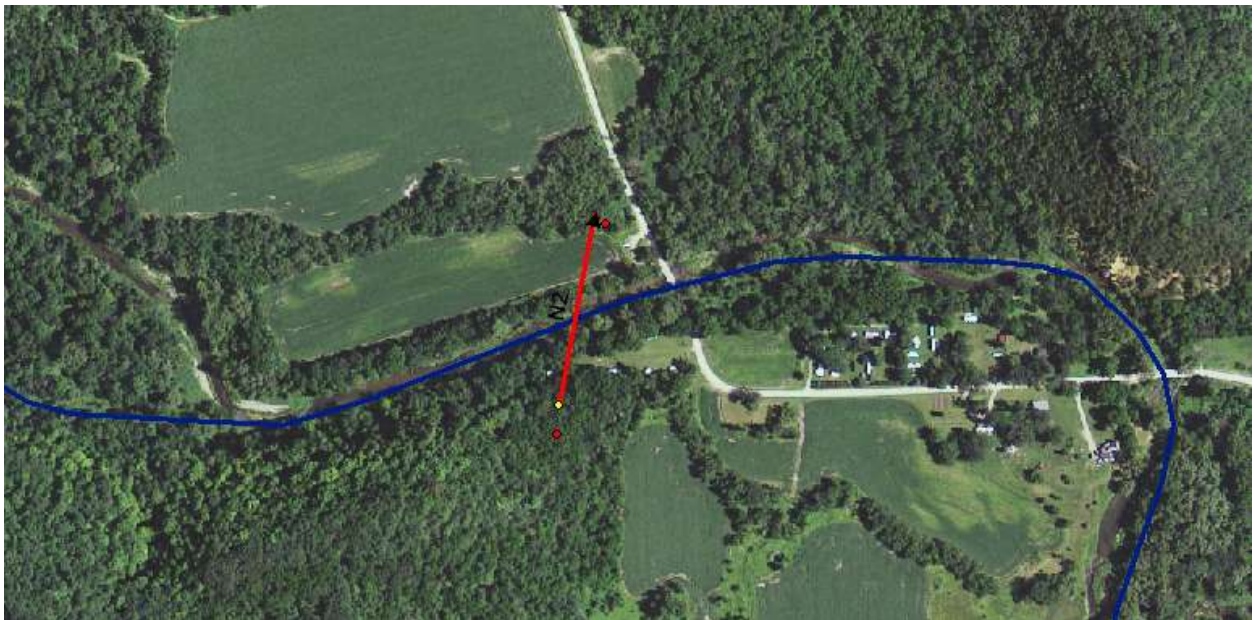
X Section Range N2 on the North Fork of Whitewater. 0+00 is located right down stream and is the south end of the line. NF-2-N has been damaged by excavation on the site and is lying on the ground. Location was determined by bearing and distance from original survey.

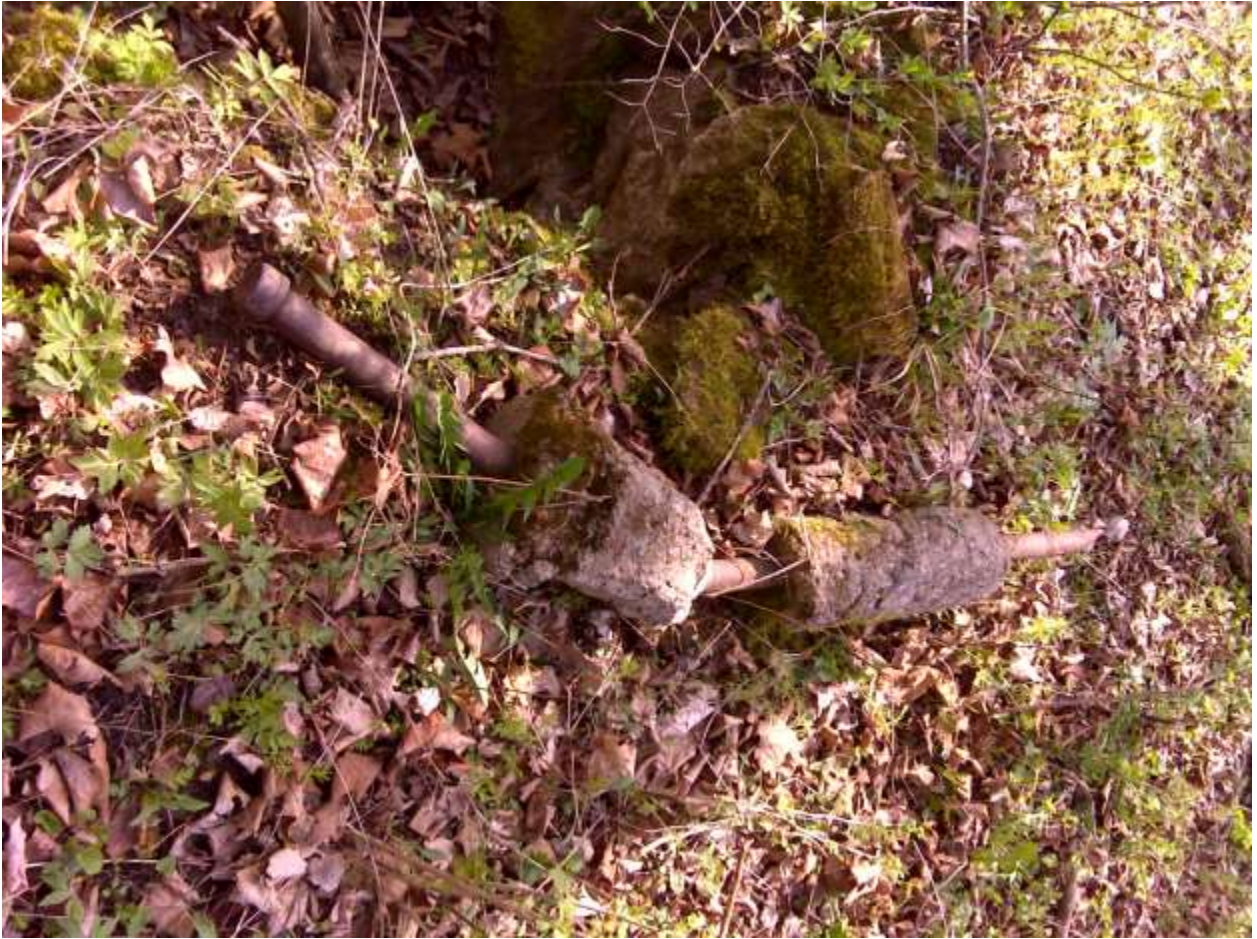
Monument N2-N has been destroyed and was lying on the ground. Located 5/6/11. You can also see remnants of the stone foundation of the house that was in the area. Its position assumed based on location of monument N-2-S, length of x-section range and azimuth from original survey. Photo by author.

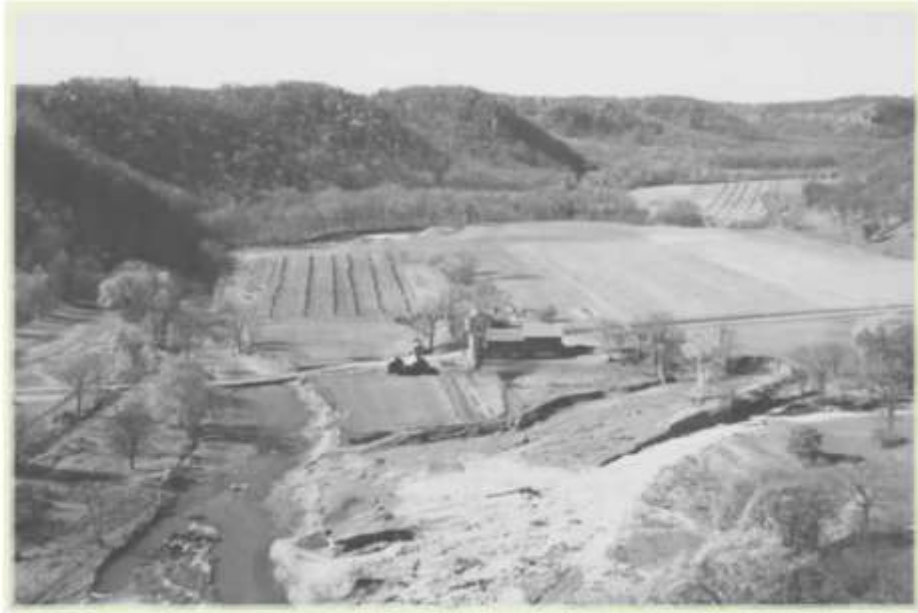
Fairwater Crossing cir. 1940. This is the location of Range NF-2. The photo was taken 1 year after the establishment of the range. Monument NF-2-N was located very near the center of the photo. According to the original notes it was close to the foundation of the house located on the back side of the road. Monument NF-2-S is located out of the photo to the left. Photo courtesy of the Whitewater River Watershed Project.

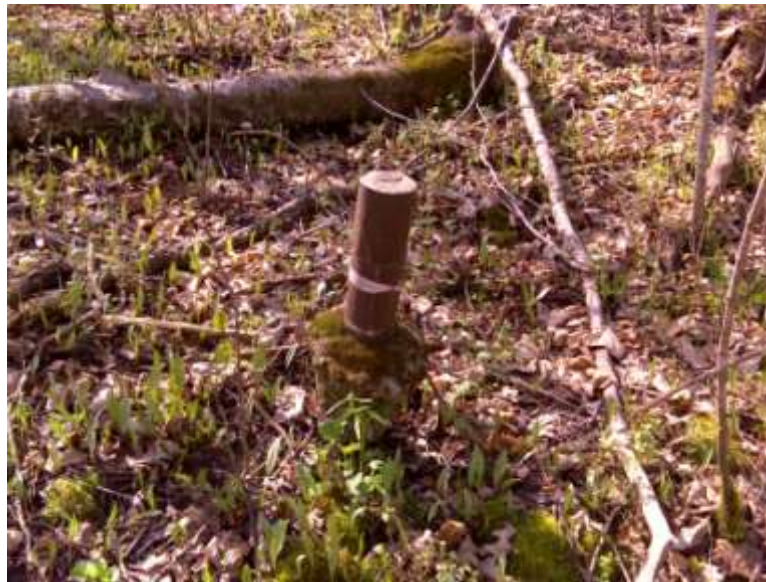
Monument N-2-S. Located 5/6/11. Also referred to in the survey notes as N-2-S. Notice the height of original ground based on concrete level. Unsure if the monument is pushing up or the land is eroding down around the monument. It is near a private campground and there is potential of disturbance based on the fate of other monuments near similar campgrounds. Photo by author.

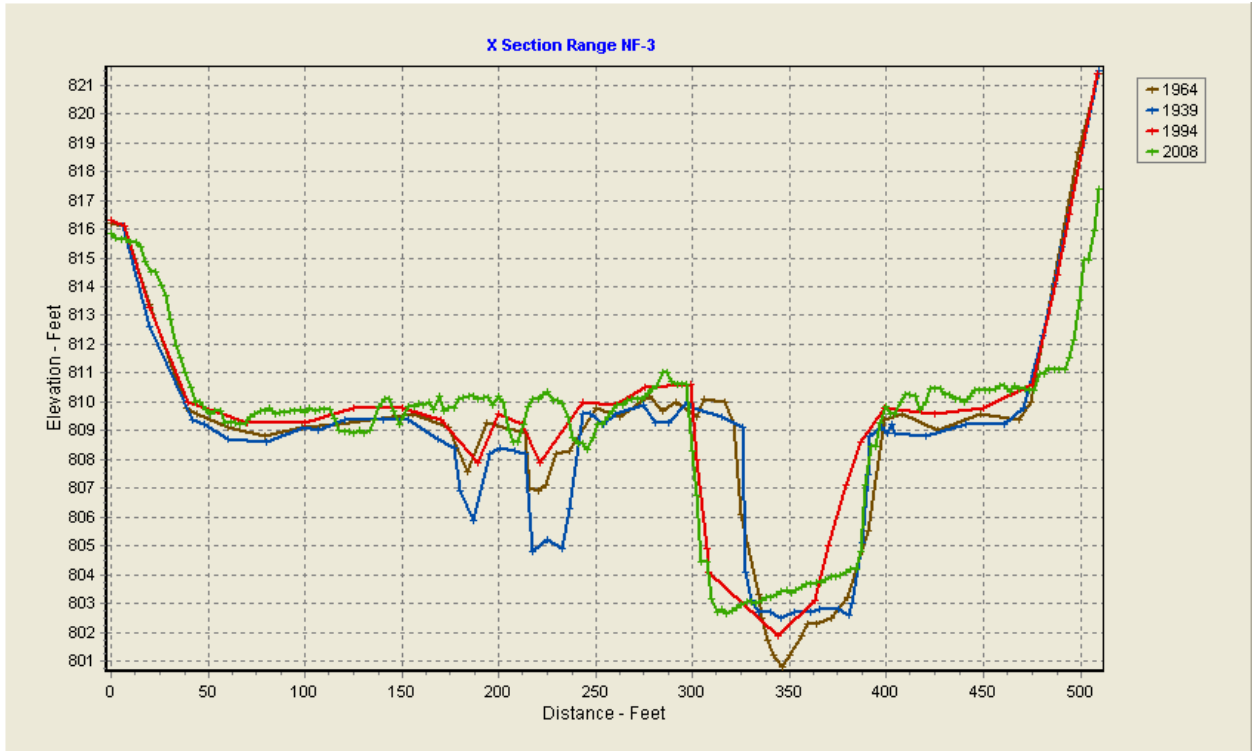
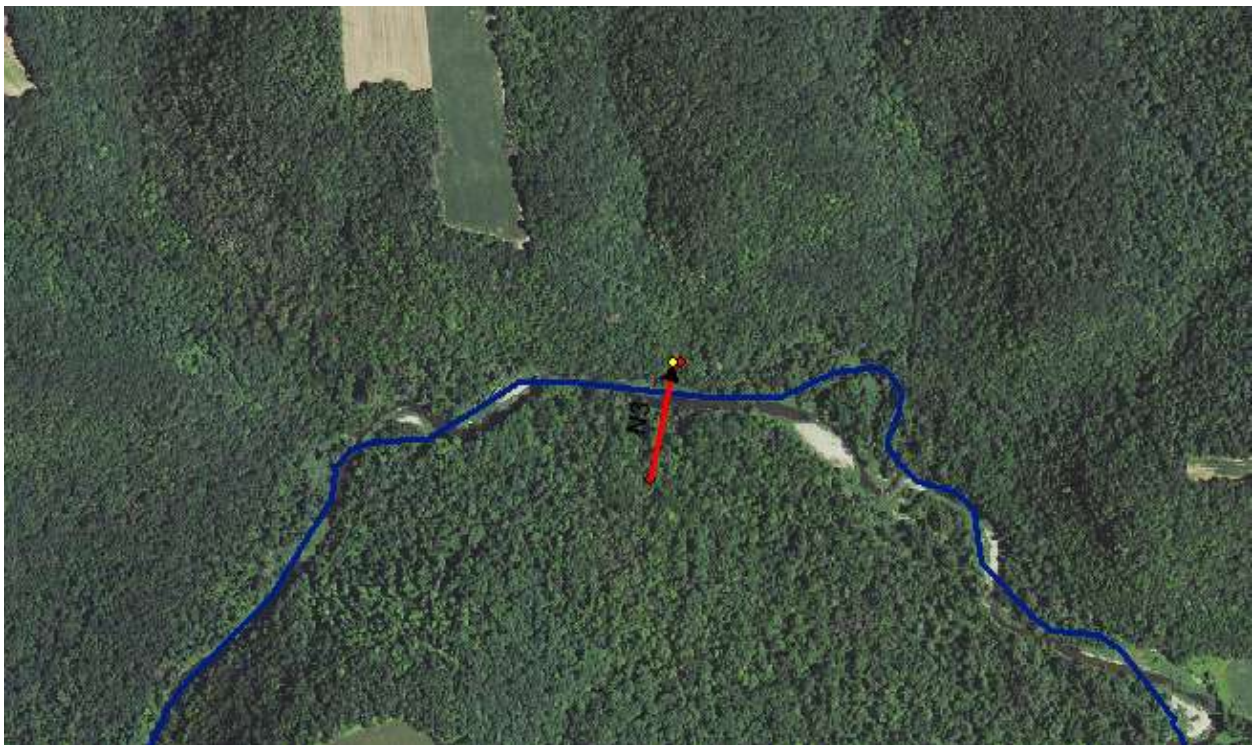
X Section Range N3 North Fork Whitewater. 0+00 is located right down stream and is located on the south end of the line.

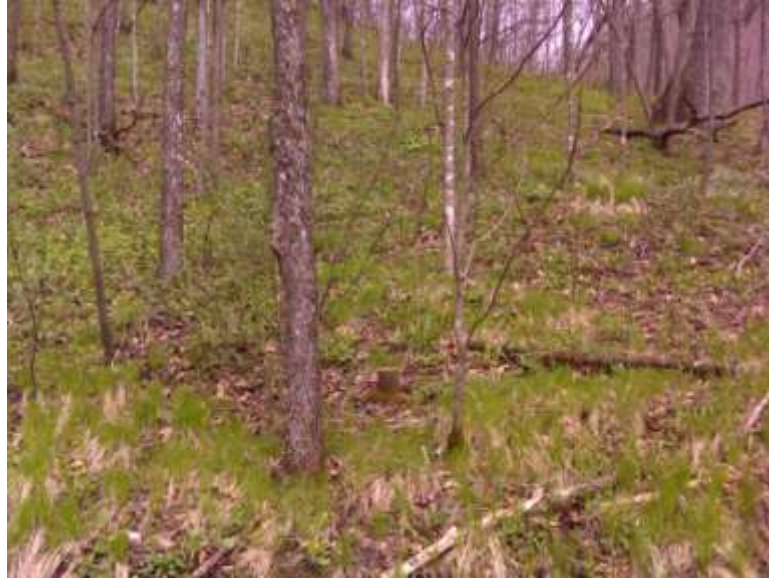
Monument N-3-L Located 5/6/11. Photo by author

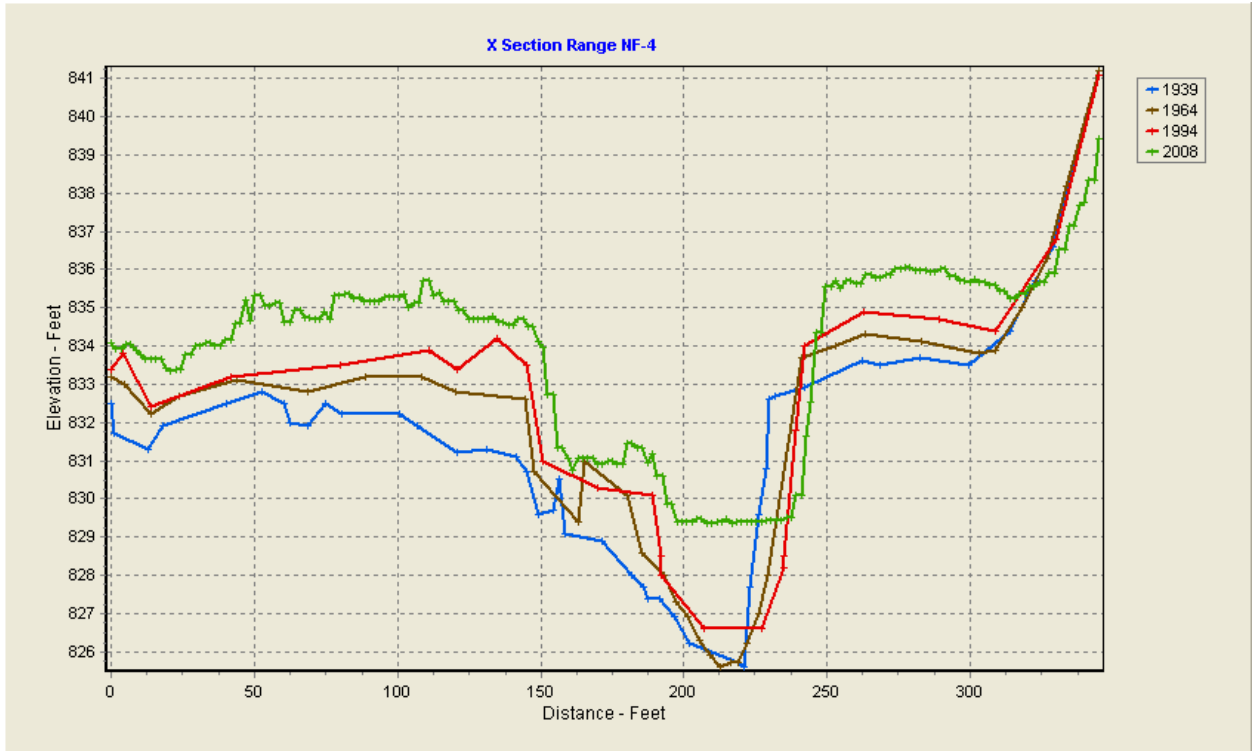
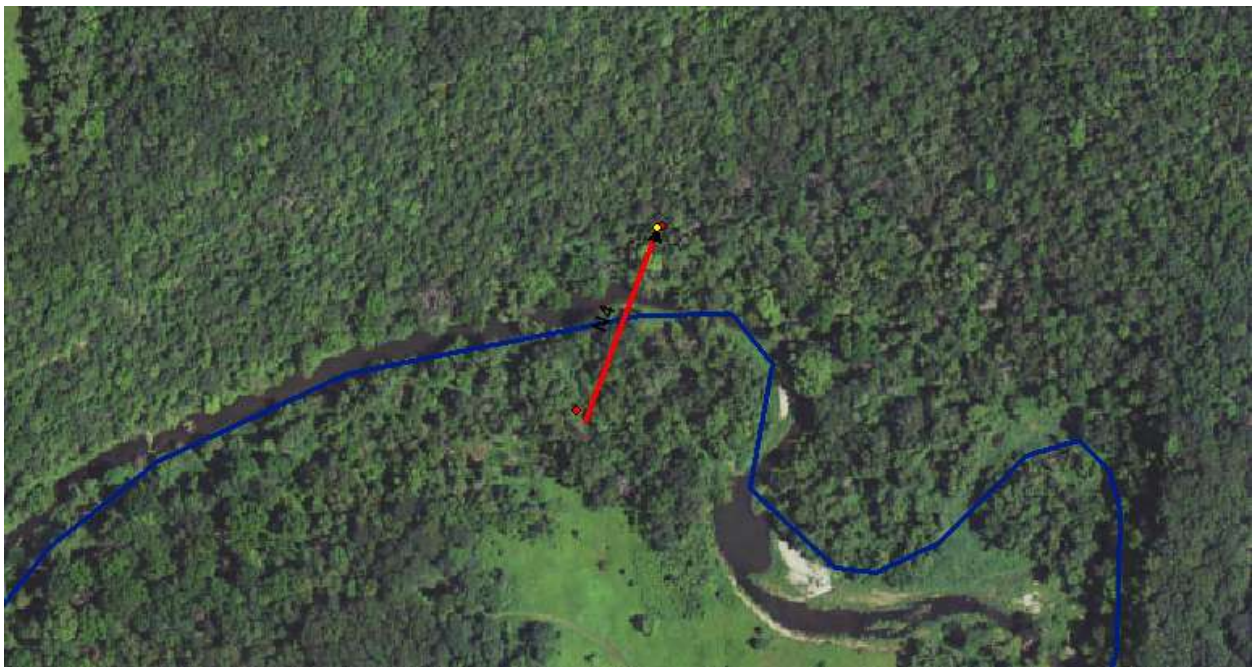
X Section Range NF-4 North Fork of the Whitewater. 0+00 is located right down stream and is on the south end of the line.

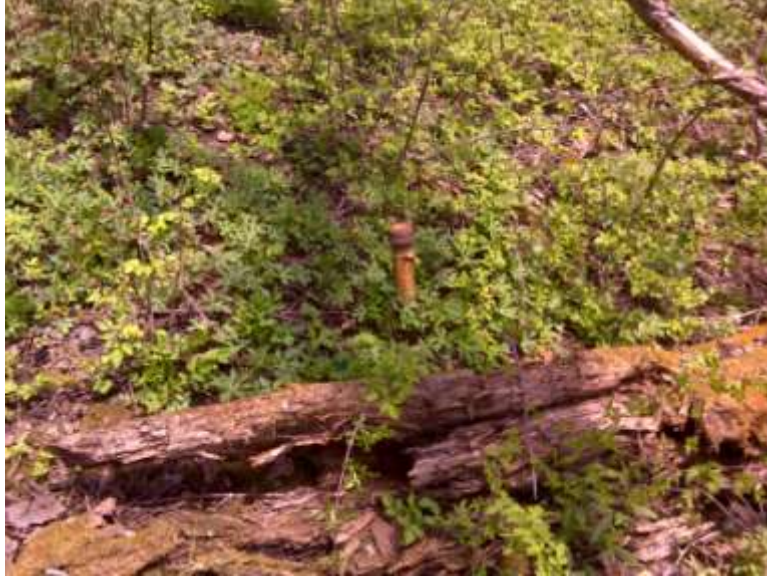
Monument N-4-L. Located 5/6/11. Photo by author

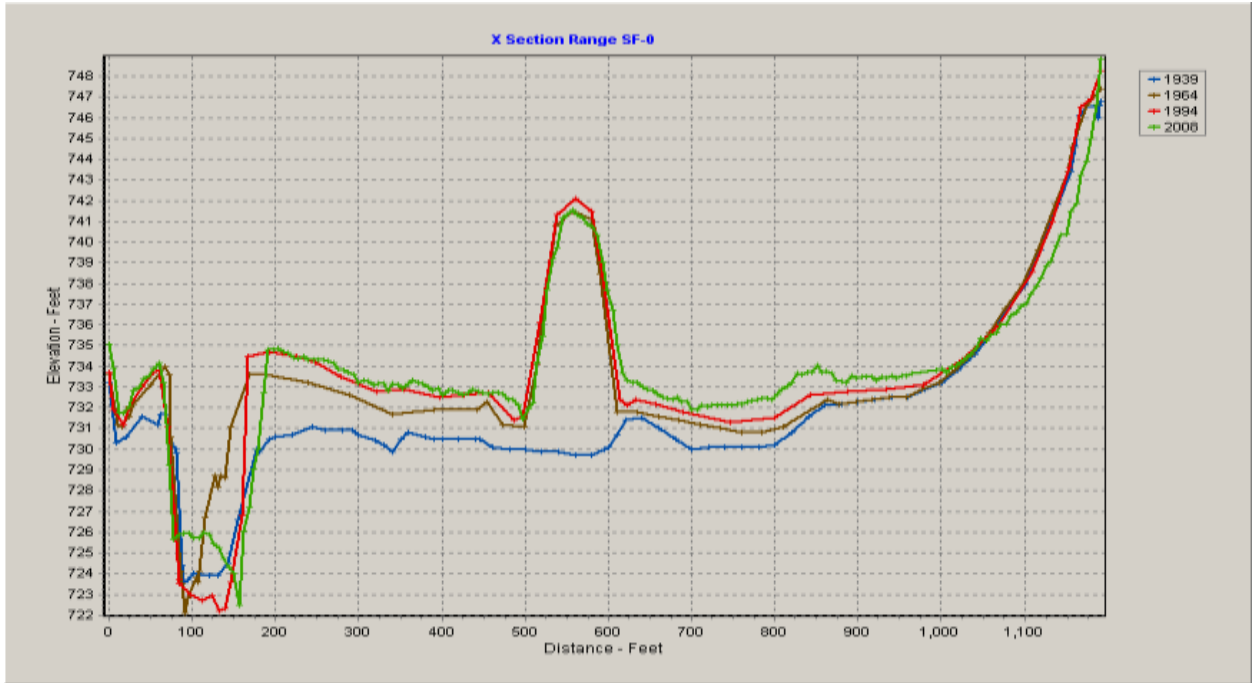
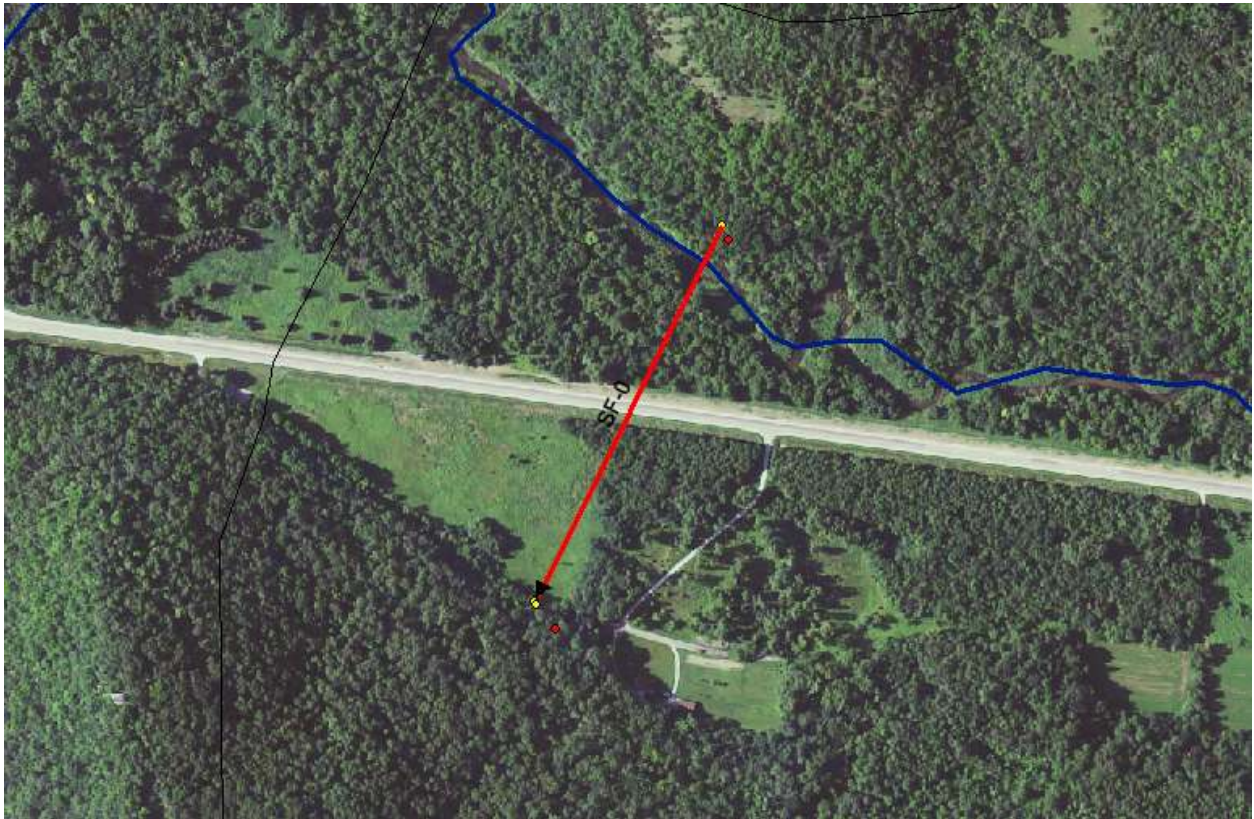
X Section Range SF-0 South Fork of the Whitewater River. 0+00 is located right down stream and is on the northeast end of the line.

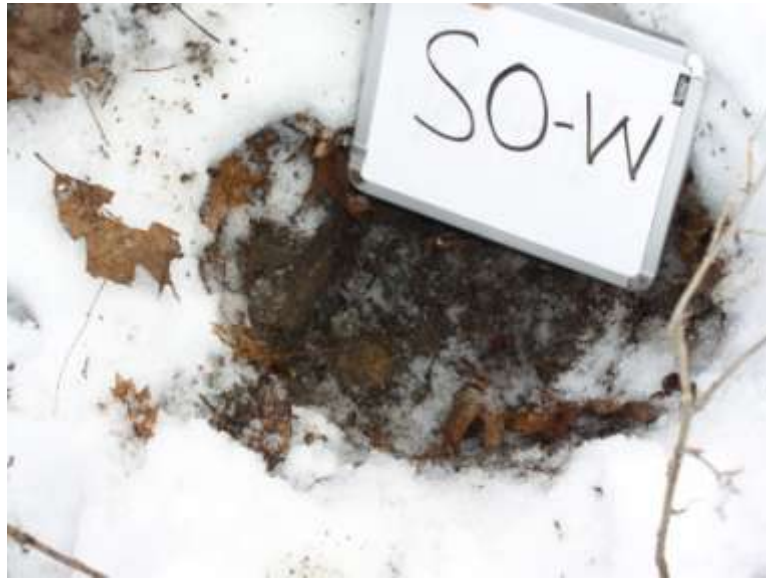
Monument SF-0-W. Located 2/10/09. Monument is slightly buried approximately 2 inches below the surface of the ground. Photo by Doug Christianson.

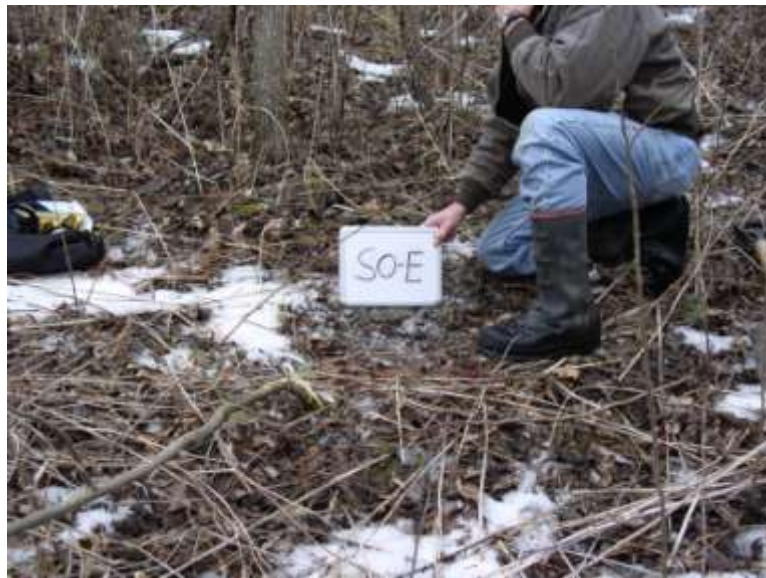
Monument SF-0-E. Located 2/11/09. Photo by Doug Christianson.

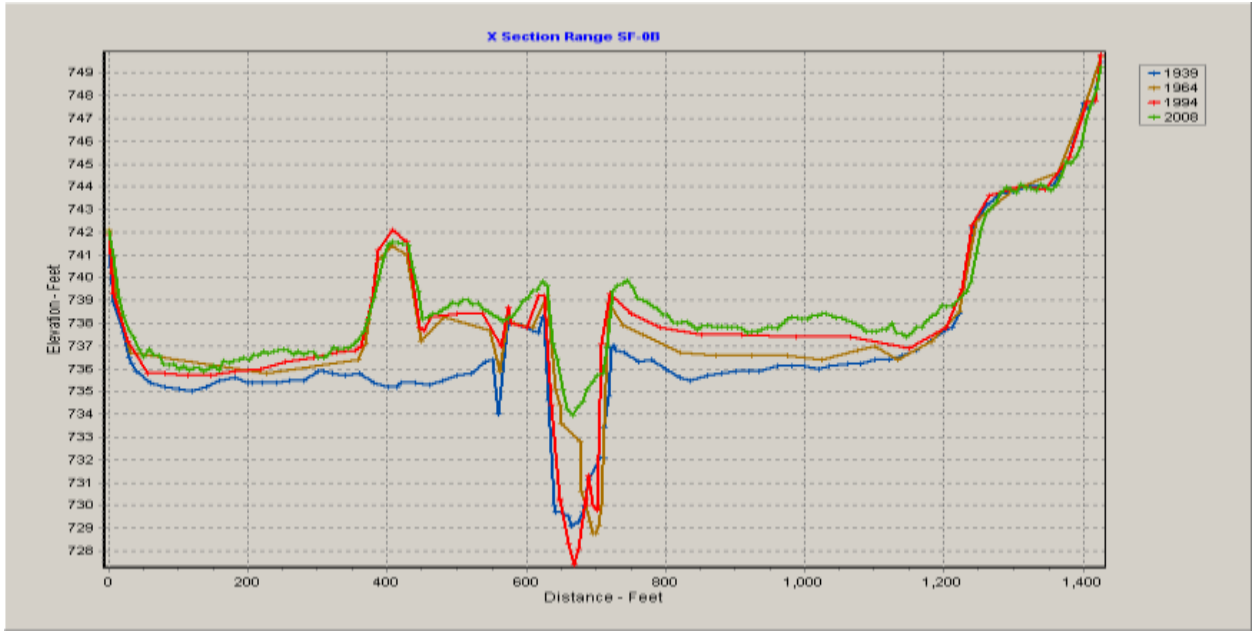
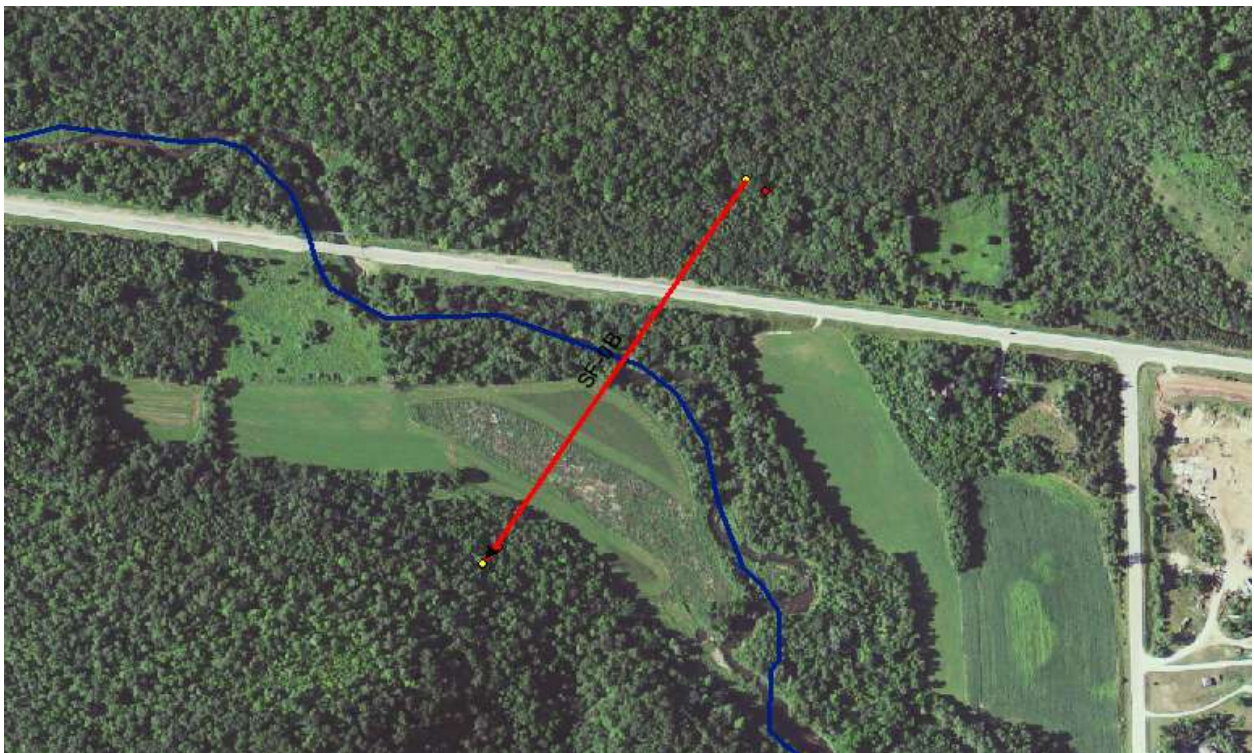
X Section Range SF-0B South Fork of the Whitewater River. 0+00 is located right down stream and is on the northeast end of the line.

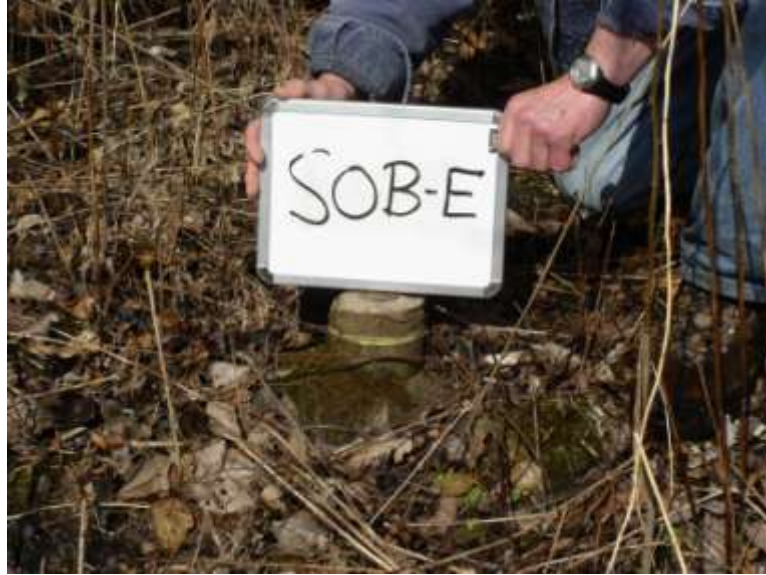
Monument SF-0B-E. Located 3/6/09. This is the 0+00 beginning point of the range. Photo by Doug Christianson

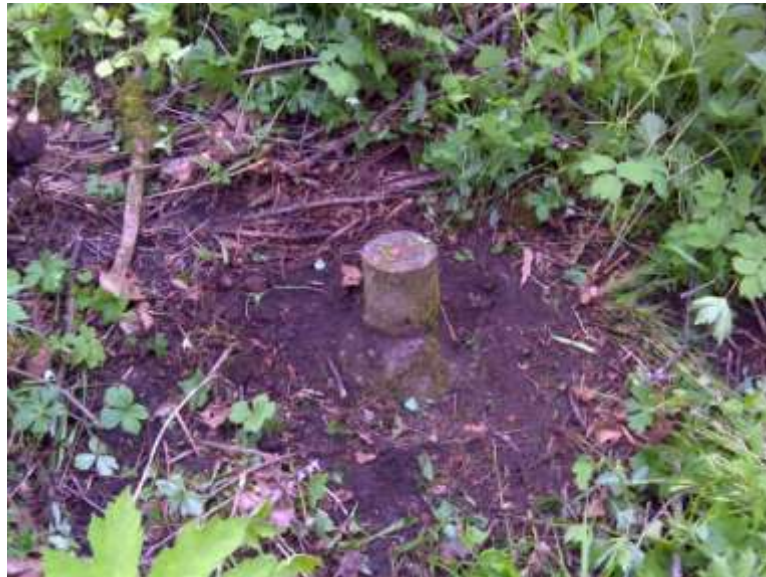
Monument SF-0B-W. Located 5/18/11. Photo by author.

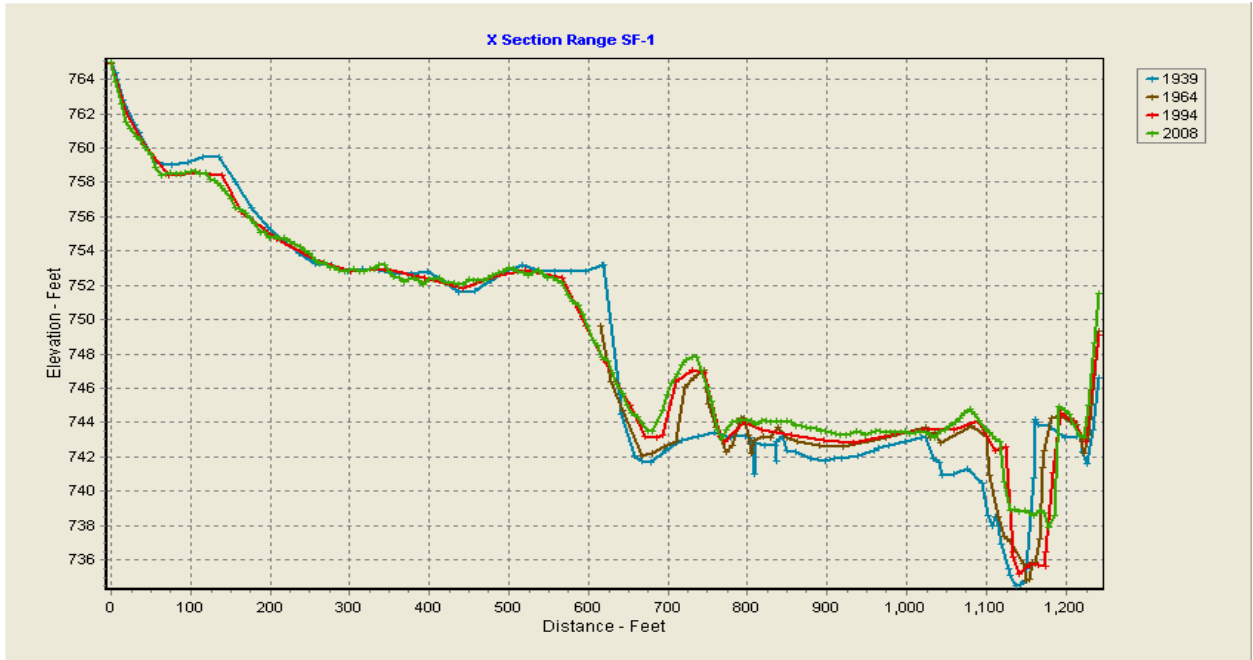
This section shows the installation of the road and the extension of the range between the 1939 and 1964 surveys

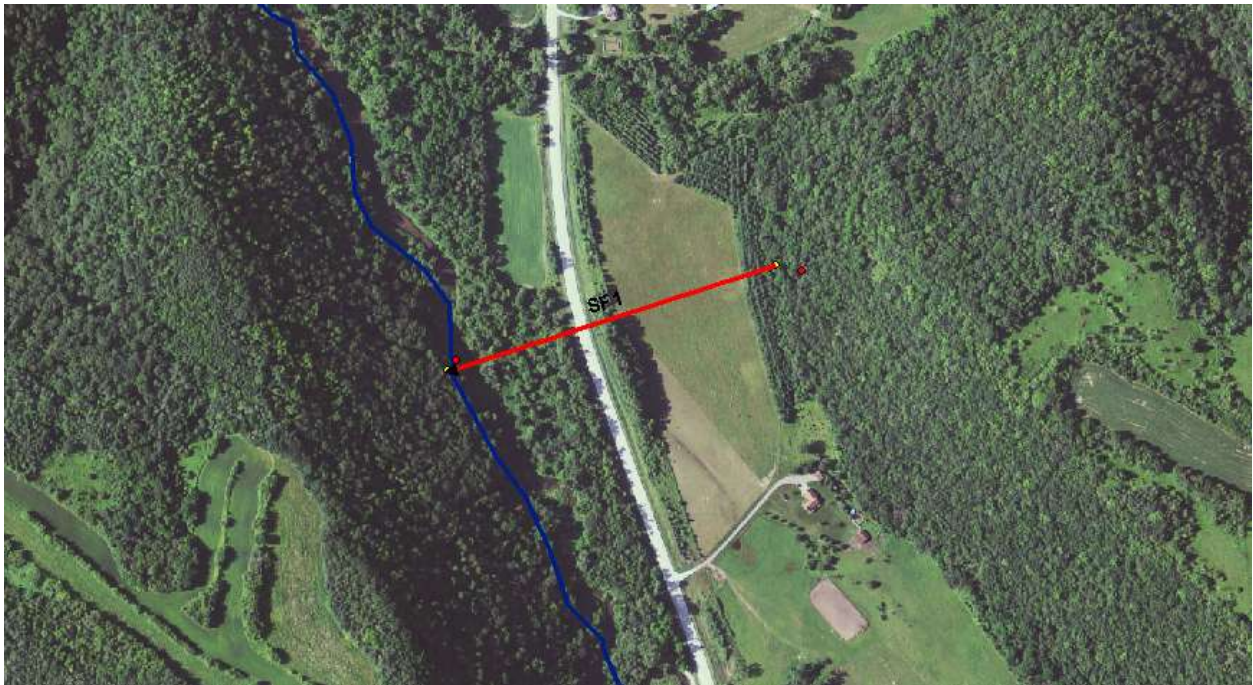
X Section Range SF-1 South Fork of the Whitewater River. 0+00 is located right down stream and is on the east end of the line.

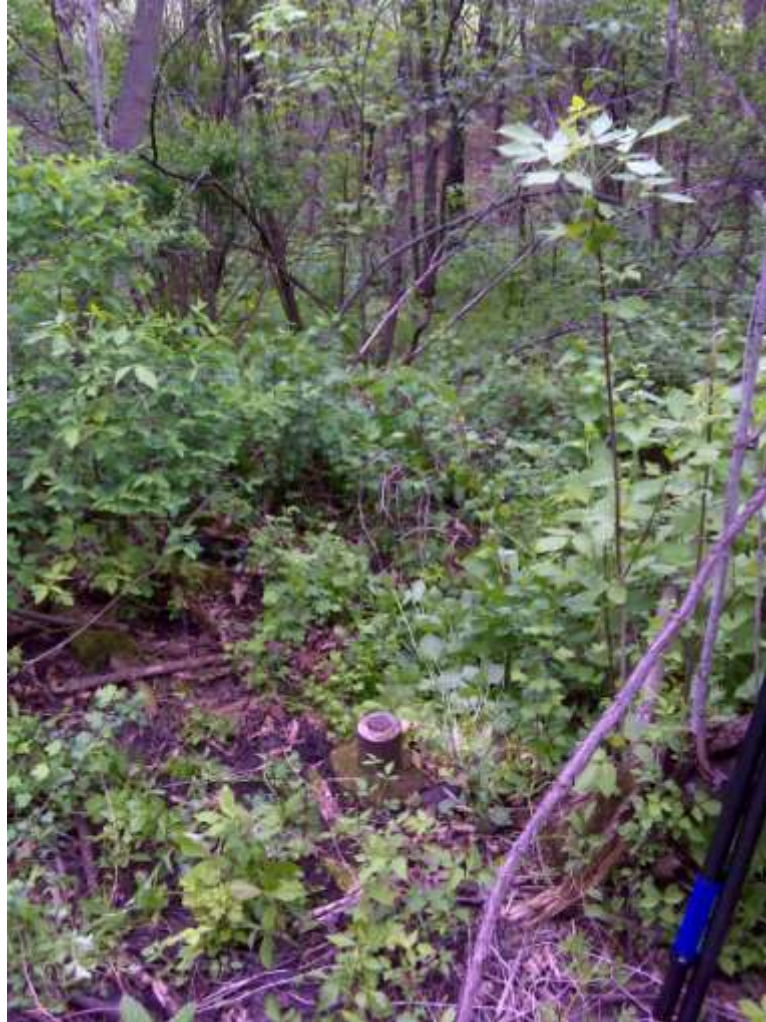
Monument S-1-E. Located 5/18/11. This view is along the x-section line toward S-1-W. This is the 0+00 beginning point of the range. The landowner was aware of what the monument was about and what it was used for. He was enthusiastic about maintaining the monument. Photo by author

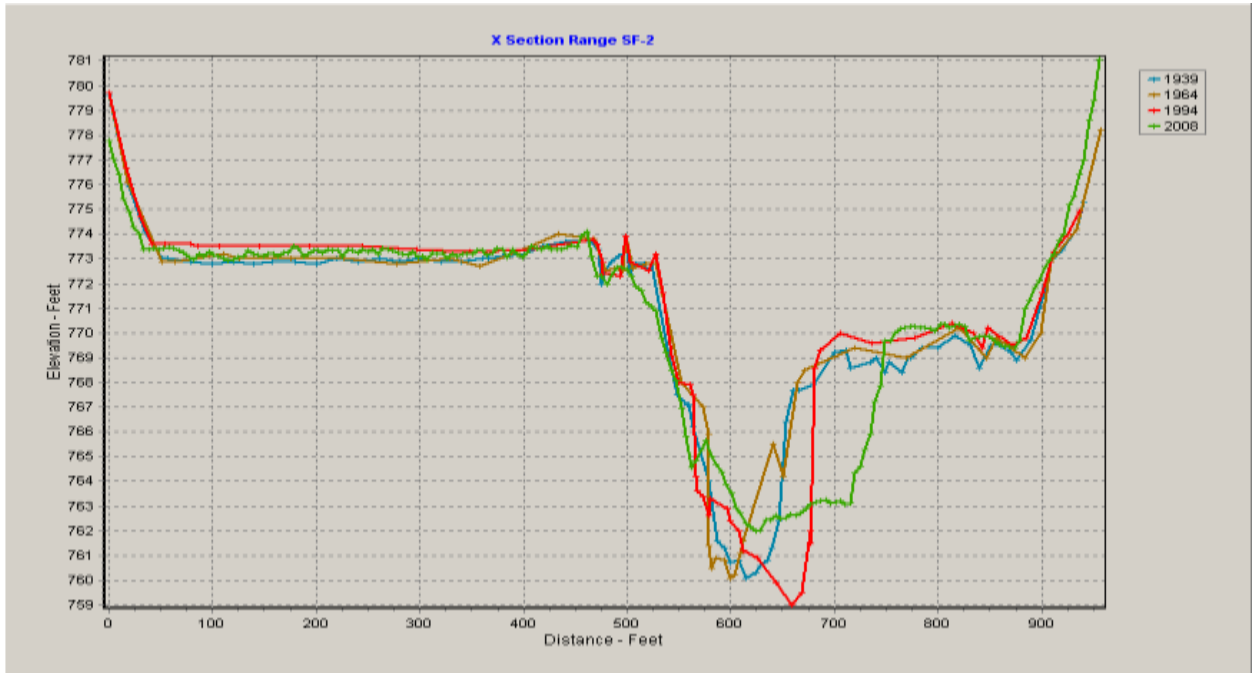
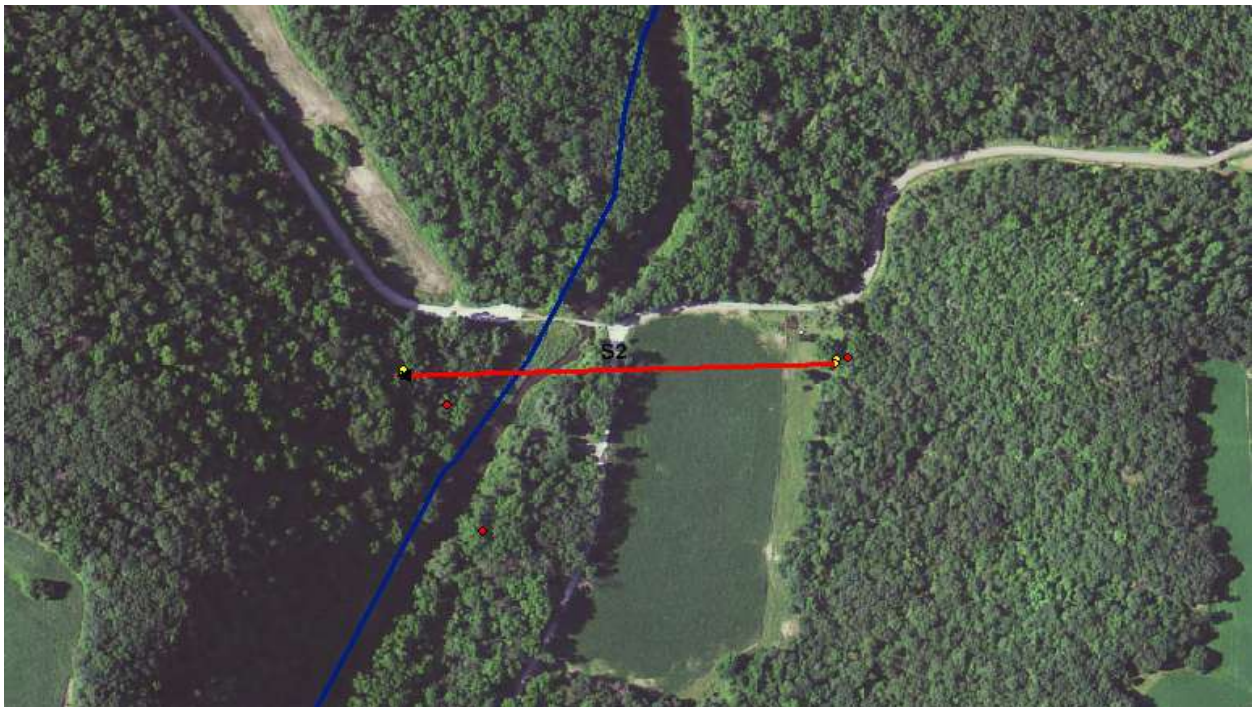
Section Range SF-2 South Fork of the Whitewater River. 0+00 is located right down stream and is on the east end of the line. Site along channel is very disturbed. Bridge below line is washed out and only suitable for foot traffic. Approximately 500 feet upstream of the S-2-W monument is a USGS stream gauging station.

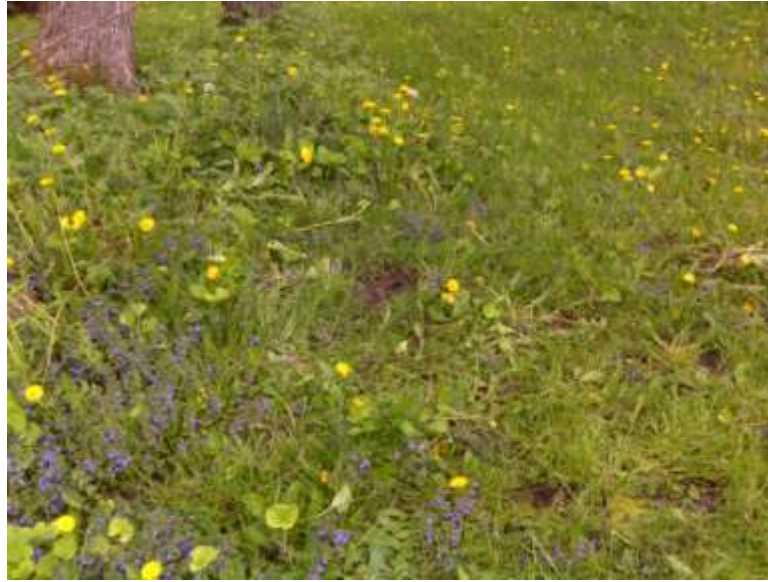
Monument S-2-E. Located 5/20/11. Located in the middle of a private campground. It is about 1-2 inches below ground. It would appear the cap has been torn off and the monument damaged. Based on appearances the elevation may be suspect but the XY is probably accurate. Photo by author.

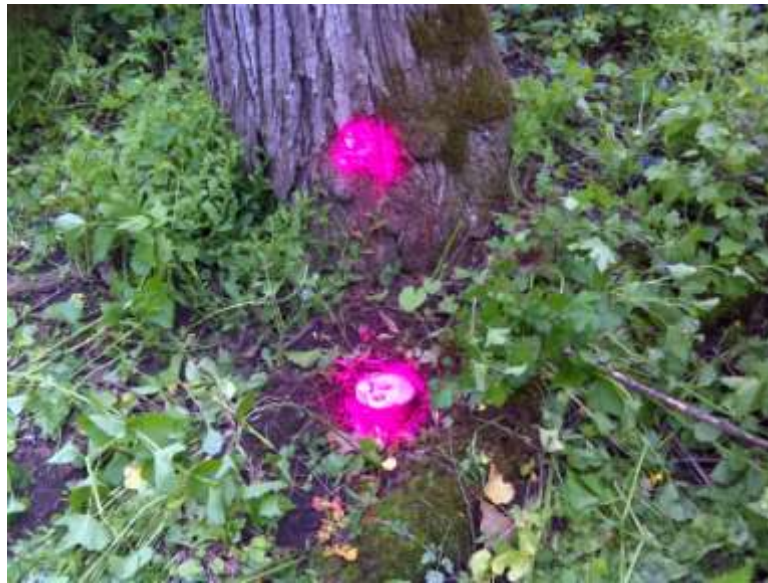
Monument S-2-W. Located 5/20/11 Photo by author

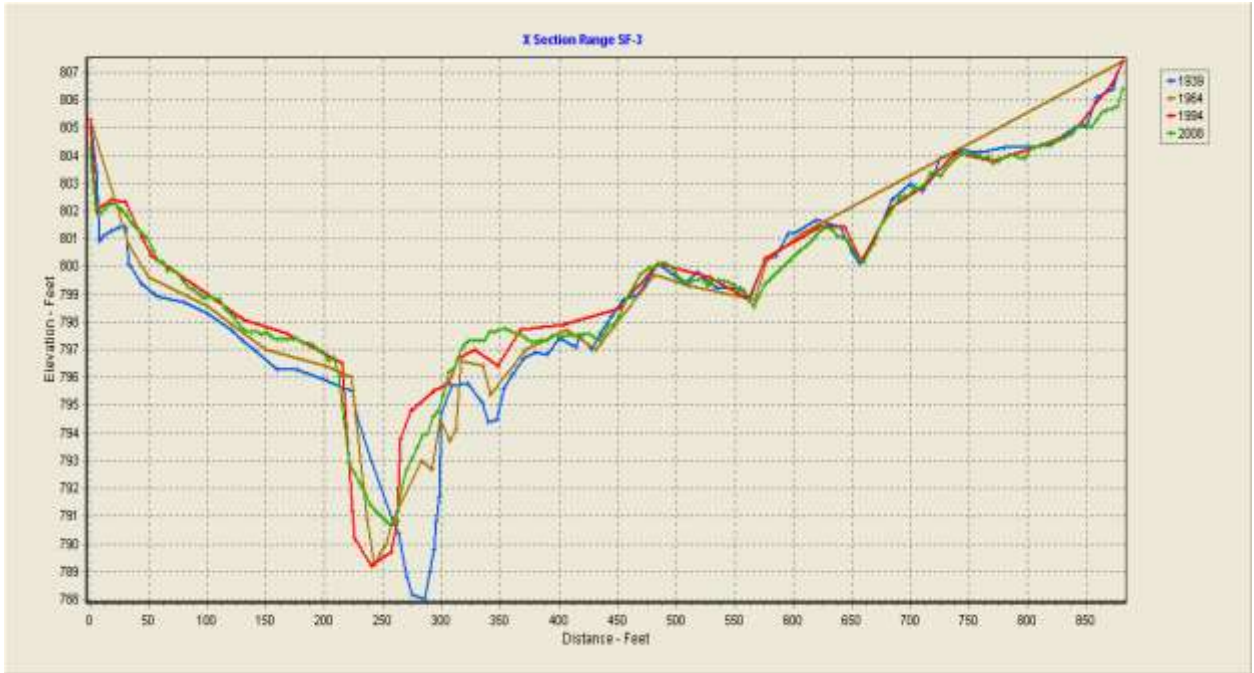
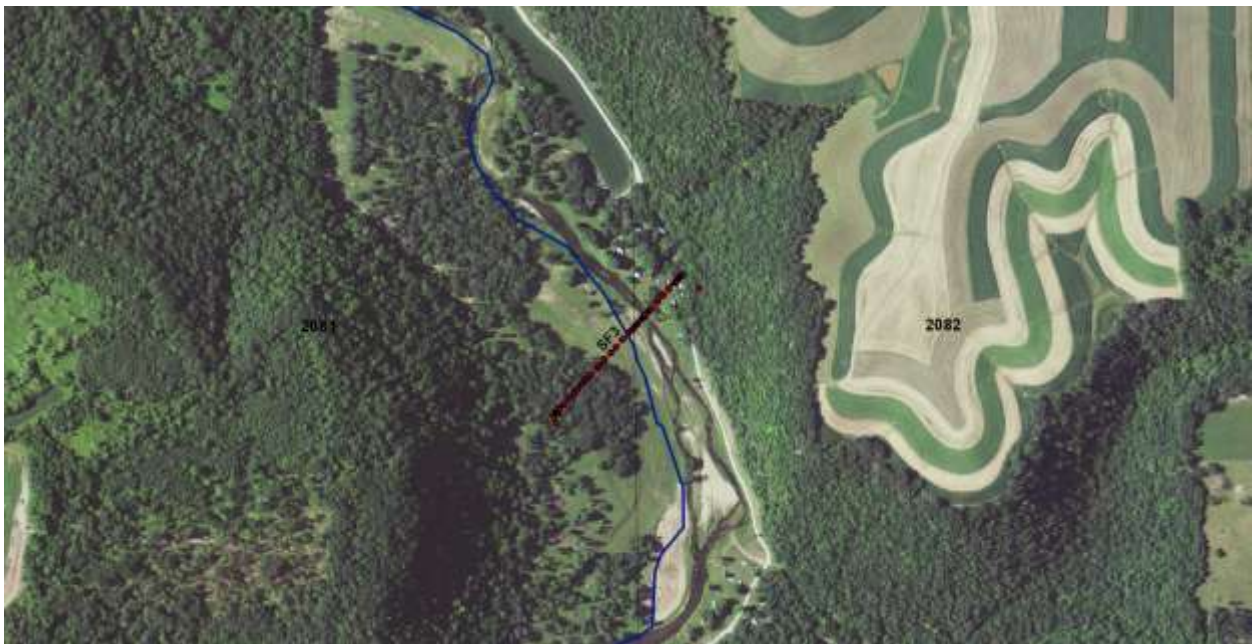
X Section Range SF-3 South Fork of the Whitewater River. 0+00 is located right down stream and is on the northeast end of the line.

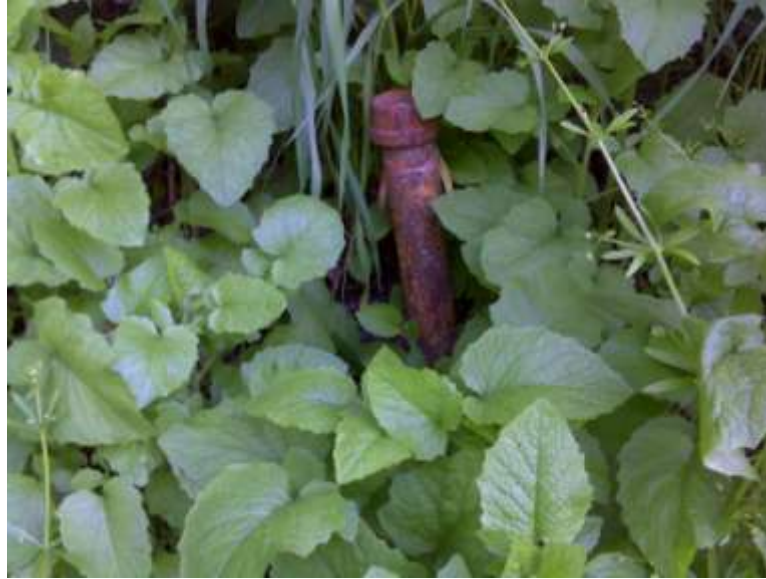
Monument S-3-R. Located 6/2/11. Right adjacent to a township road and just across the road from a private campground area. While it would appear to be well hidden in this photo it does visibly stand out when the vegetation is down or dead. Somewhat surprising that the monument has not been disturbed. Photo by author.
