# **The Restoration of a Historical Sediment Study and the use of LiDAR in the Determination of Elevations in the Whitewater River Valley.**

By Lawrence Svien, Graduate Student, Penn State MGIS program

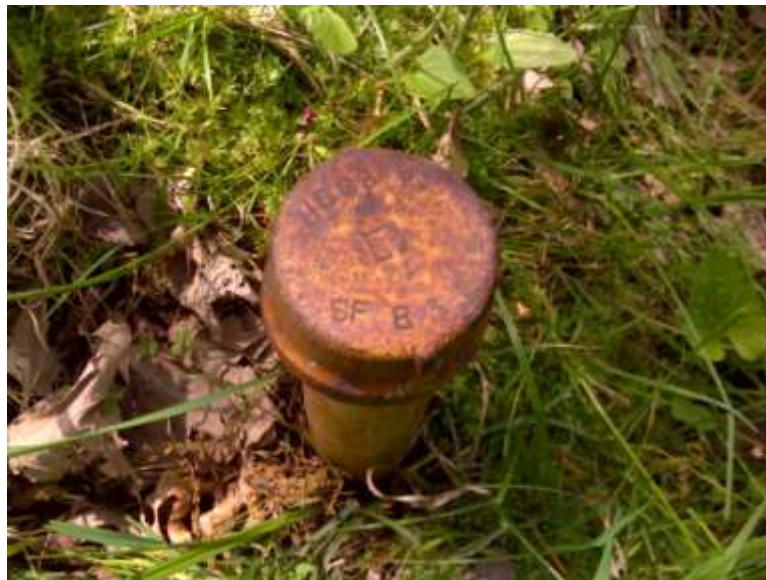
Monument S-3-L. Located 6/2/11. Located in a pasture area with scattered trees. This is also an example of how most of the caps are stamped. In this example it is a close up photo of the cap stamped with USGS and SF R 3 L. Photo by author

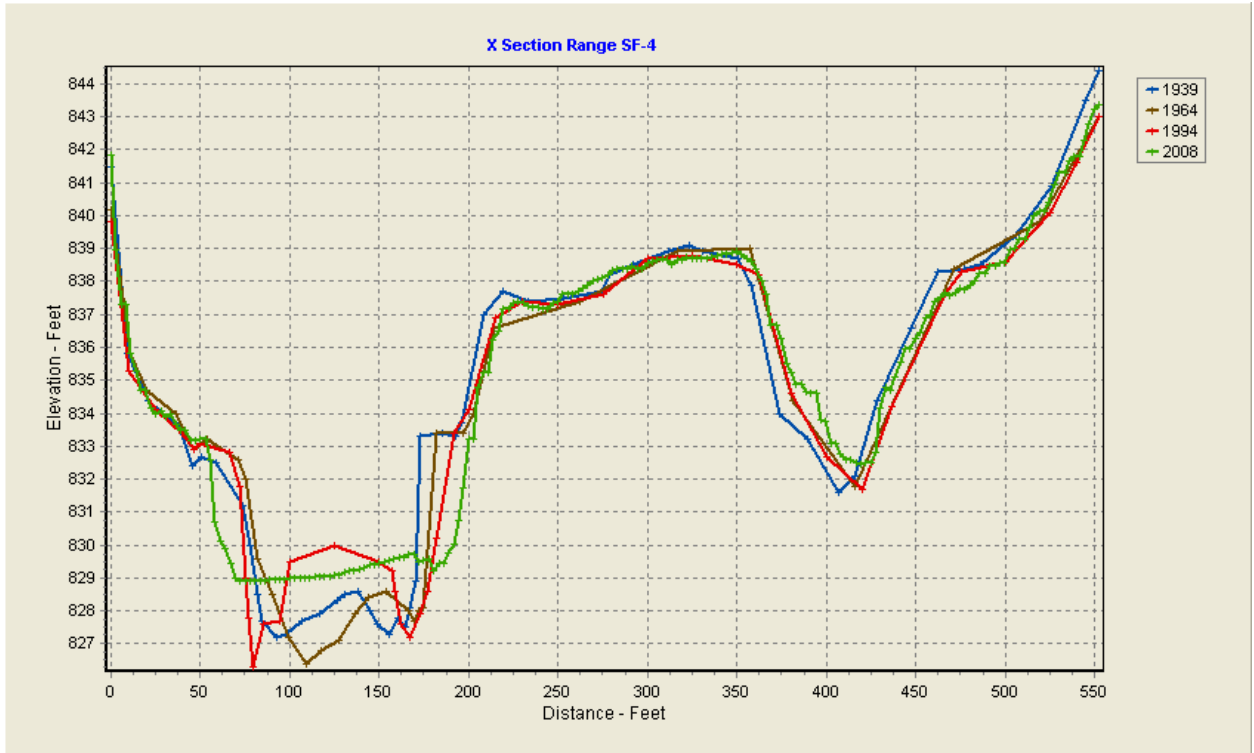
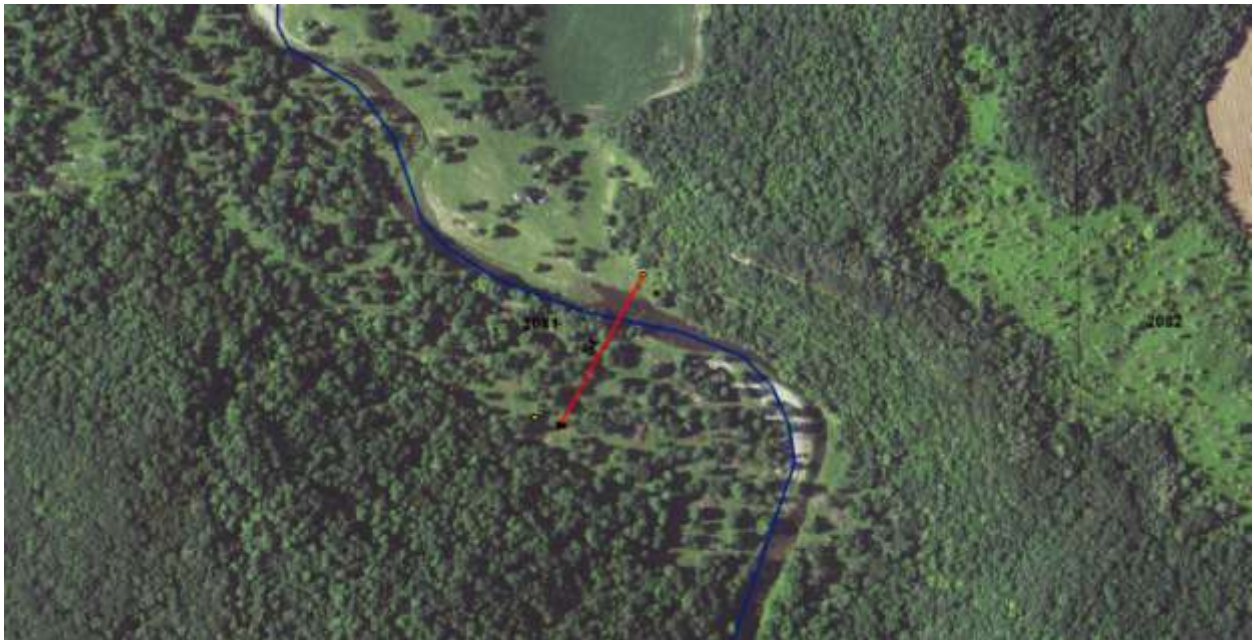
X Section Range SF-4 South Fork of the Whitewater River. 0+00 is located right down stream and is on the northeast end of the line.

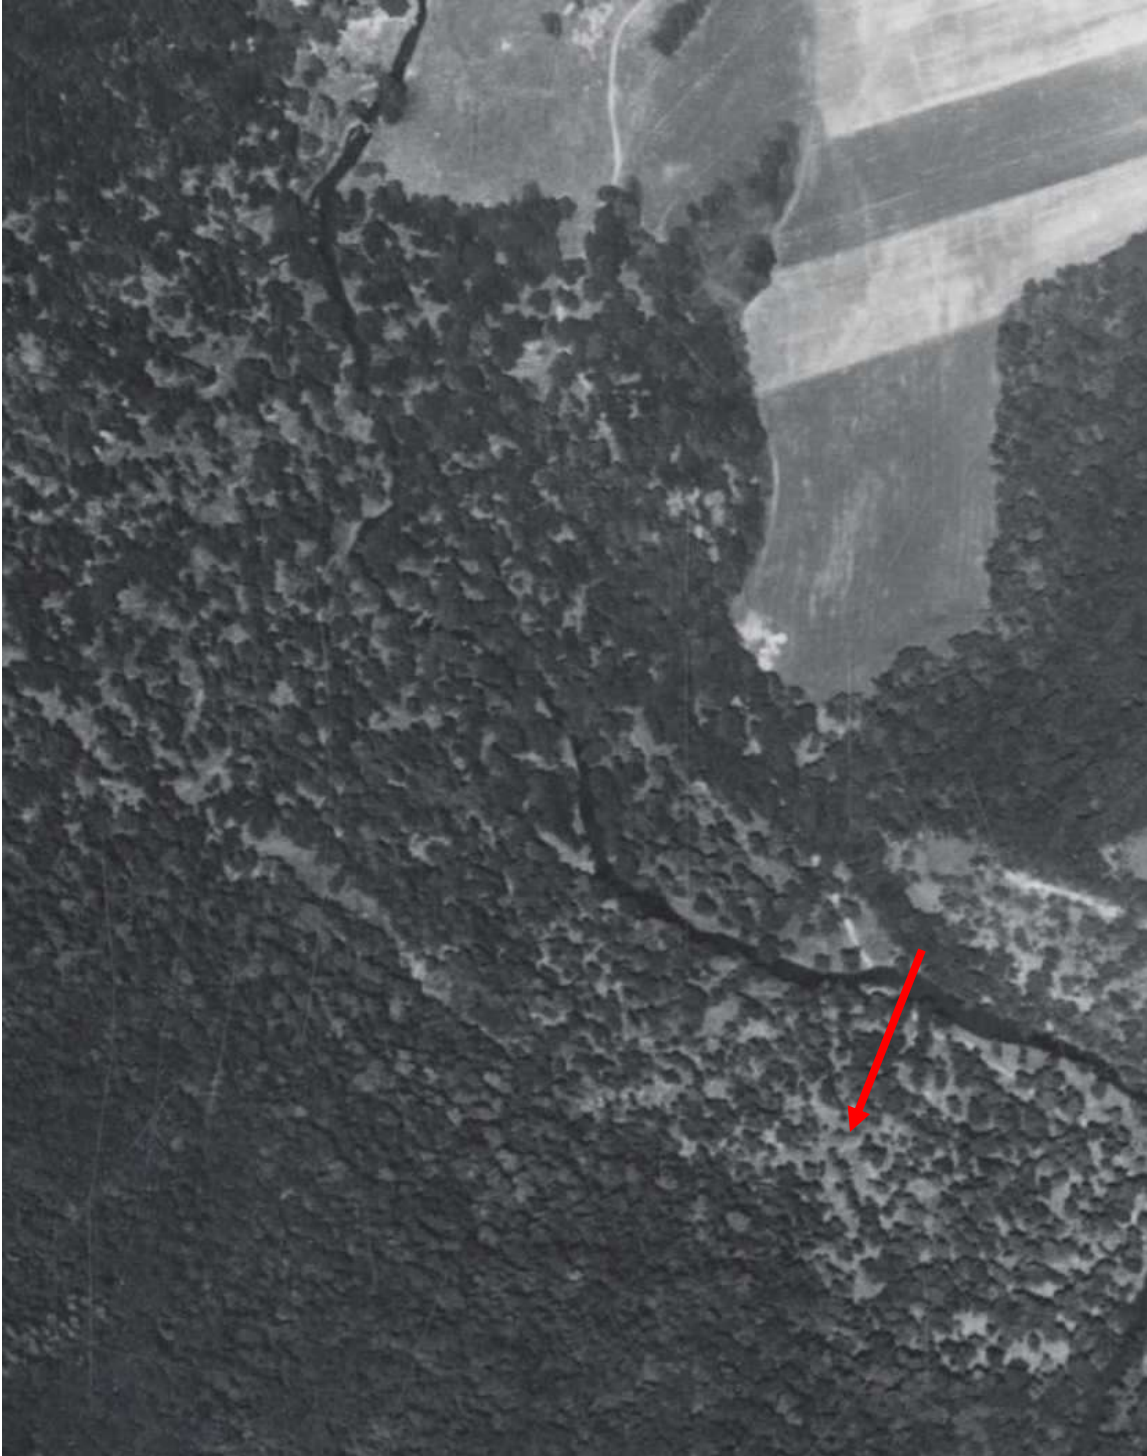
X Section Range SF-4 1954 photo of area around SF-4. Location of x section range is approximate. Note that stream is much narrower and heavier woodland cover than the 2010 photo above. Landowner is actively removing trees at the time of this study. Background photo courtesy of USDA NRCS.

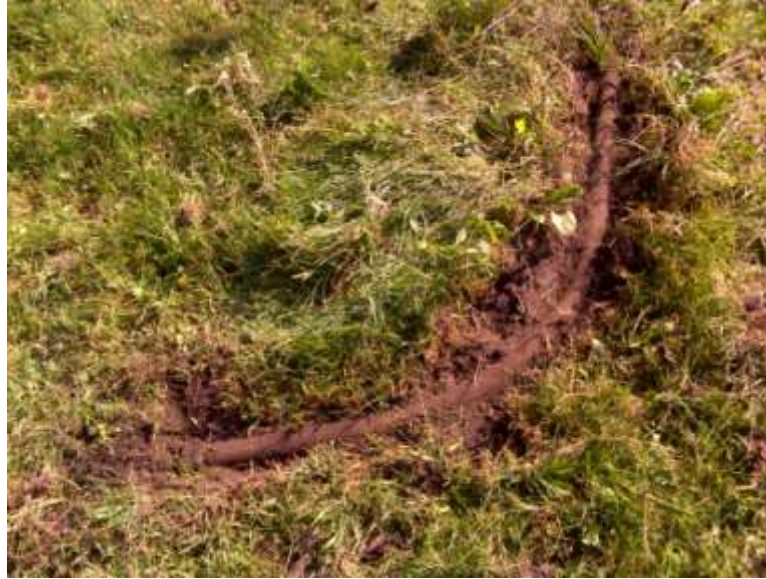
Monument SF-4-L. This area is near a private campsite with 80 – 100 sites, the area is highly disturbed with lots of human presence throughout the year. It would appear that monument was pulled out with a chain and bent in the process. Monument pipe was laying on surface of the ground and it appears to have lain there for quite a while. Monument was located and recorded during the 1994 survey. Its present location was noted and recorded but more for posterity than any scientific reason. Lying approximately 45 feet from expected location based on the location of SF-4-R, distance of x section, and azimuth recorded in previous surveys. Photo by author

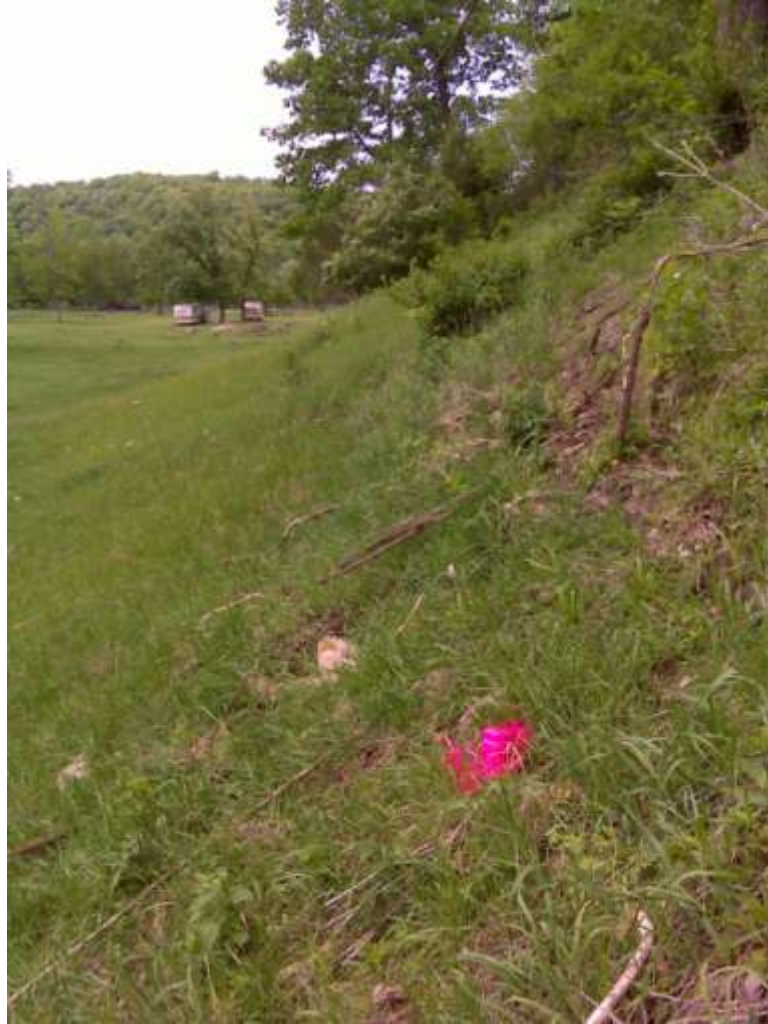
Monument SF-4-R. Located 6/2/11. Notice campground in background. This is one of approximately 80 in the area. Much long term human disturbance in the area. Photo by author.
